Taxiway Overflight  
Air Canada Flight 759  
Airbus A320-211, C-FKCK  
San Francisco, California  
July 7, 2017

NTSB/AIR-18/01  
PB2018-101561

# Aircraft Incident Report

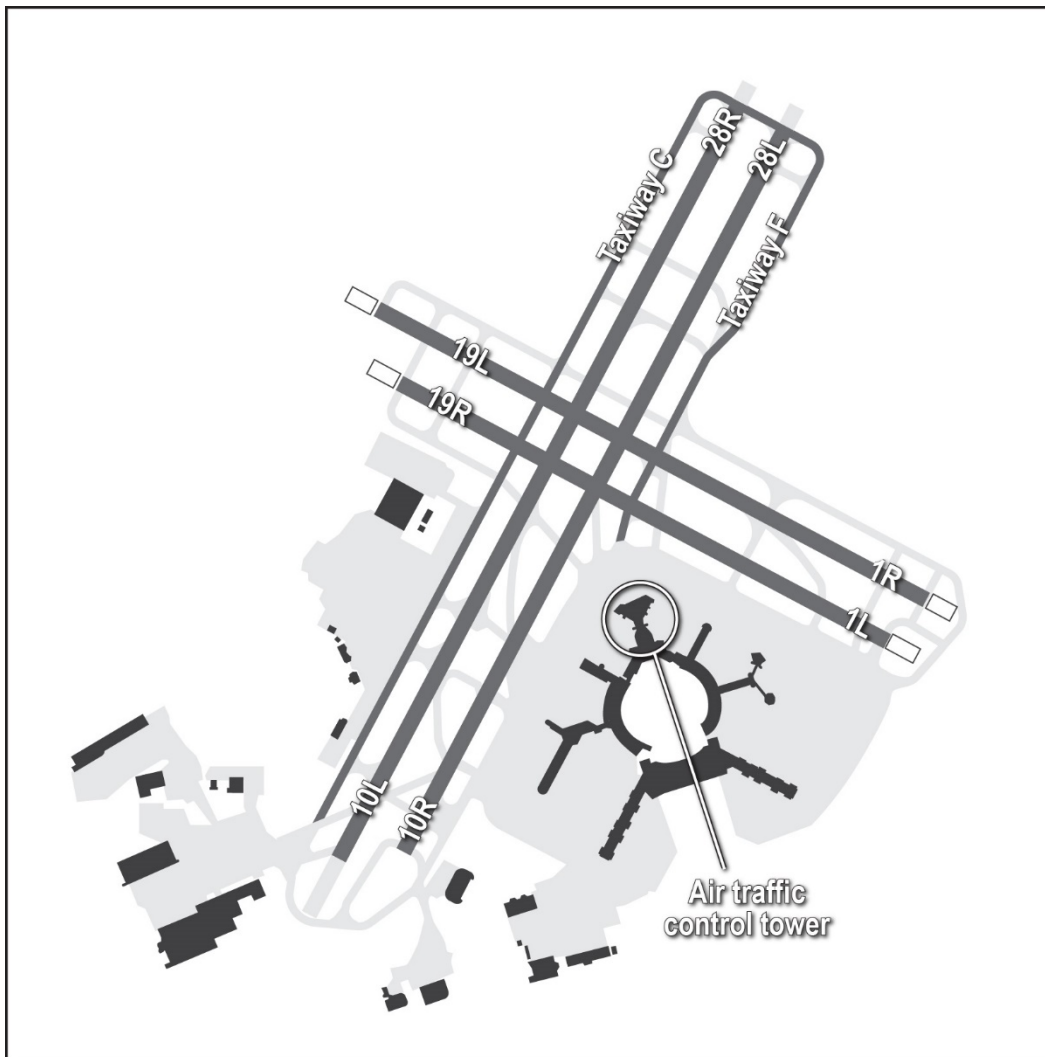
**Figure 3.** SFO layout map.

Because the flight crewmembers were not aware of the runway 28L closure, they were likely expecting SFO to be in its usual configuration, which would include runway 28L being open for departures and arrivals and airplanes using taxiway F (as shown in figure 3) to reach the departure end of runway 28L. Because of the runway 28L closure on the night of the incident, airplanes were using taxiway C to depart from runway 28R.
