Collision Between Freight Train and Charter Motorcoach at
High-Profile Highway–Railroad Grade Crossing
Biloxi, Mississippi
March 7, 2017

NTSB/HAR-18/01
PB2018-101328

Highway Accident Report

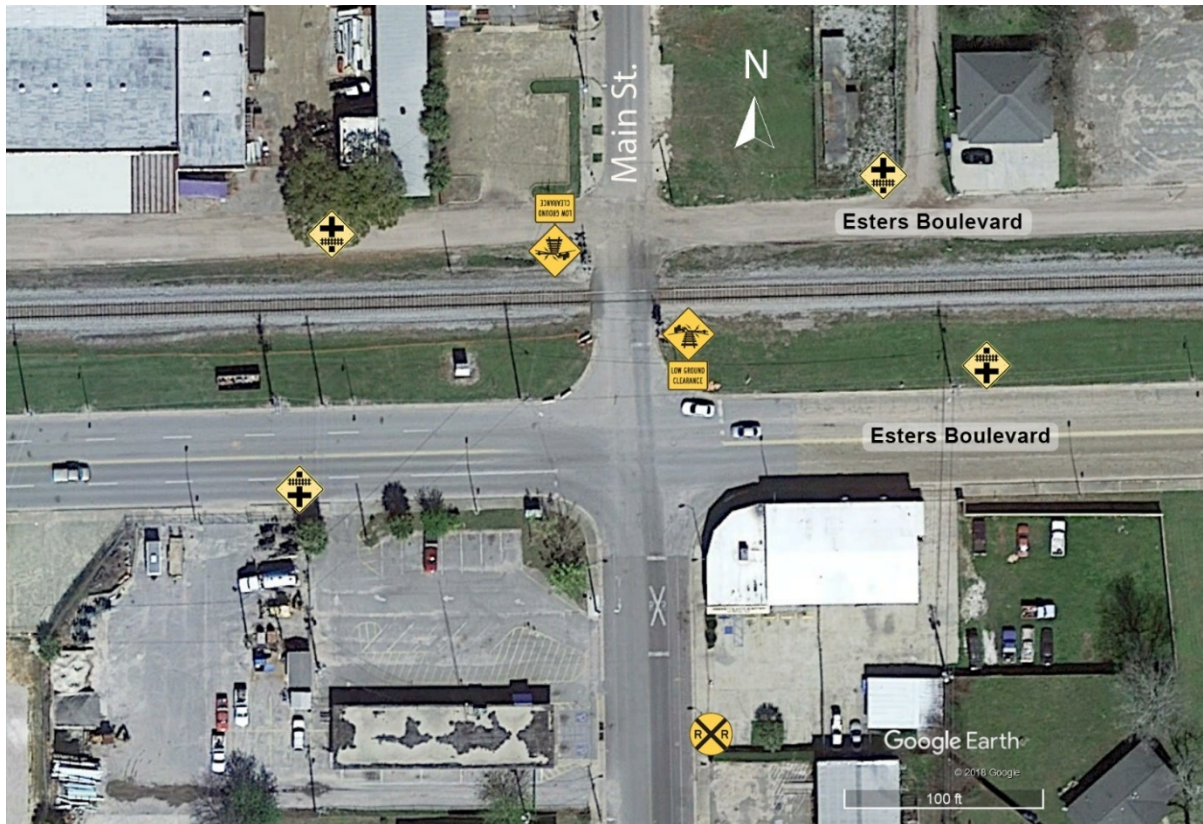
1.5.3.1 Pavement Markings. The northbound approach to the Main Street grade crossing is marked with a grade crossing pavement symbol, about 155 feet south of the railroad tracks (see figure 7). The southbound approach (north of the tracks) is not marked with a grade crossing pavement symbol. Both the northbound and southbound approaches to the crossing have worn, but visible, 2-foot-wide white stop lines. The line is located about 22.5 and 23 feet, respectively, from the nearest rail track on the northbound and southbound approaches.

Figure 7. Diagram of Main Street, grade crossing, and Esters Boulevard north and south of the crossing.

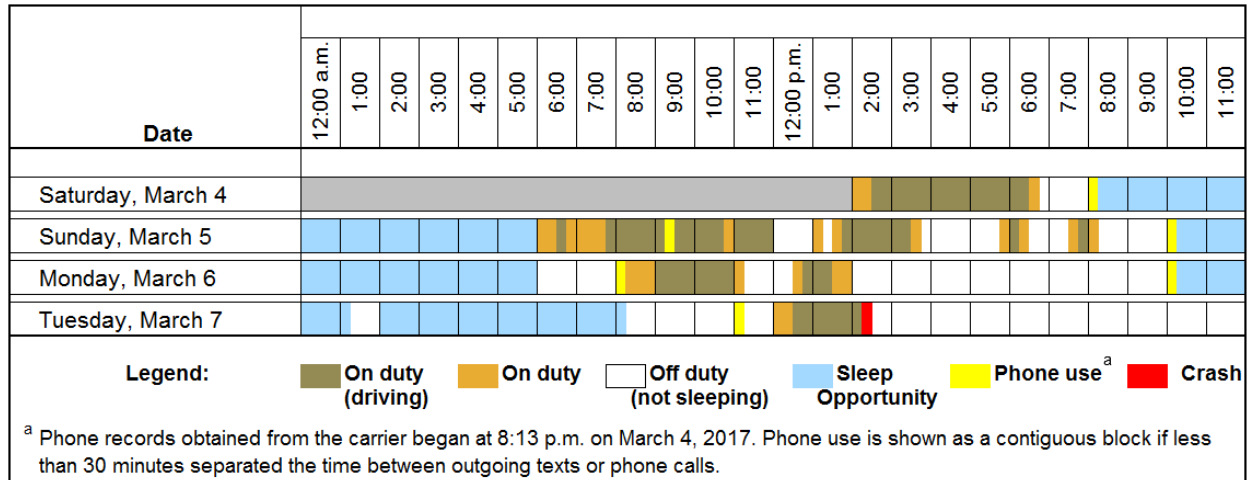
trip to Boomtown Casino in Biloxi. When the crash occurred, the driver had been on duty and driving for less than 2 hours. Figure 11 shows the driver’s activities for the 3 days before the crash.

Figure 11. Activities of the motorcoach driver, March 4–7, 2017. (Driver’s activity on March 4 before 2:00 p.m. is unknown.)

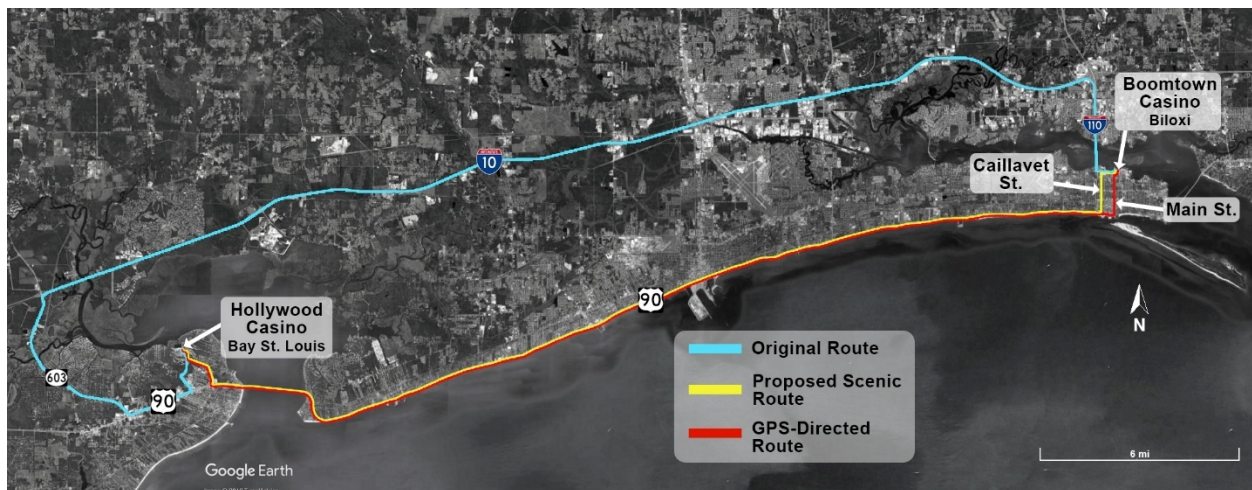
Soon after the ECHO Transportation motorcoach left Bay St. Louis, its group leader asked the driver if they could take a scenic route along US-90 to travel to the Boomtown Casino. In response, the driver began driving toward US-90. At that time, his GPS device recalculated its navigational instructions, which now directed the driver to Main Street in Biloxi and across the grade crossing. This GPS-provided scenic route, which the crash driver followed, was different both from the route included in the original Diamond Tours itinerary and from the optional scenic route with specific directions suggested by the Diamond Tours manager in her text message sent on the morning of the crash. (See figure 12 for a map showing the three routes from Bay St. Louis to Biloxi discussed above.)

Figure 12. Three alternative routes proposed for the motorcoach to travel from Hollywood Casino in Bay St. Louis to Boomtown Casino in Biloxi. The route in blue is the original planned route from the Diamond Tours itinerary; the route in yellow is the optional scenic route proposed by the Diamond Tours manager on the morning of the crash trip; and the route in red is the one indicated by the motorcoach driver's personal GPS device. The route in red is the crash route.
