School Bus Run-Off-Road and Fire
Oakland, Iowa
December 12, 2017

Highway Accident Report

NTSB/HAR-19/01
PB2019-100808

The National Transportation Safety Board (NTSB) determines that the probable cause of the fatal school bus run-off-road and fire in Oakland, Iowa, was (1) the driver's failure to control the bus, backing it into a roadside ditch for reasons that could not be established; and (2) the failure of the Riverside Community School District to provide adequate oversight by allowing a driver to operate a school bus with a known physical impairment that limited his ability to perform emergency duties. The probable cause of the fire was ignition of a fuel source on the exterior of the engine's turbocharger due to turbocharger overload and heat production, resulting from the blockage of the exhaust pipe by the bus's position in the ditch and the driver's attempts to accelerate out of the ditch. Contributing to the severity of the fire was the spread of flames, heat, and toxic gases from the engine into the passenger compartment through an incomplete firewall.

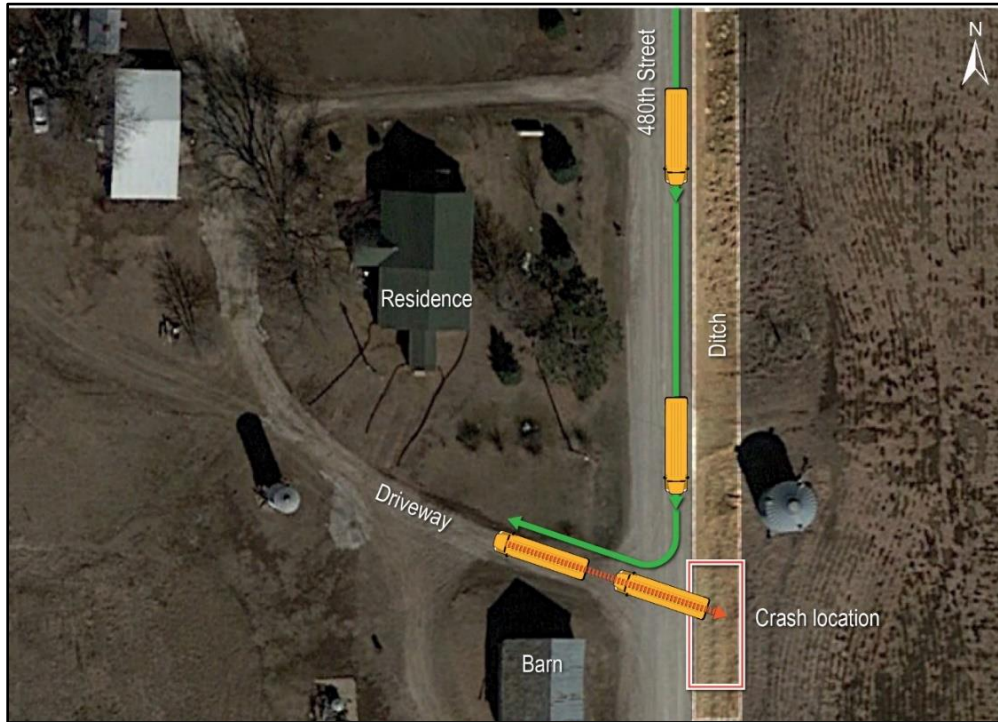
Figure 2. Aerial view showing direction school bus traveled on 480th Street, path into driveway entrance, and path in reverse to crash in roadside ditch (Source: Digital Globe Vivid Image)

By about 6:50 a.m., the scheduled pickup time, the driver had turned right into the residence’s driveway. As was his standard practice at the stop, after the student boarded the bus, the driver reversed out of the driveway so he could continue on 480th Street (a gravel road). At this location, the road is bordered on the east side by a 2.5-foot-wide earthen strip and then a 3-foot-deep drainage ditch. The driver reversed the bus out of the driveway and across 480th Street (figure 2). The bus’s right rear wheels crossed the earthen strip and dropped into the ditch.

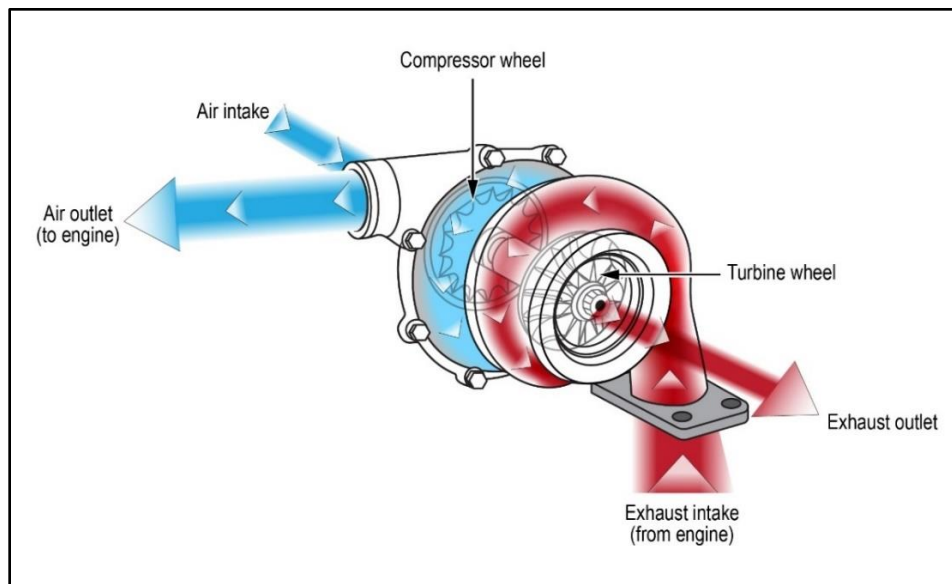
Figure 7. Diagram of generic diesel engine turbocharger.

The rear of the school bus's turbocharger (hot side) had small areas of reddish-brown oxidation over the entire surface. The exhaust duct exhibited similar signatures. The front end (cold side) was intact but covered with white oxidation. The intake duct was missing and found among debris on the ground after the bus was towed from the scene. The duct displayed thermal damage similar to that on the turbocharger and exhaust duct. Intake and exhaust sections examined by video borescope showed similar levels of soot, with no evidence of detonation or other signs of internal ignition. A low burn pattern was found in the area of the turbocharger.³⁹ The lowest point

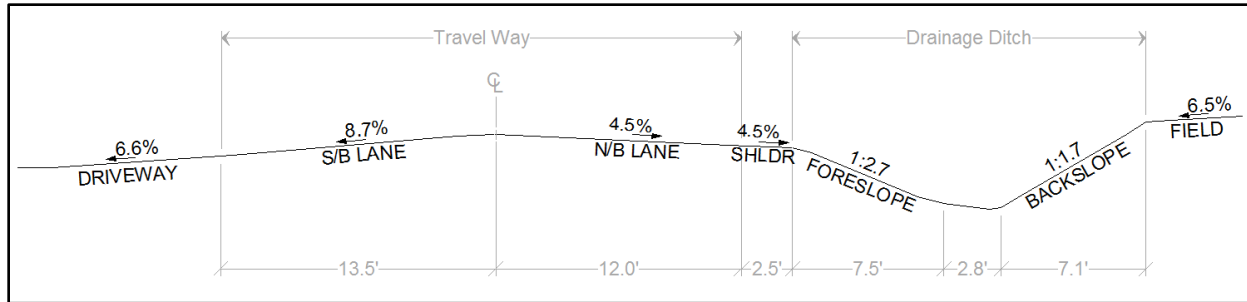
Figure 15. Cross section of curvature and alignment of 480th Street at crash site. (Based on Pottawattamie County Secondary Roads Department survey data)

Where the driveway to the student's residence intersects it, 480th Street has a 4.2-percent upgrade slope northbound. As the bus driver backed out of the driveway, the bus first crossed an upslope of 6.6 percent, then an 8.7-percent cross slope (over 13.5 feet) on the 480th Street southbound lane before encountering the northbound lane's downward slope (figure 15). The cross slope of the northbound lane and shoulder is 4.5 percent downward for 14.5 feet to the edge of the drainage ditch. A 1:2.7 foreslope runs 7.5 feet into the ditch.⁵⁰

⁵⁰ Construction and design plans related to the roadway's original construction in 1877 are no longer available. County standards for new construction of a roadway similar to 480th Street would require a 20-foot-wide roadway with 2-foot shoulders and any drainage ditch to have a 1V:3H entrance (or foreslope). Roadway slopes, ditches, and the slopes of other structures or features alongside the roadway are typically described as a ratio of vertical distance (V) to horizontal distance (H), or V:H. Therefore, a ditch described as 1V:3H would rise or drop 1 unit of measure (feet, inches, meters) for each 3 of the same unit of measurement horizontally. Drainage ditches are typically 3 feet lower than the near edge of the roadway but can vary due to erosion, aggregation, and drainage needs. For a roadway that averages fewer than 400 vehicles daily, ditch bottoms can be as narrow as 0 feet, when the ditch forms a V-shape.
