Motorcoach Collision With Combination Vehicle
After Traffic Break on Interstate 10
Palm Springs, California
October 23, 2016

NTSB/HAR-17/04
PB2018-100195

Highway Accident Report

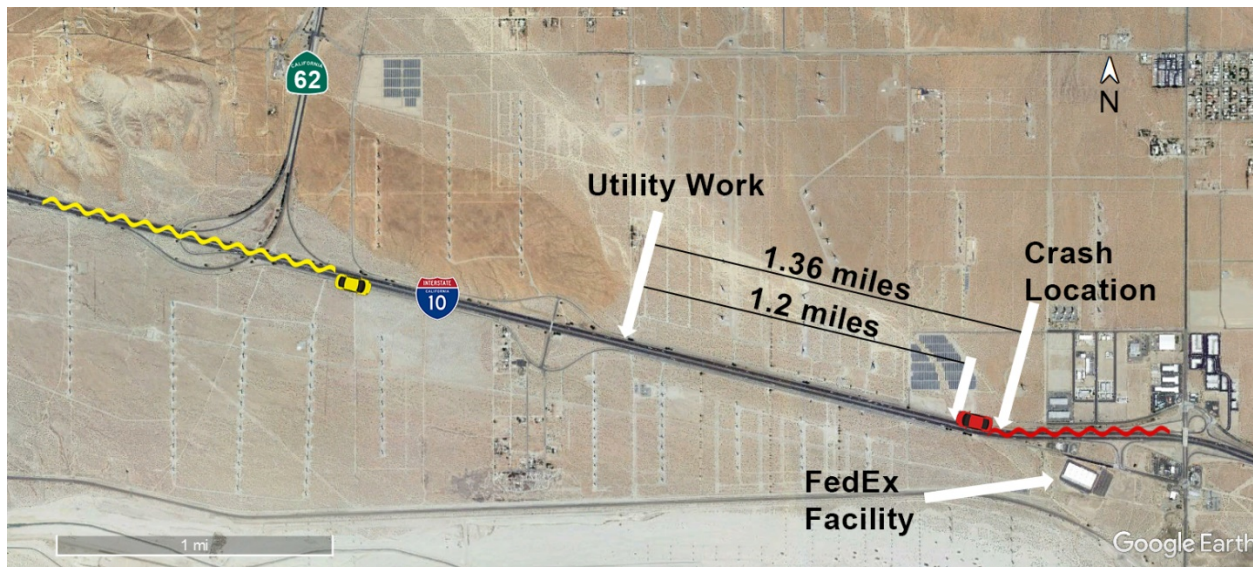
1.4.2.2 Completion. About 5:00 a.m., the SCE foreman contacted CHP units and requested that they begin the first traffic break. To implement the traffic break, CHP units conducted rolling roadblocks on both the eastbound and westbound travel lanes of I-10.¹⁹ To initiate the rolling roadblock for westbound traffic, a single CHP unit entered westbound I-10 at the North Indian Canyon Drive ramp, 2.04 miles east of the utility work, and began to drive west while gradually decelerating from highway speed and performing a serpentine maneuver across all four travel lanes—weaving from the left shoulder to the right shoulder in a controlled manner with the patrol car’s emergency lights activated (see figure 6). The emergency lights and serpentine movement were intended to alert the traffic behind the patrol car to slow down and remain behind it. The CHP unit conducted the rolling roadblock for 2 minutes 51 seconds before gradually coming to a stop about 1.2 miles east of the utility work, about 650 feet west of the crash location. This was the only rolling roadblock that the CHP conducted for westbound traffic before the crash. The SCE work crew completed the relocation of the top three transmission lines within about 5 minutes; including the time used for communication between the CHP officers and the SCE foreman, the total stoppage of westbound traffic lasted about 7 minutes. Another CHP vehicle simultaneously performed a rolling roadblock in the same manner on the eastbound lanes of I-10.

Figure 6. Map indicating the movements of the CHP vehicles (westbound rolling roadblock in red and eastbound rolling roadblock in yellow) on I-10, and the locations where the utility work and crash took place, the location of the FedEx facility, and the location where the westbound CHP vehicle stopped (white arrows).
