Collision between US Navy Destroyer *John S McCain* and Tanker *Alnic MC*
Singapore Strait, 5 Miles Northeast of Horsburgh Lighthouse
August 21, 2017

Marine Accident Report

NTSB/MAR-19/01
PB2019-100970

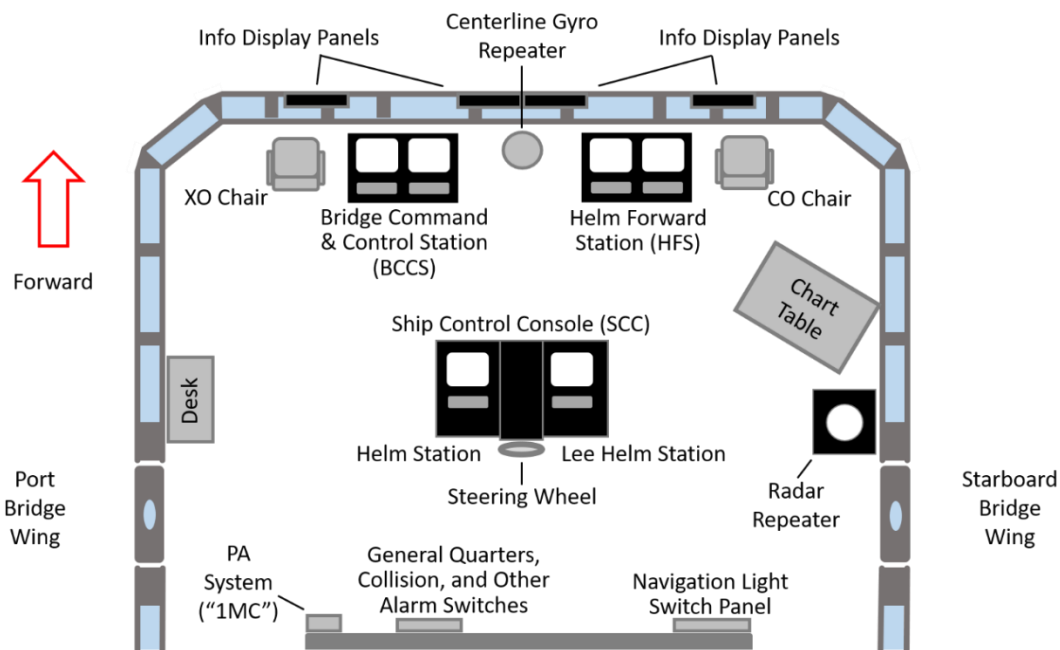
The *John S McCain*'s propulsion and steering were controlled via a Northrop Grumman Maritime Systems Integrated Bridge and Navigation System (IBNS). The IBNS was a relatively new system on the ship, having been installed in 2016. Through the IBNS, propulsion and steering could be controlled from four different locations on the bridge: the Helm Forward Station (HFS), the Bridge Command and Control Station (BCCS), and the helm and lee helm operator stations at the SCC. Additionally, steering could be controlled from the Aft Steering Unit (ASU) station, located in the ship's aft steering compartment.

Figure 3. *John S McCain* bridge layout with IBNS control stations. (Illustration not to scale; some equipment not relevant to the accident has been eliminated.)

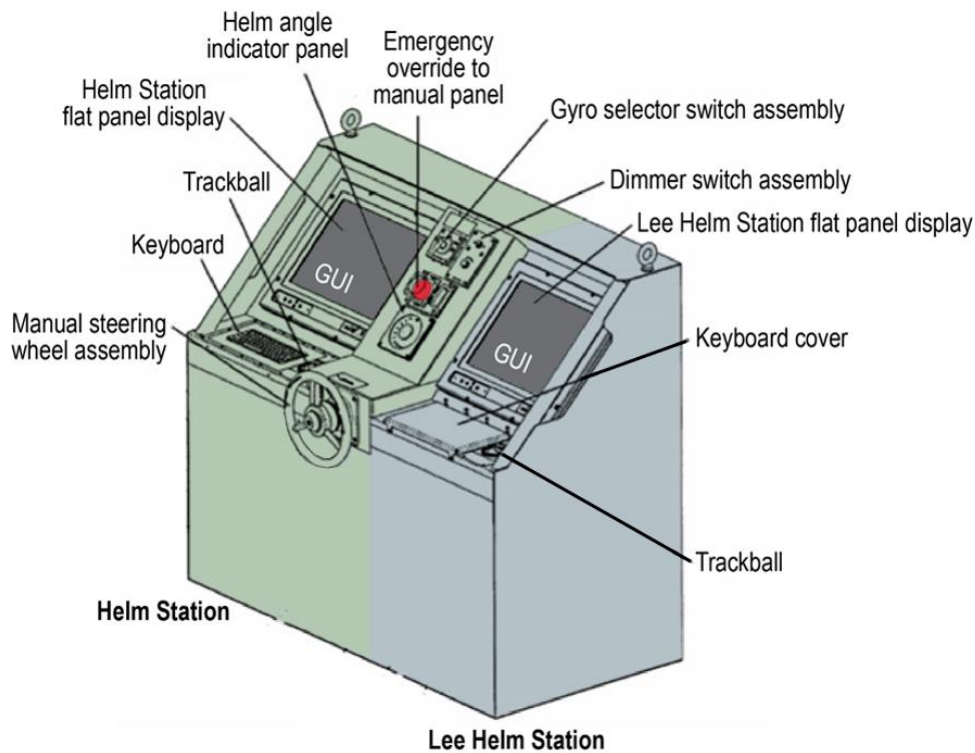
The bridge control stations contained flat-panel touch screens, and the helm and lee helm stations of the SCC each had a touch screen. (The touch screens at the helm and lee helm stations were identical.) A graphical user interface (GUI) displayed on the touch screen allowed the operator to enter commands for steering and thrust.

Figure 4. *John S McCain* SCC. (Drawing from IBNS technical manual; color added by NTSB)

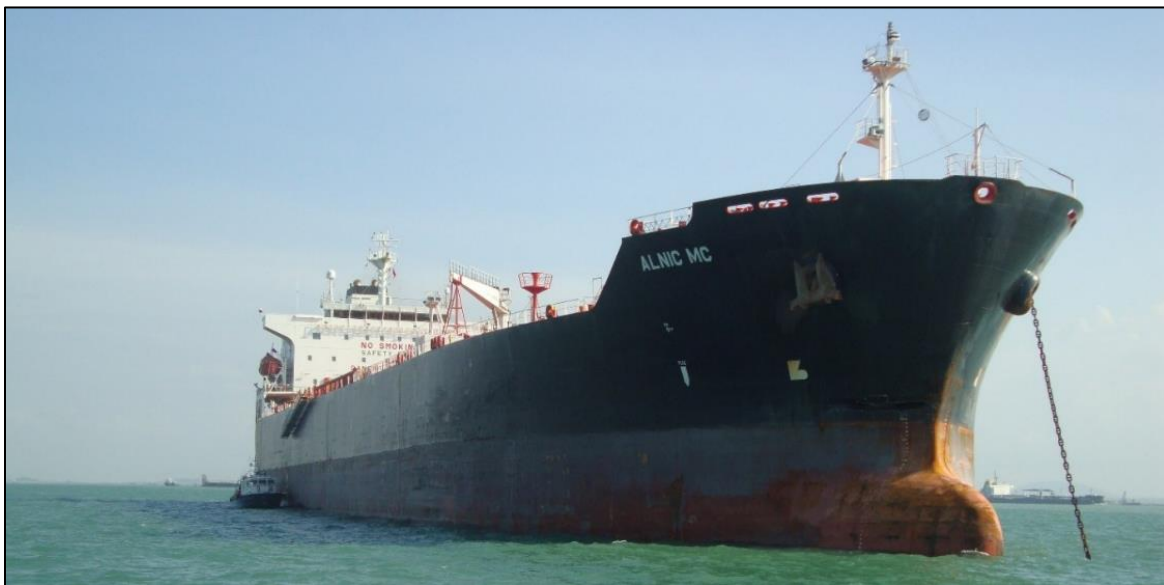
Figure 8. *Alnic MC* after the accident. (Photo by US Coast Guard)

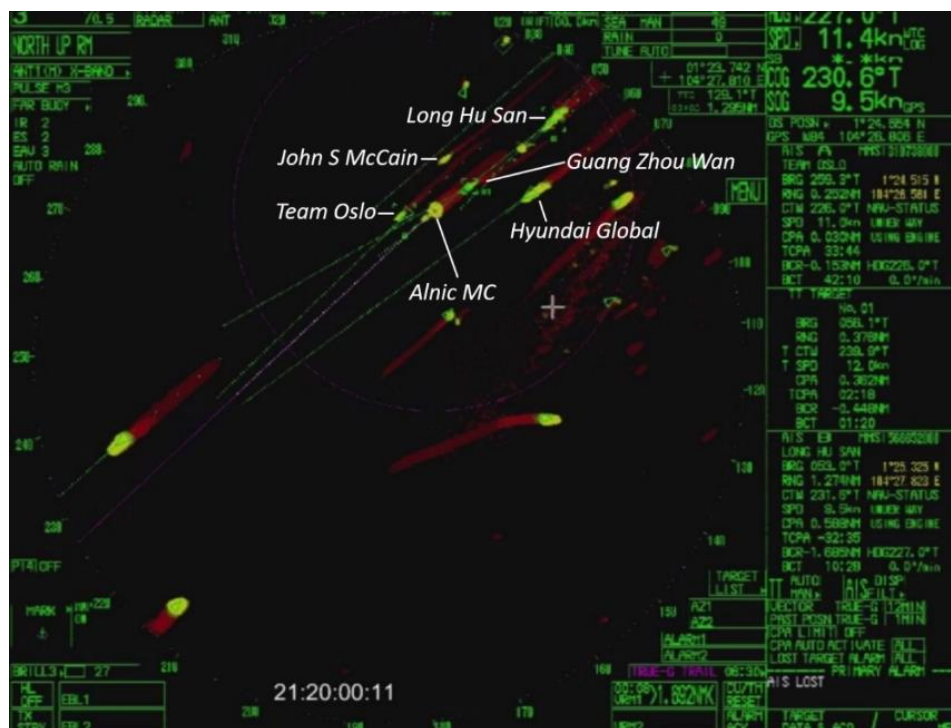
About 4 minutes later, the *John S McCain* entered the TSS and was at the northern extremity of the westbound traffic lane transiting at a speed of 18 knots. At the time, the *Alnic MC* was 45 degrees off the destroyer's port bow at a distance of about 0.6 miles and moving at 9.5 knots at a full ahead engine order. Other vessels in the vicinity, as shown on radar images from the tanker's voyage data recorder (VDR), included the tanker *Team Oslo* moving at 11.0 knots close to and just forward of the *Alnic MC*'s starboard bow, the *Guang Zhou Wan*, also a tanker, traveling at 12.0 knots about 0.5 miles off the port quarter of the *John S McCain* and about 0.4 miles astern of the *Alnic MC*, and the large containership *Hyundai Global*, which was astern and to port of the *Alnic MC* and making speed (16 knots) to overtake the *Alnic MC*.¹⁴

Figure 10. Screen capture from *Alnic MC* automatic radar plotting aid (ARPA) at 0520 on the morning of the accident. (Ship name labels added by NTSB)
