NATIONAL TRANSPORTATION SAFETY BOARD

AIRFRAME AND ENGINE EXAMINATION

WPR15LA014

Location: Big Bear City, CA
Date: October 16, 2014
Aircraft: Cessna 172S, Registration Number: N612SP, Serial #: 172S8594
NTSB IIC: Howard Plagens

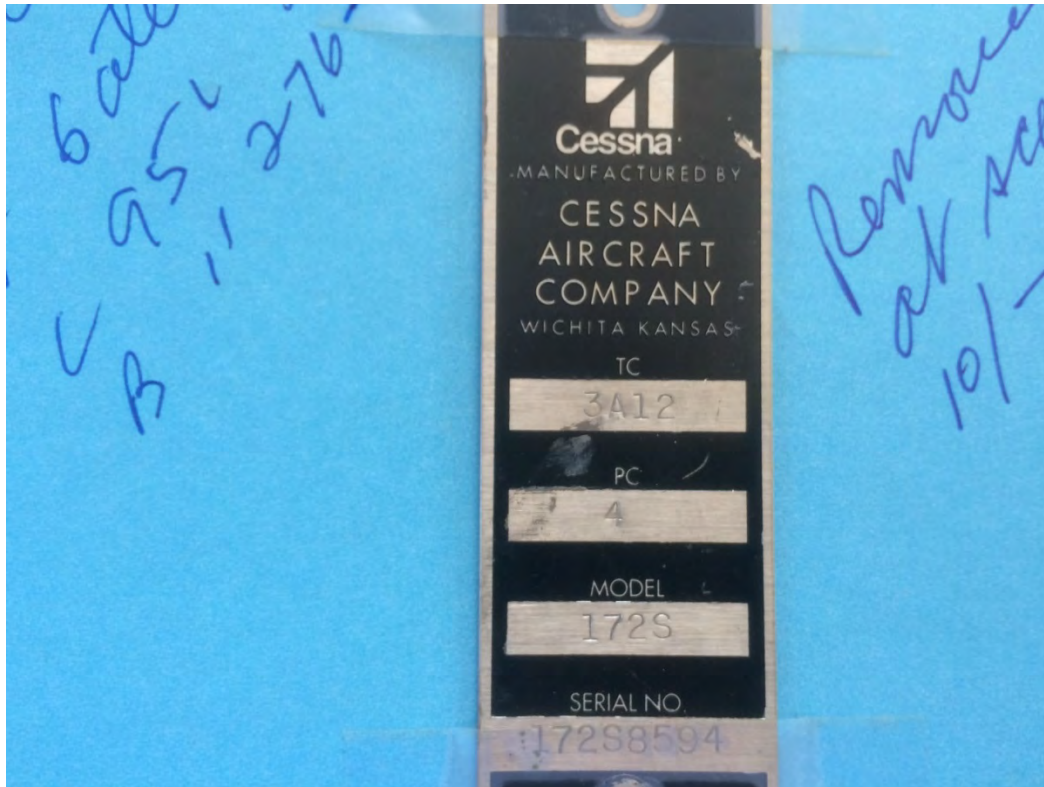
Photo 1 Airframe Data Plate

The airplane was a Cessna 172S, serial number 172S8594.

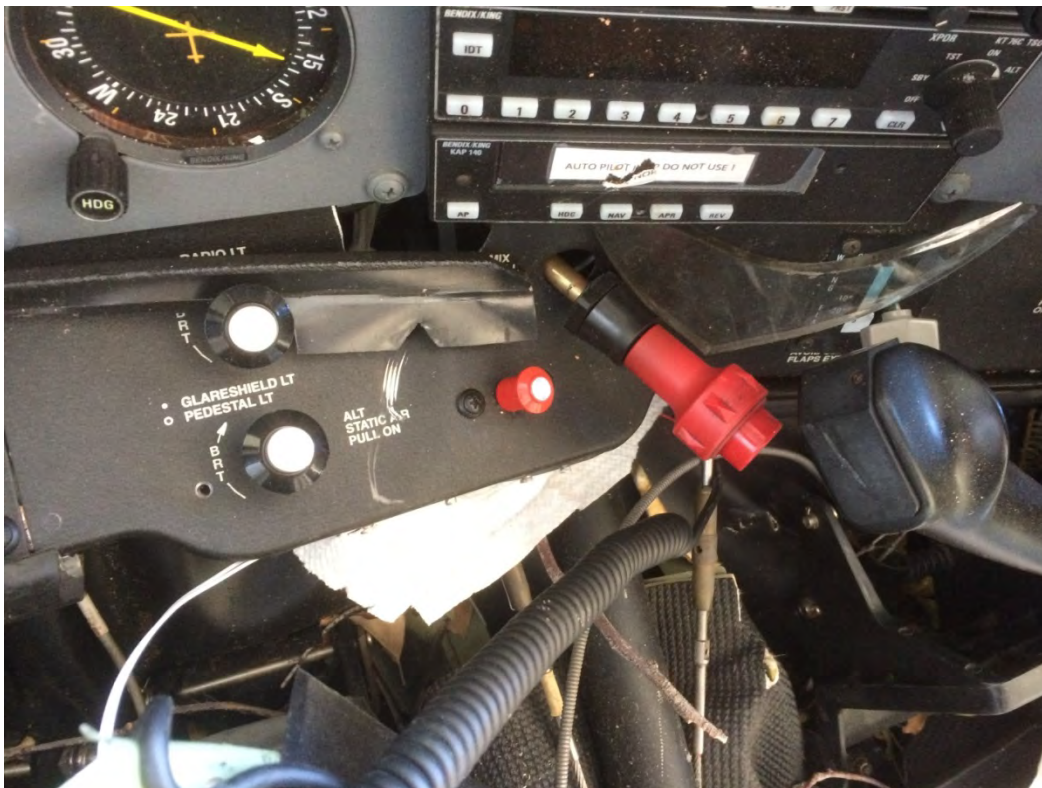
Photo 7 Throttle Quadrant

There was a fuel shutoff valve on the center portion of the instrument panel that was in the forward position, which was OPEN. The fuel selector valve had three positions that were 90 degrees apart; left was LEFT, forward was BOTH, and right was RIGHT. The selector lever had partially broken off, and was pointing was to the 1-o'clock position. Investigators removed the valve, and determined that it was in the BOTH position. The mixture cockpit control was in the full forward position.

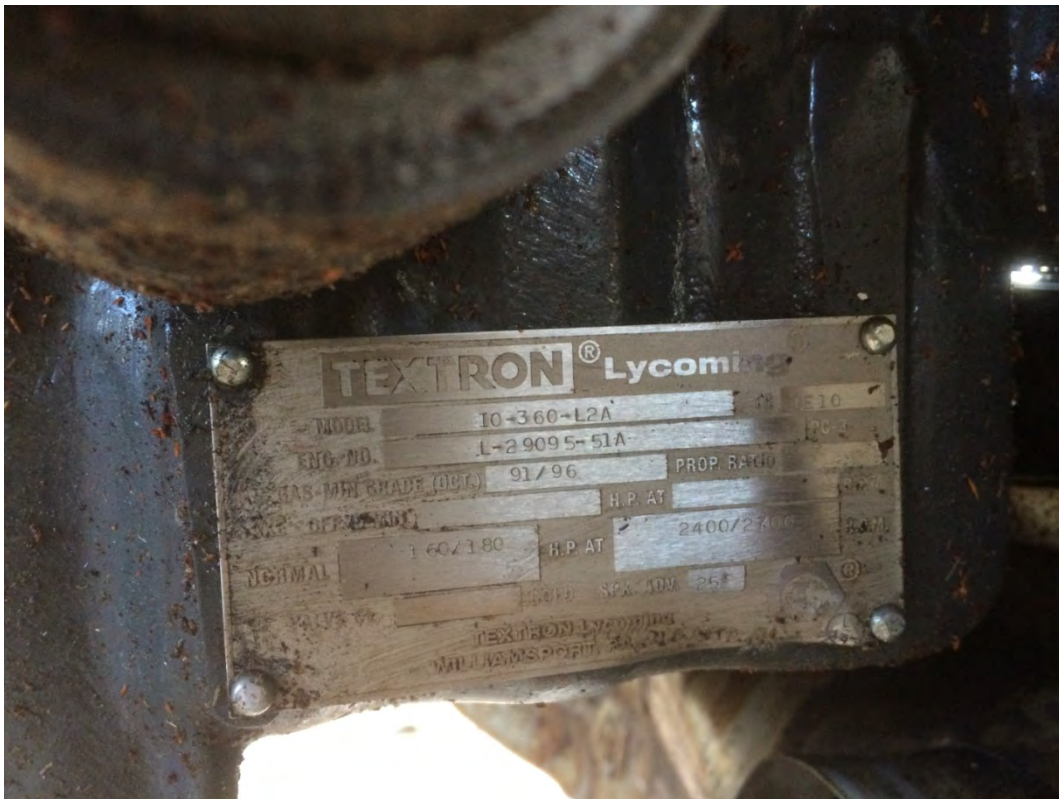
Photo 15 Engine Data Plate

The engine was a Lycoming IO-360-L2A, serial number L-29095-51A, rated at 160/180 horsepower at 2,400/2,700 rpm.
