NATIONAL TRANSPORTATION SAFETY BOARD

AIRFRAME AND ENGINE EXAMINATION

WPR16FA002

Location: Cedar City, Utah
Date: October 3, 2016
Aircraft: Cessna 152, Registration Number: N6449M, Serial #: 15284733
NTSB IIC: Patrick H. Jones

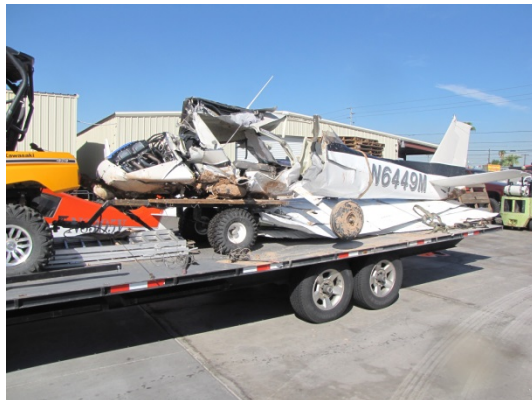
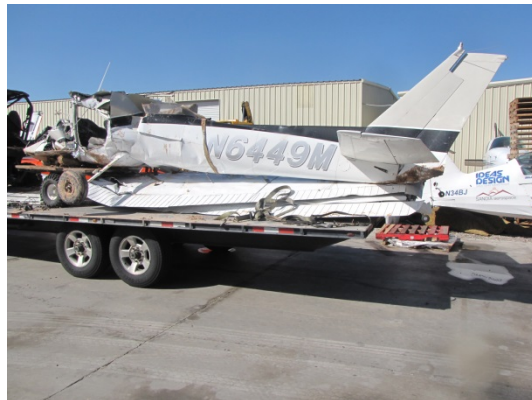
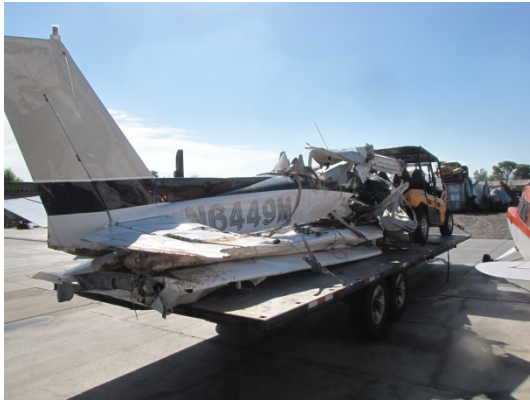
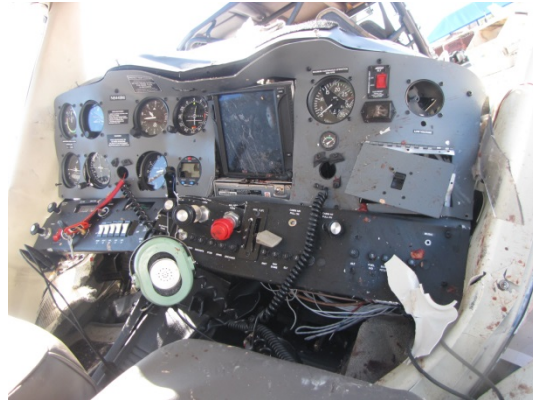
Nothing was observed during the course of this examination that would have precluded airframe or engine from normal operations prior to impact.
