## **NATIONAL TRANSPORTATION SAFETY BOARD**

# **AIRFRAME AND ENGINE EXAMINATION**

**WPR14LA272**

Location: Dietrich, ID  
Date: June 29, 2014  
Aircraft: Aerospatiale AS350B2, Registration Number: N3540CL, Serial #: 232  
NTSB IIC: Howard Plagens

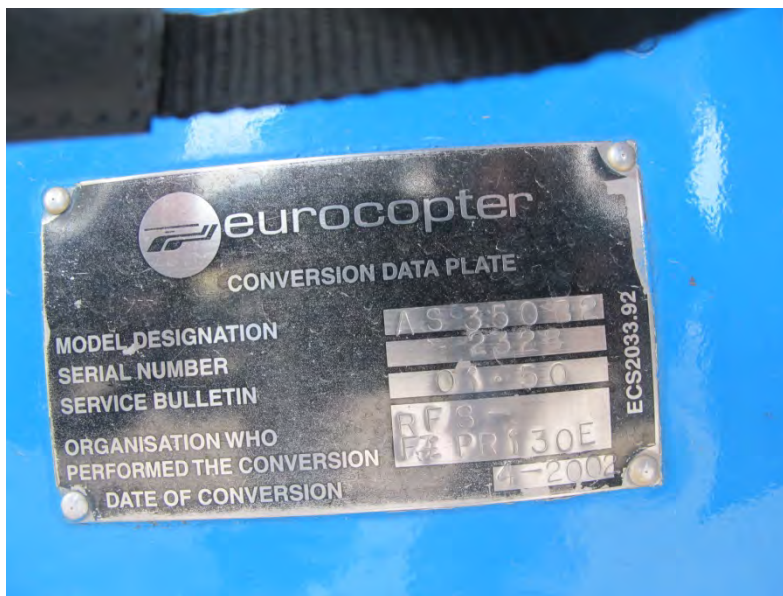
Photo 1 Airframe Dataplate

The hour meter read 0090.9 hours.

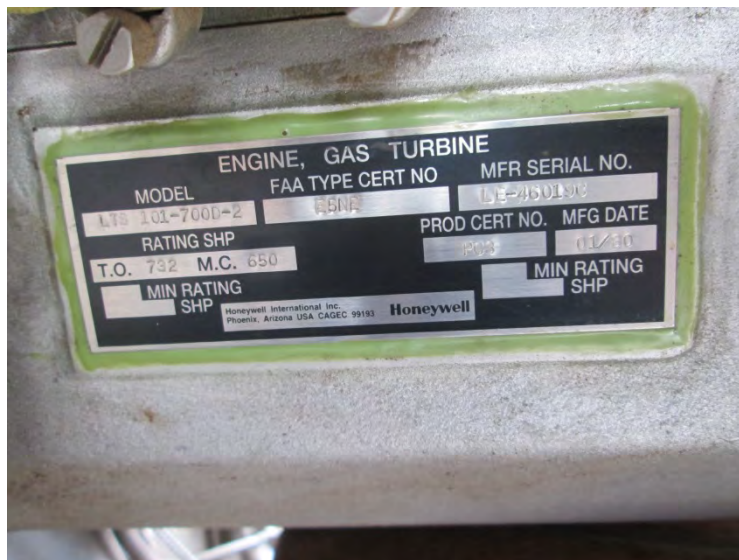
Photo 9 Engine Dataplate

The engine was a Honeywell LTS101-700D-2, serial number LE-46019C. The type certificate number was E5NE; the maximum continuous power was 650 hp.
