AIRPLANE EXAMINATION

WPR16FA035

Apple Valley, California

Aero Vodochody – N39AY

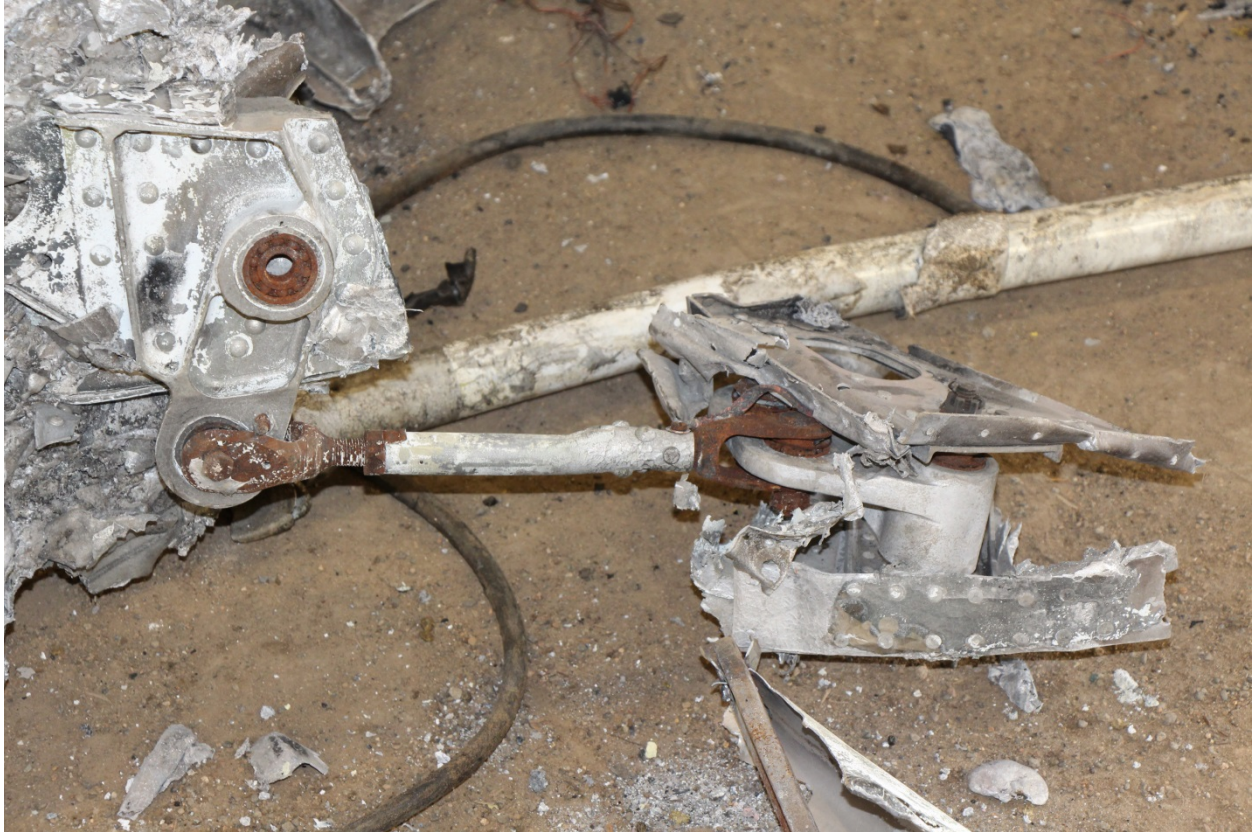
Photograph 7: Right aileron turnbuckle

main aileron bell crank was intact, but also separated from its control tubes. The inboard and outboard right wing flap tracks had separated from the wing, but portions of the flaps remained attached to their respective tracks, which indicated a 25° deployed (takeoff) position (see *photograph 6*). The right aileron turnbuckle was attached to a portion of the wing through a bearing (see *photograph 7*). The right aileron leading edge steel balance bar was thermally damaged, but remained connected to a portion of airframe skin. The right main landing gear uplock assembly was intact, but thermally damaged. The left landing gear door bell-crank was intact. The right wing pitot tube was intact, but the hoses were impacted separated at the tube root.

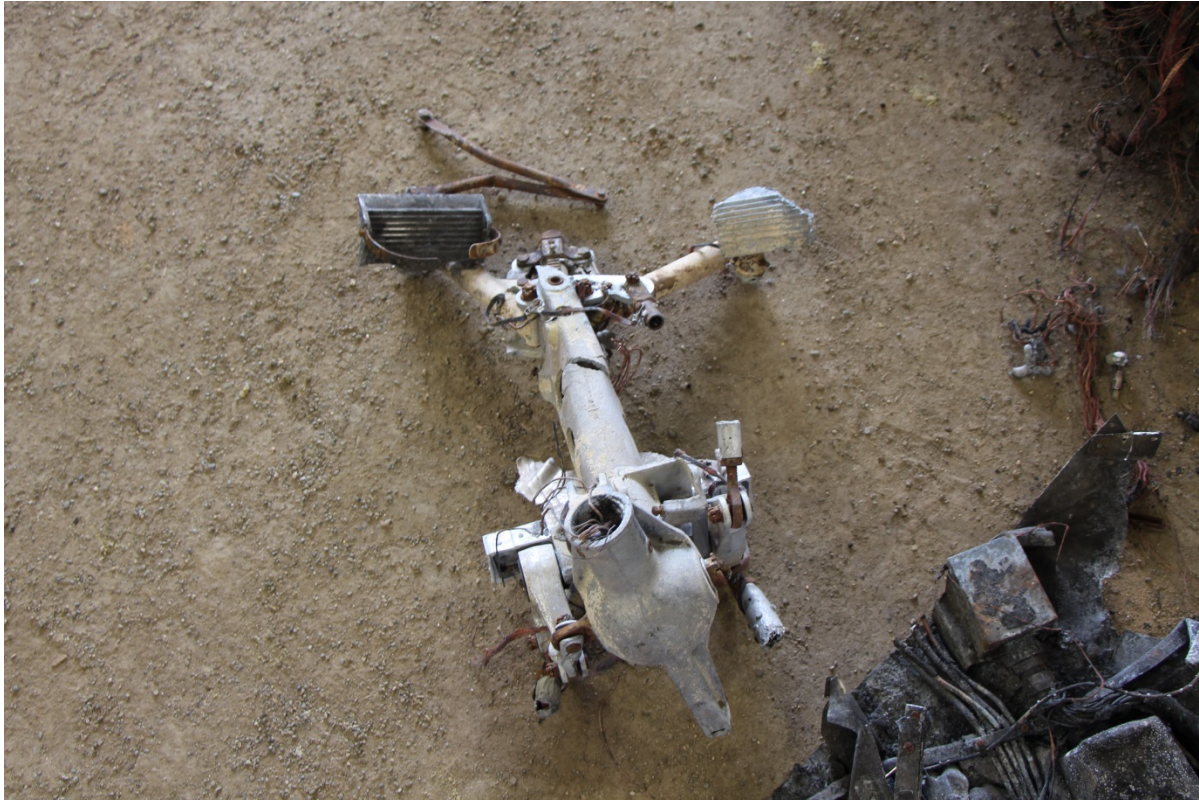
Photograph 10: Front seat occupant rudder assembly

The front seat occupant throttle lever was located in the full forward position beyond the detent and fixed (see *photograph 8*). The rear seat occupant throttle had broken free of the fuselage structure and could be manipulated by hand, which precluded an evaluation of the lever position (see *photograph 9*). The front seat occupant's rudder pedal assembly remained intact and had been adjusted to the forward position; however, the left rudder pedal was bent approximately 50° forward and the right rudder pedal was bent about 25° forward (see *photograph 10*). Both control tubes separated from the pedals and bell crank mounts. The rear seat occupant's rudder assembly was also intact; the control tubes remained attached and the rudder pedal mounting tubes were straight (see *photograph 11*). The rudder assembly was in the aft position.
