**National Transportation Safety Board**  
Office of Research and Engineering  
Washington, D.C. 20594

**Airplane Performance Study**

Location: Duluth, MN  
Date: June 7, 2014  
Time: 1121 CDT  
Airplane: Lancair IV, Registration N86NW  
NTSB Number: CEN14FA278

**CEN14FA278, Experimental Lancair IV, N86NW, 6/7/2014**

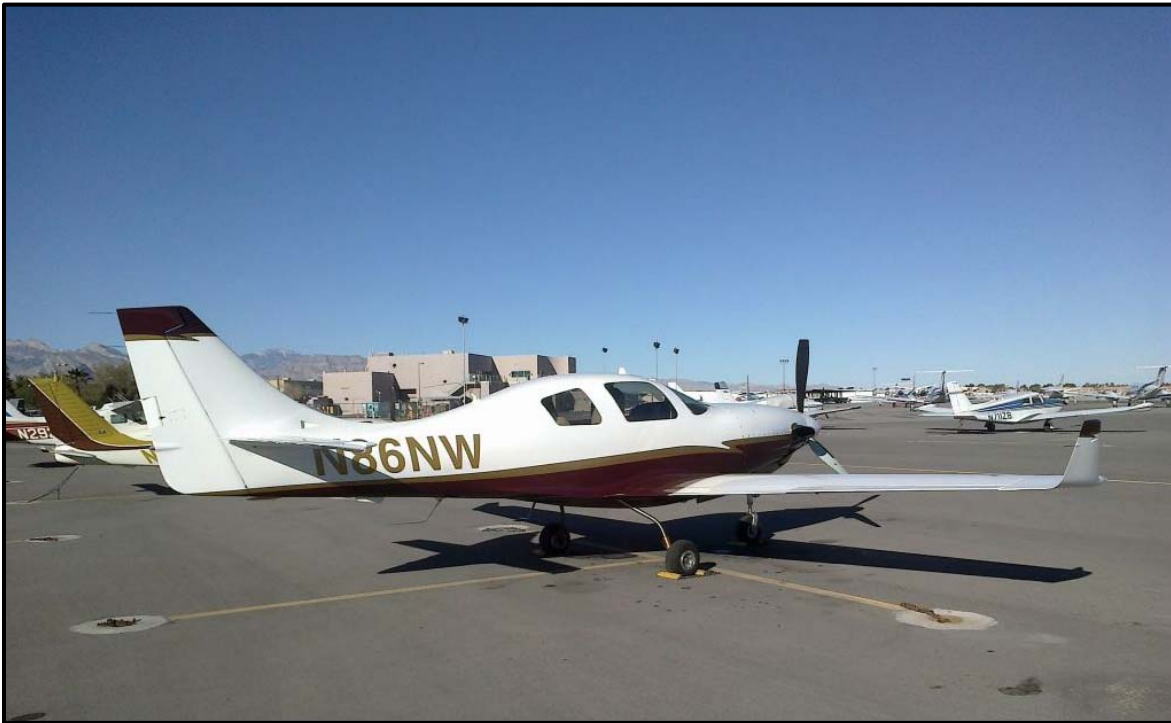
**Figure 1: Accident Airplane N86NW, an Experimental Lancair IV**

<sup>1</sup> See Figures 1 and 2 for pictures of the accident airplane. The accident pilot did not build the experimental, amateur-built, airplane but had recently purchased it.

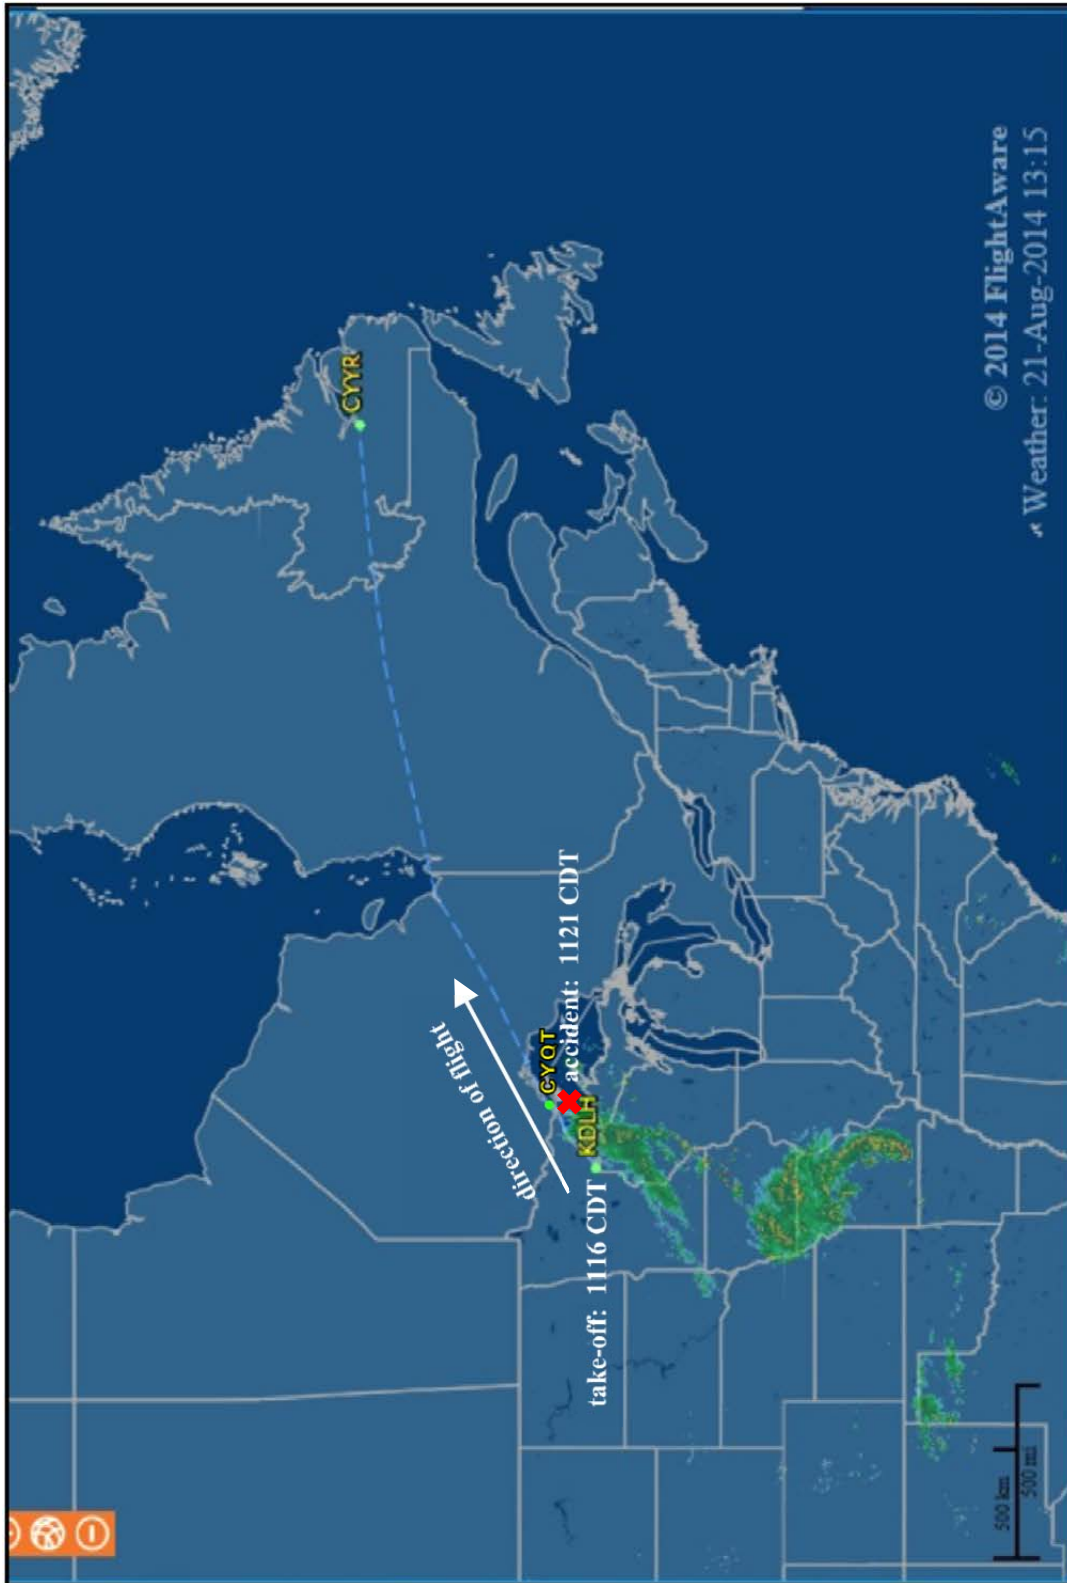
Figure 3: Accident Flight Plan (note: weather not representative of the accident)

On June 7, 2014, about 1121 central daylight time (CDT), an experimental, amateur-built, Lancair IV, N86NW<sup>1</sup>, was destroyed when it impacted Lake Superior after departing from the Duluth International Airport (KDLH), Duluth, Minnesota. The pilot, the sole occupant, received fatal injuries. The airplane was registered to A.O. Engineering Inc. and was being operated by the pilot under 14 Code of Federal Regulations Part 91 as a personal flight. Marginal visual meteorological conditions (VMC) prevailed at the time of the accident, and an instrument flight rules (IFR) flight plan had been filed. The airplane departed KDLH about 1116 CDT, and was en route to Goose Bay (CYYR), Newfoundland, Canada. See Figure 3. (Note that the weather in Figure 3 is not representative of that for the accident.)

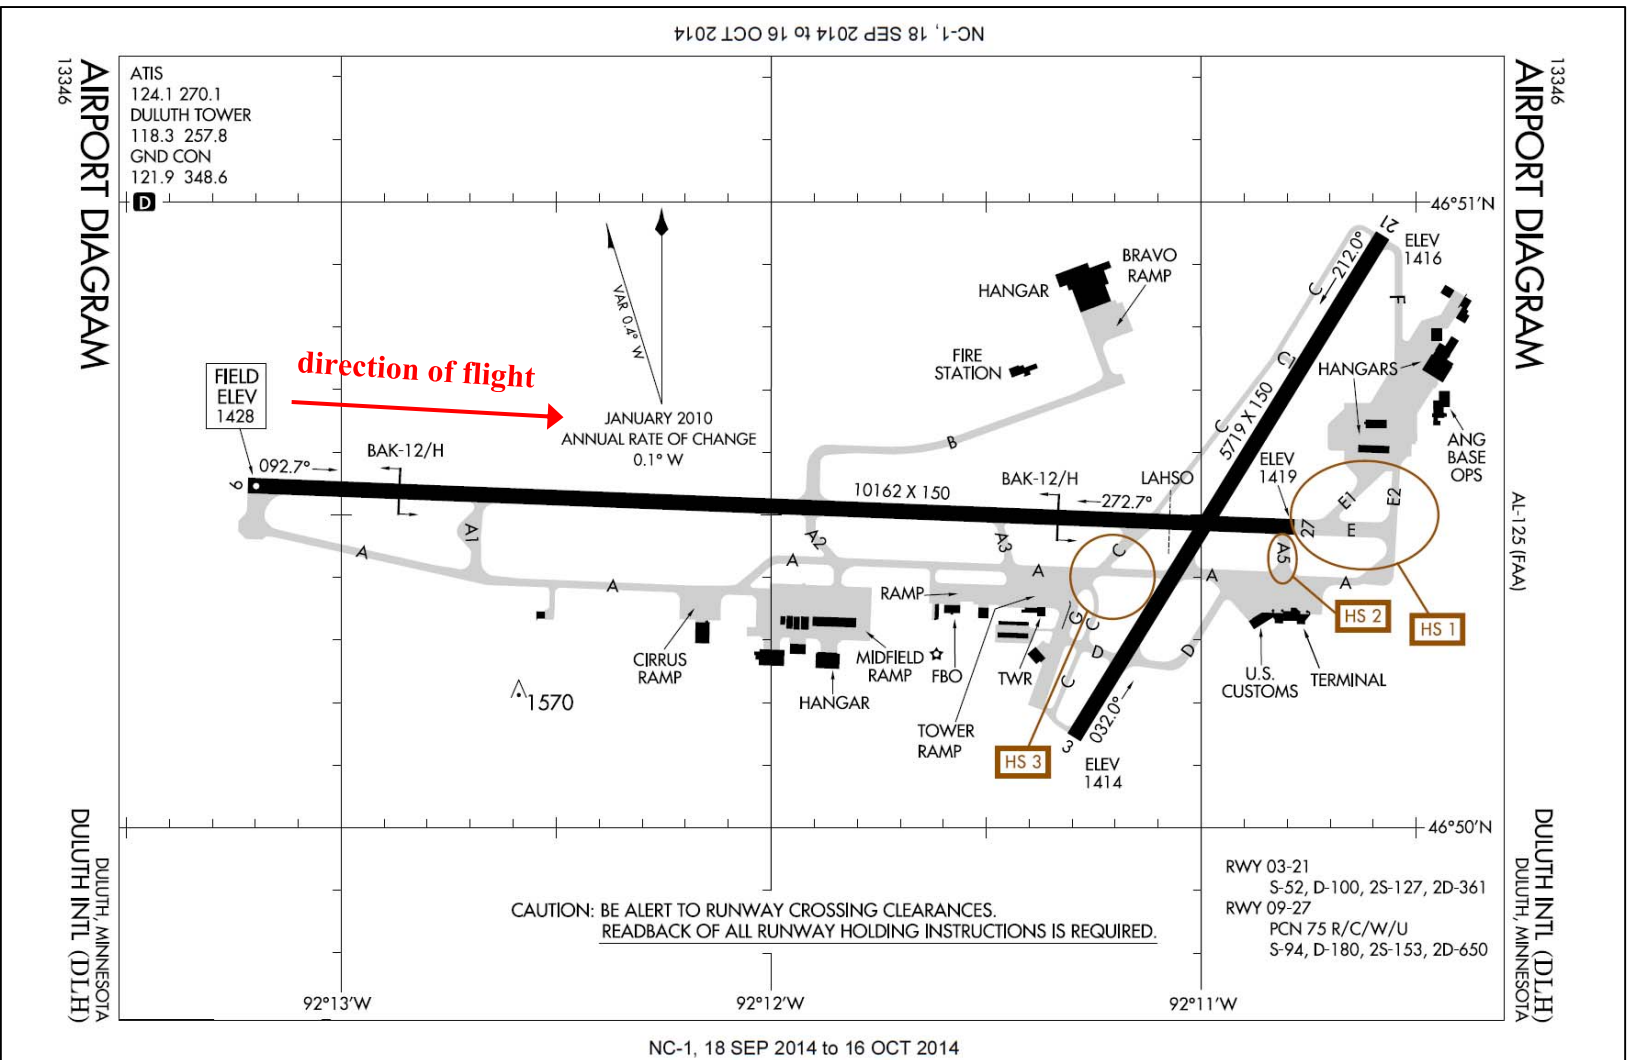
Figure 6: Duluth International Airport Diagram

Figures 4 and 5 highlight the radar ground track for N86NW as the airplane departed Duluth International airport. Each radar point in the figures has an associated GMT time, altitude above mean sea level  $\pm$  50 ft, and a calculated calibrated airspeed in knots (in blue)<sup>2</sup>. Figure 6 shows the airport diagram for Duluth International including the departure runway 9.

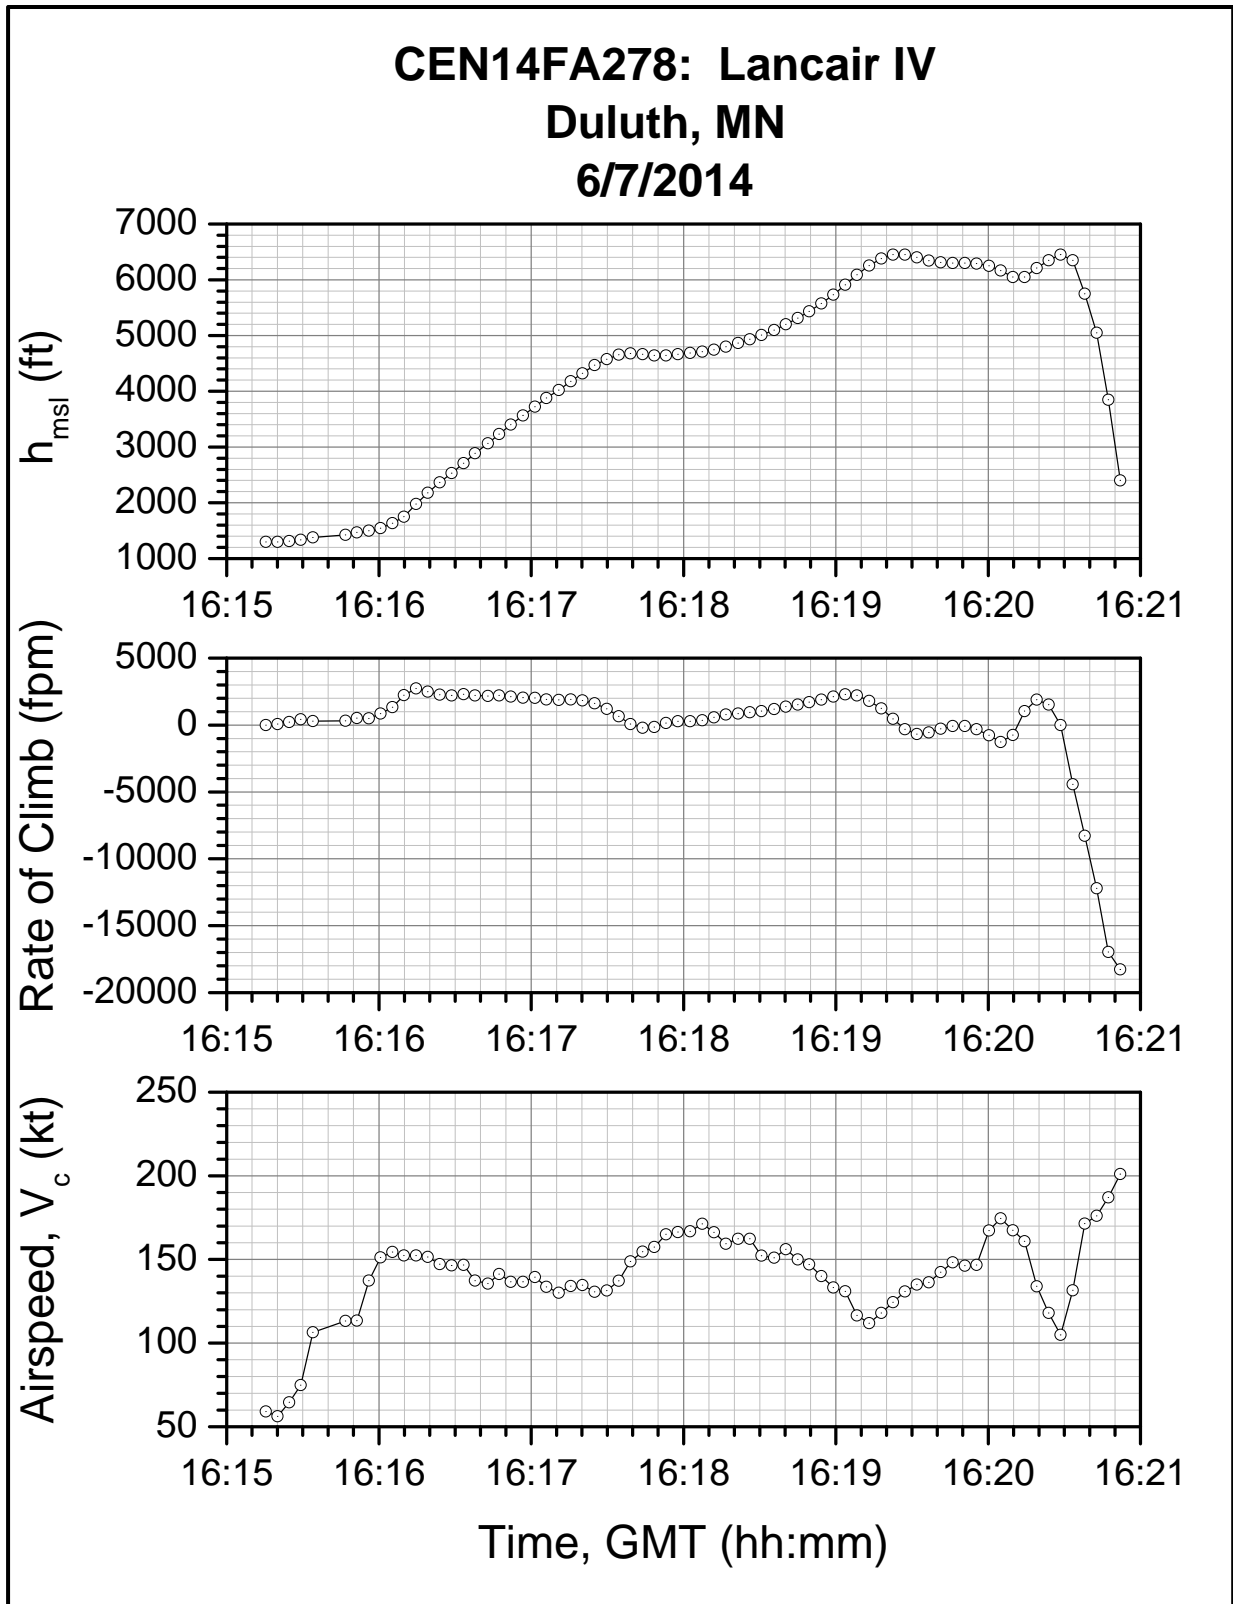
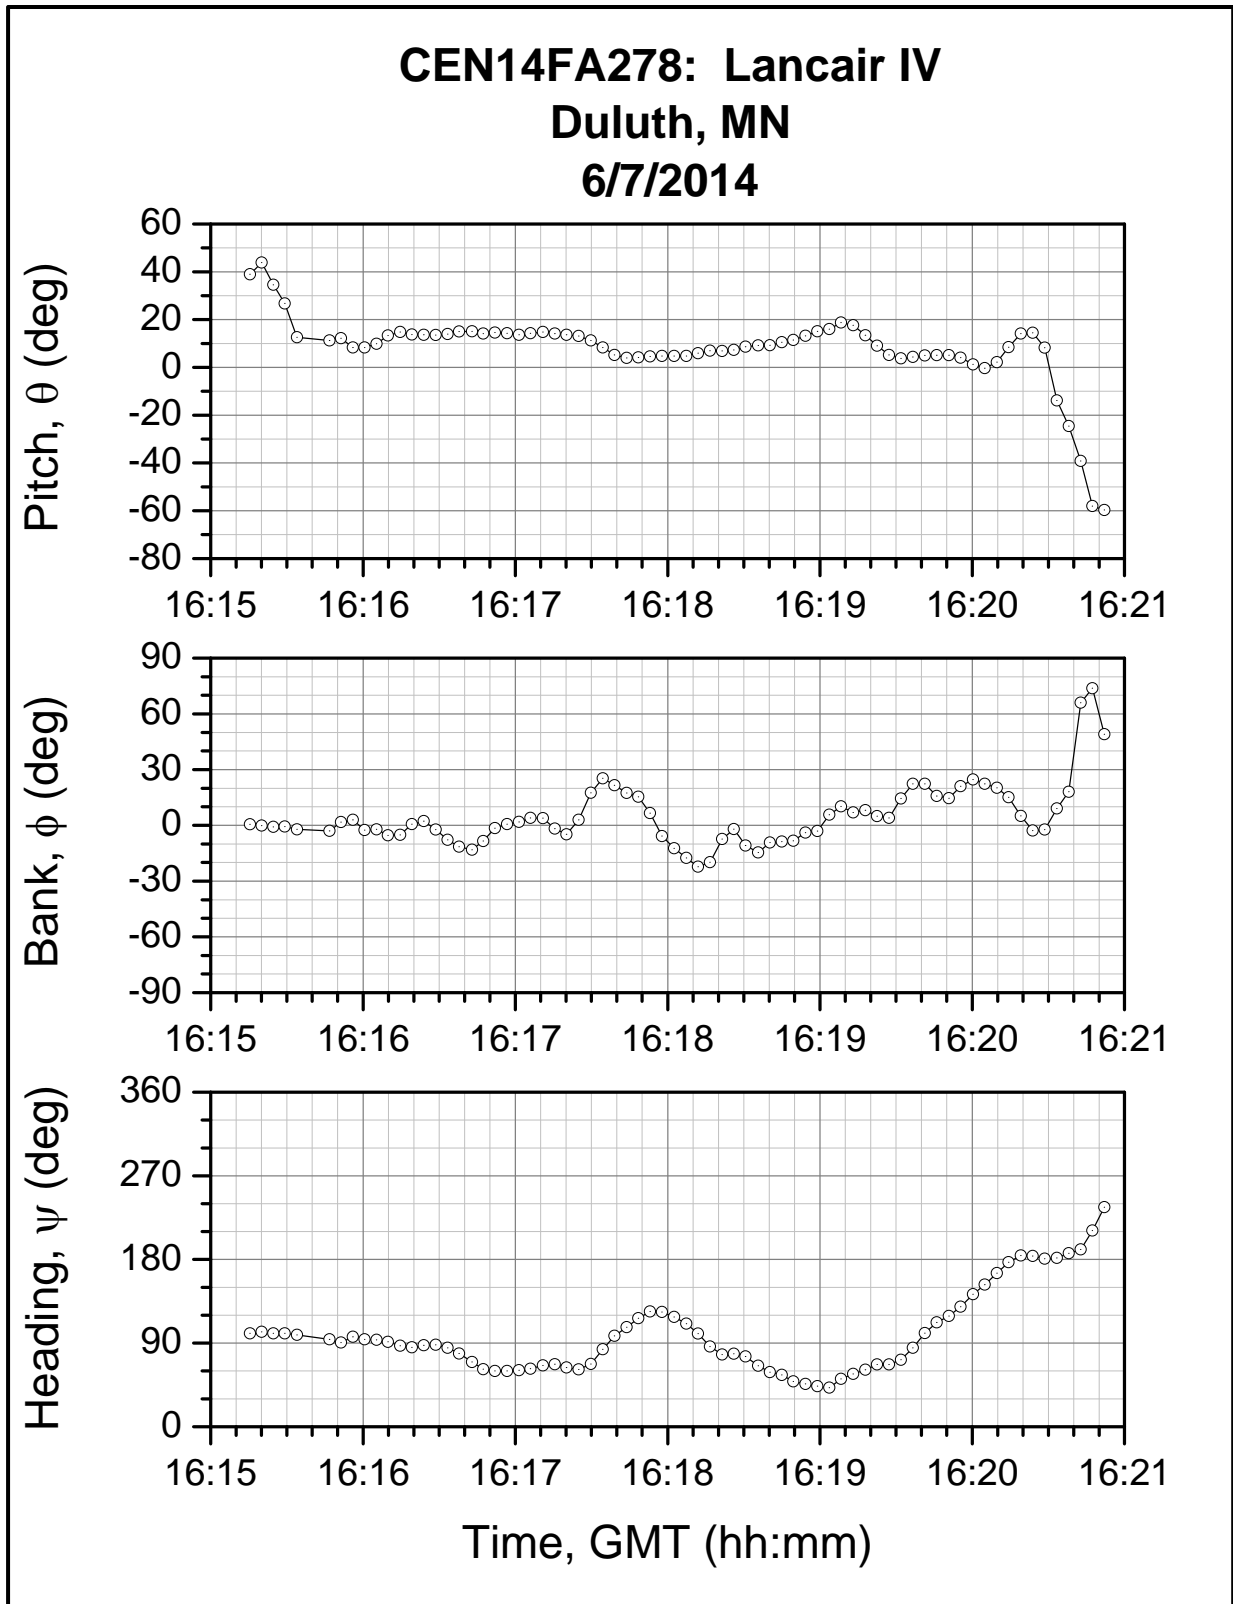
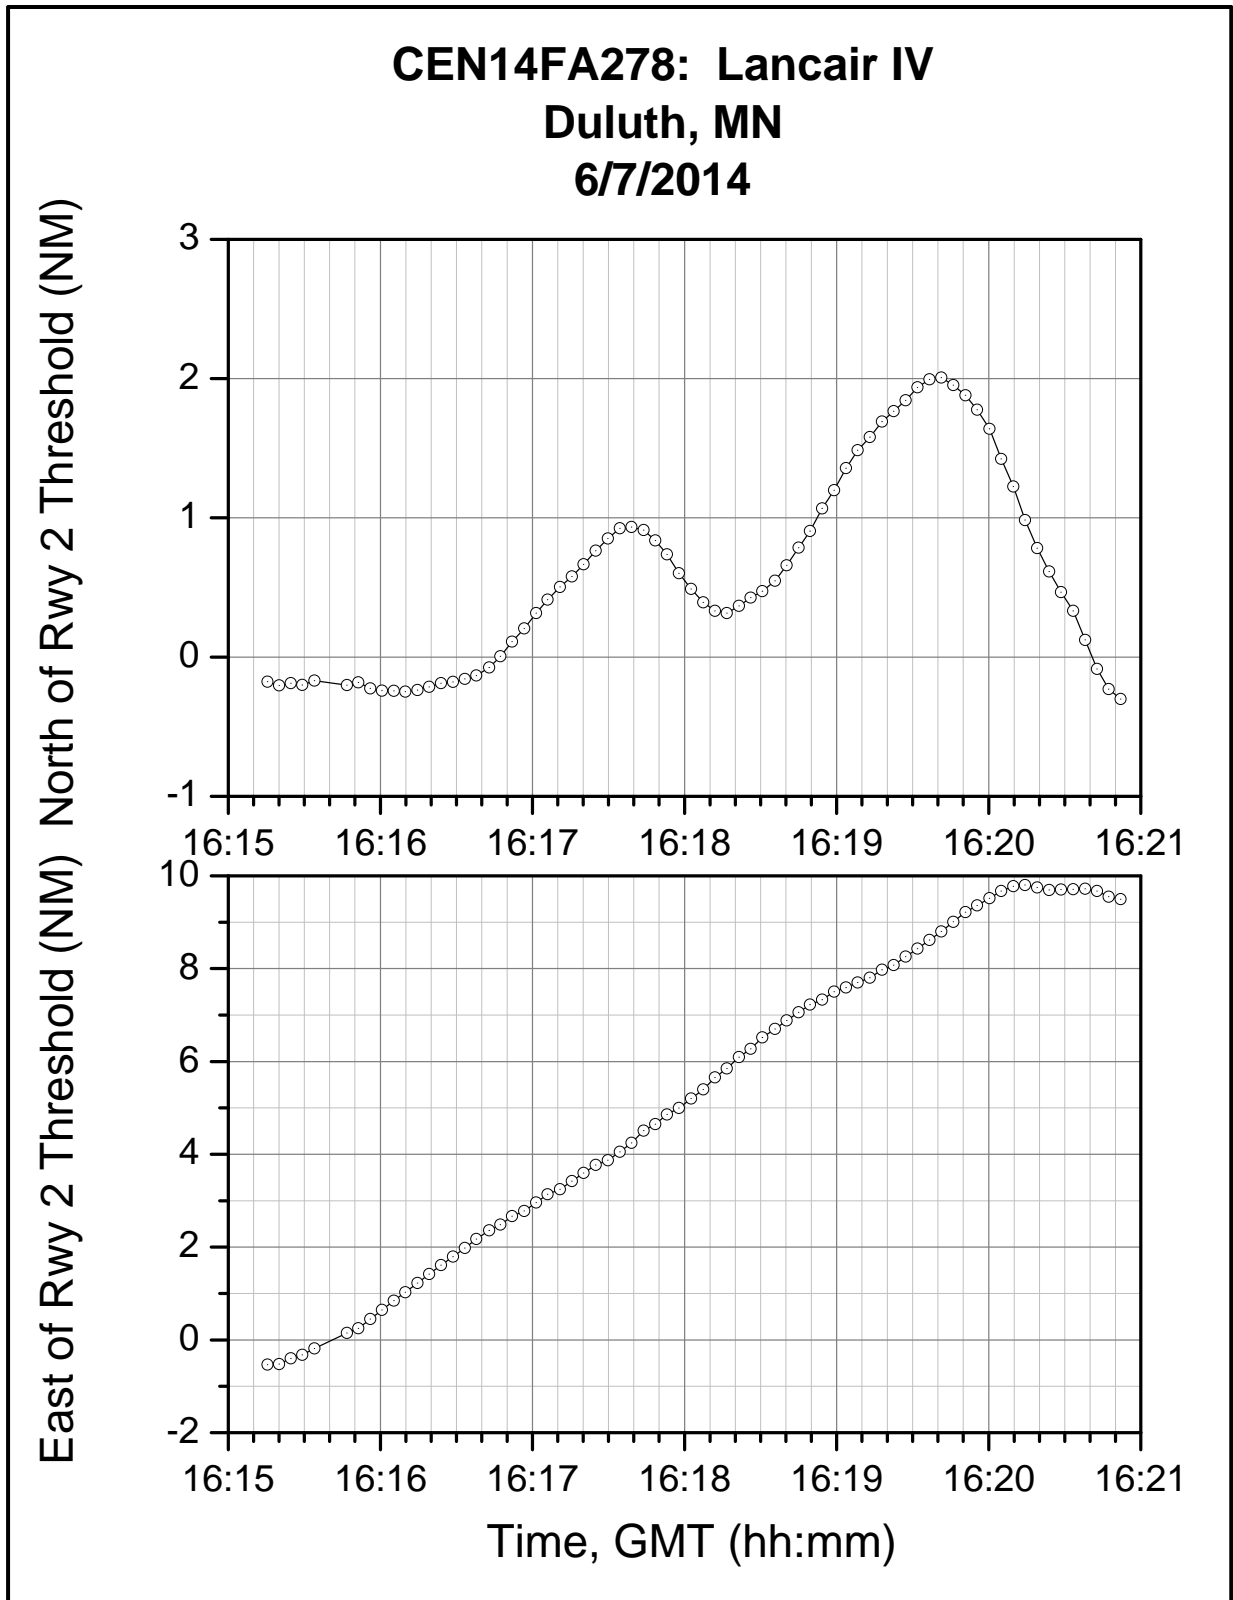
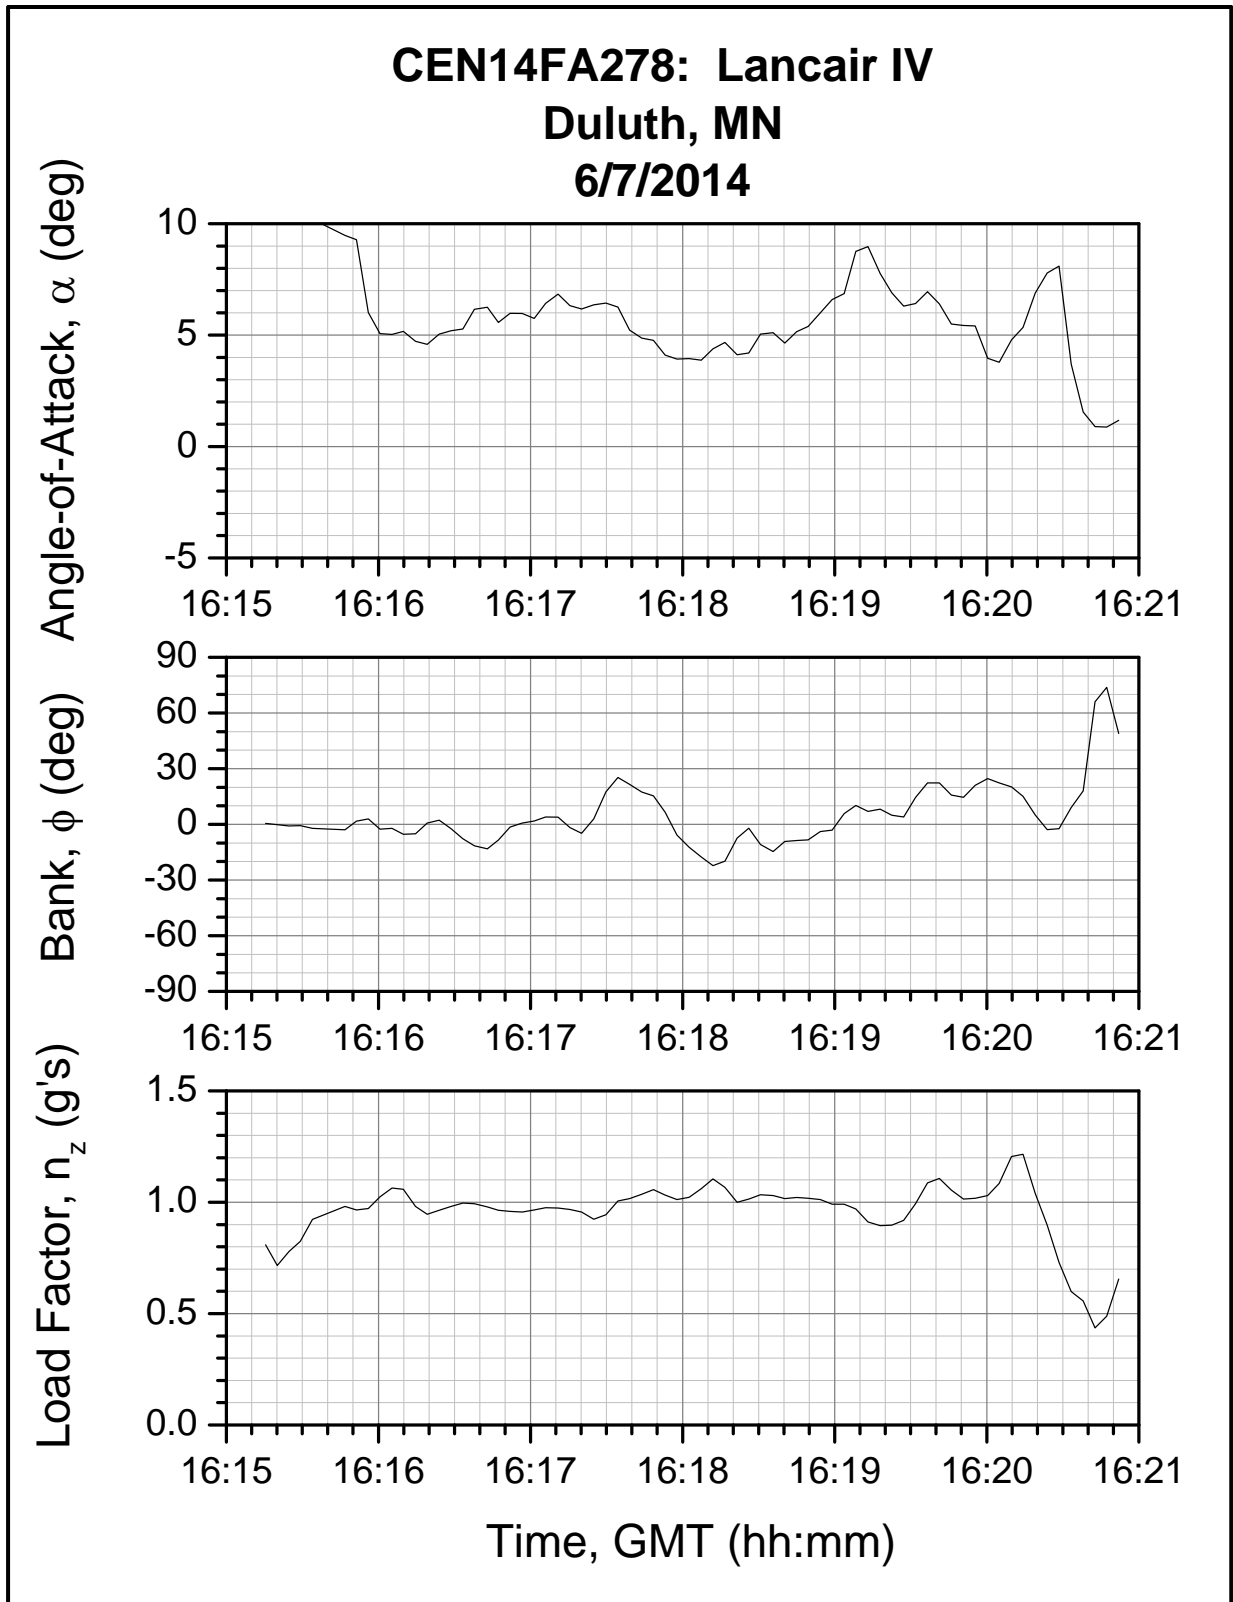
Figures 8 through 11 highlight other radar data and flight parameters that were estimated from radar assuming that the airplane was in coordinated flight with little or no sideslip.<sup>4</sup>
