Sinking of Cargo Vessel *El Faro*  
Atlantic Ocean, Northeast of Acklins and  
Crooked Island, Bahamas  
October 1, 2015

## Accident Overview Sinking of Cargo Vessel *El Faro*

## Accident Narrative: Sinking of Cargo Vessel *El Faro*

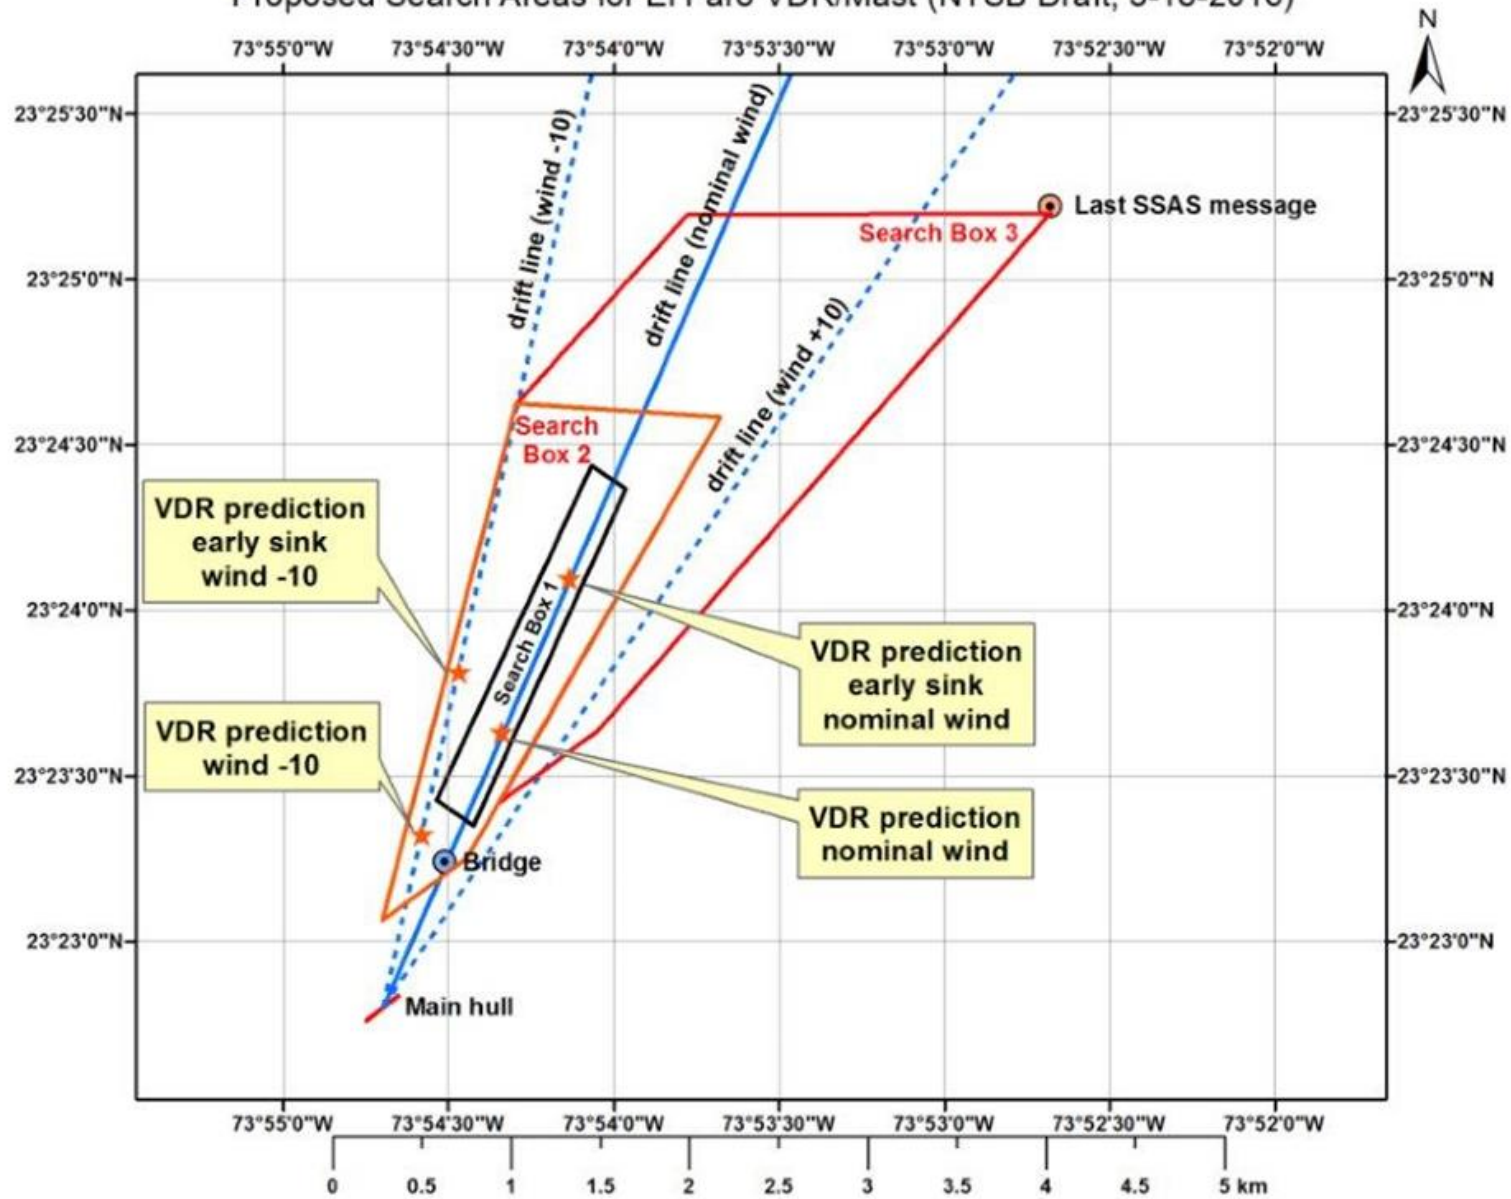
Proposed Search Areas for El Faro VDR/Mast (NTSB Draft, 3-18-2016)

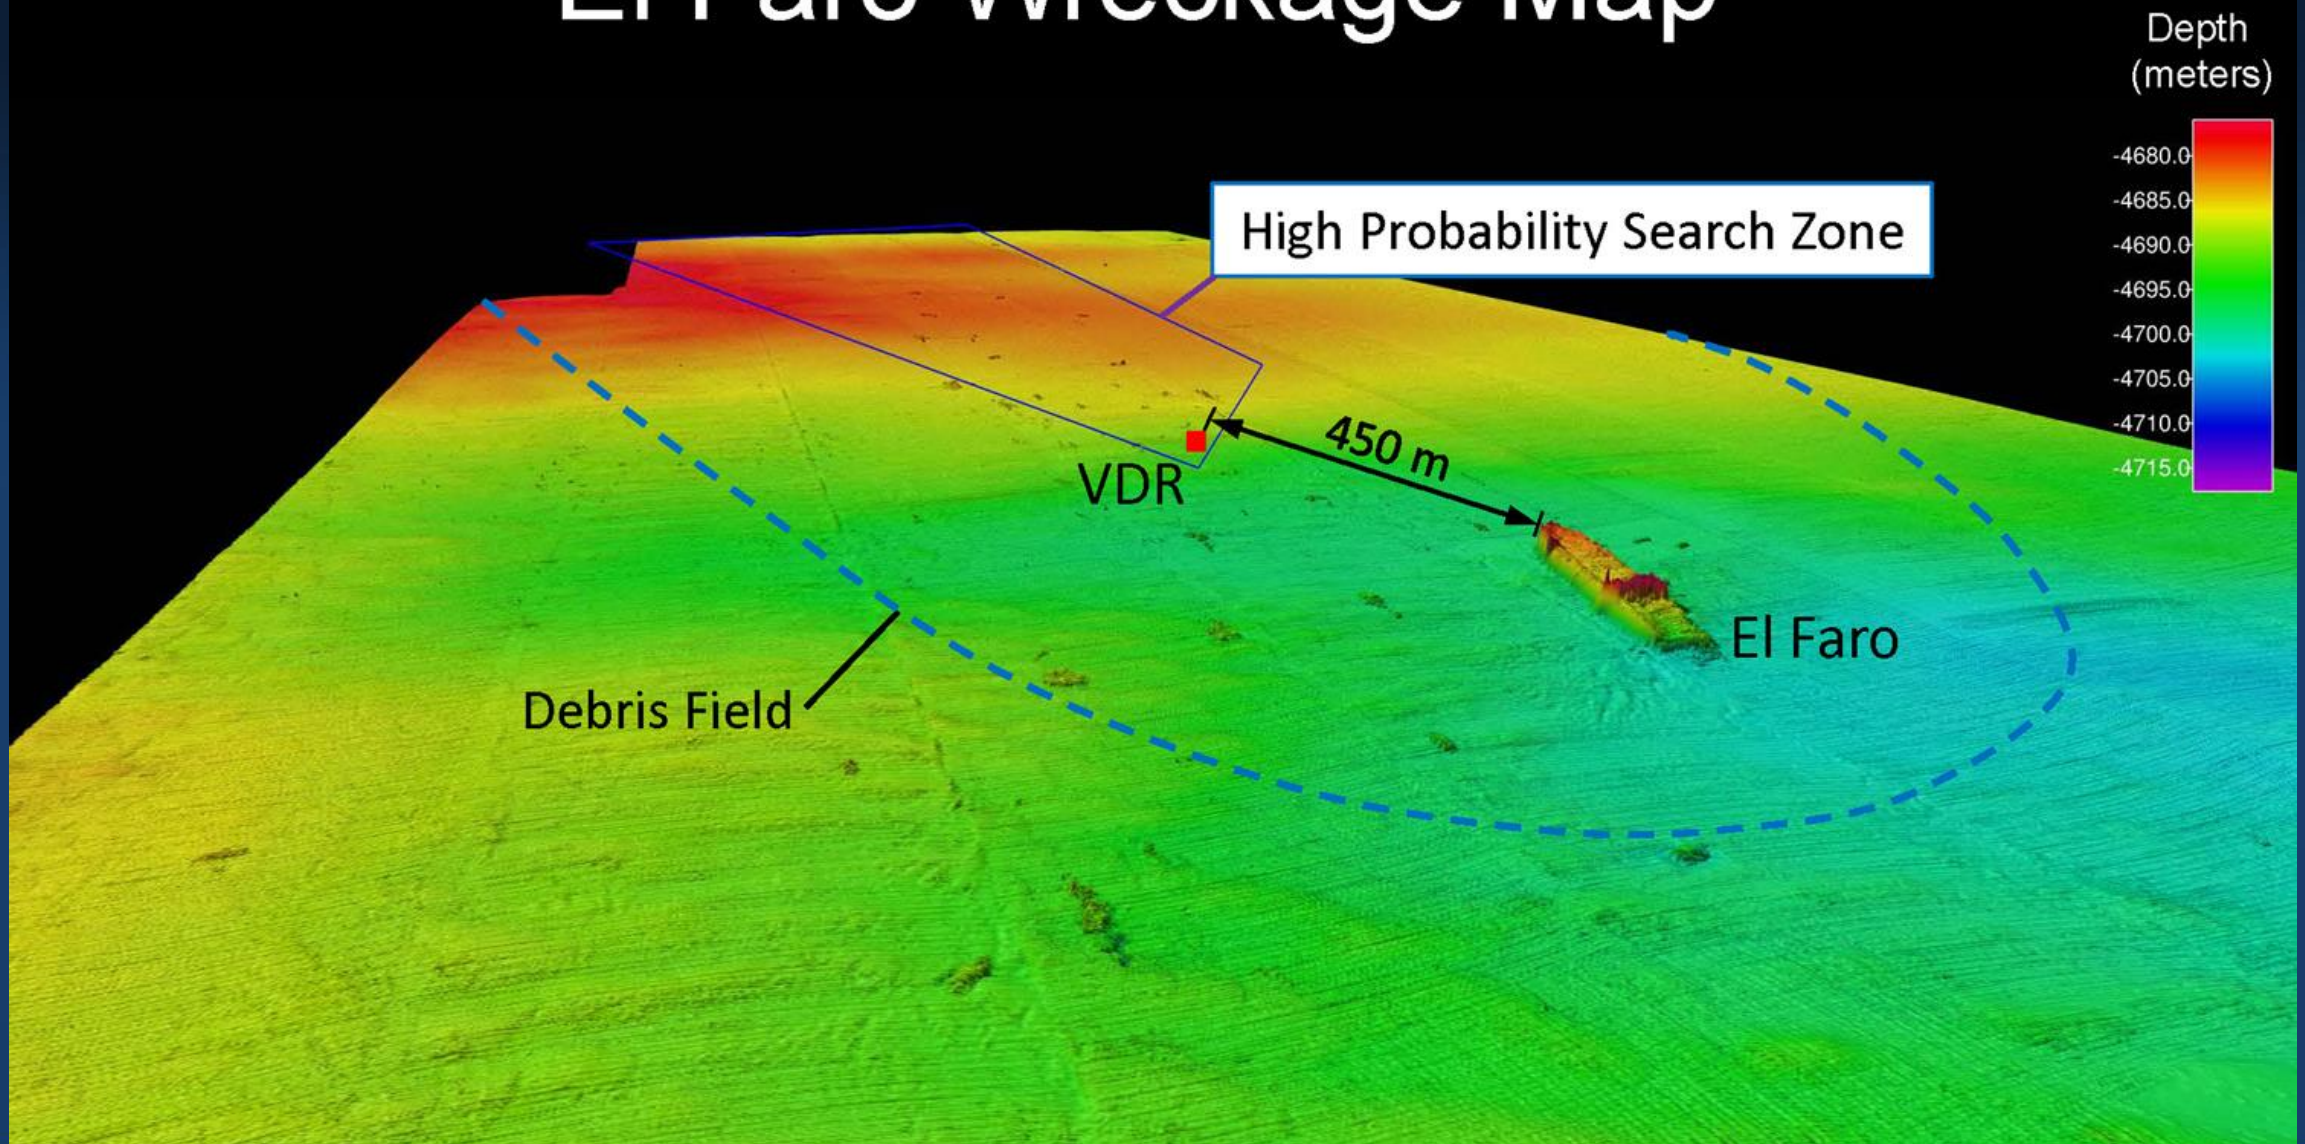
# El Faro Wreckage Map

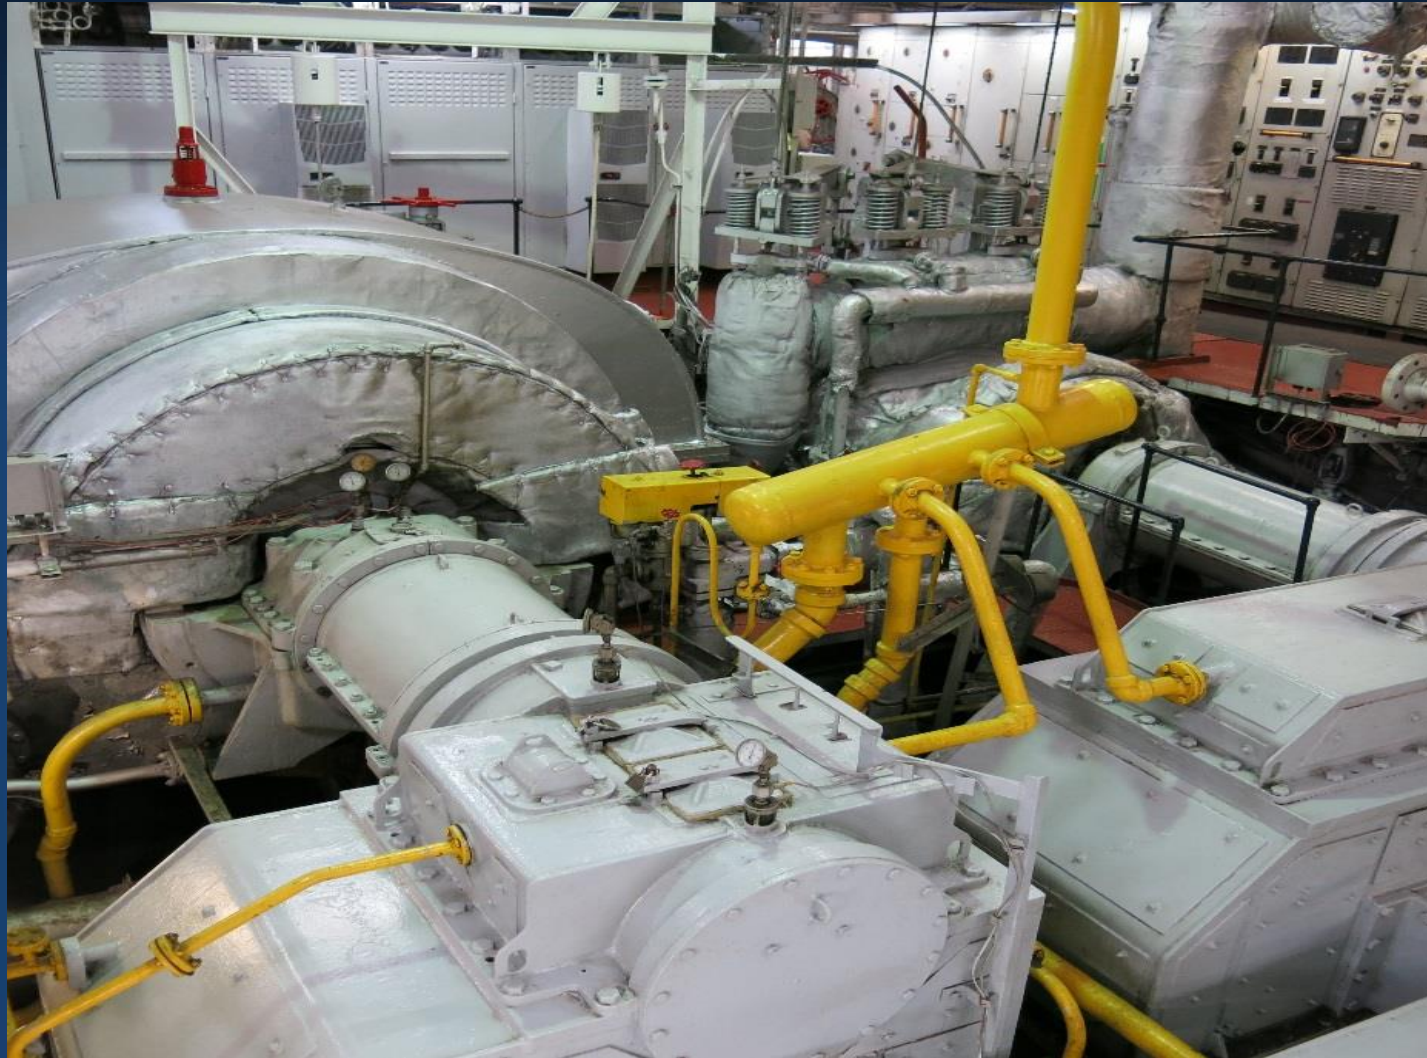
# Lube Oil System

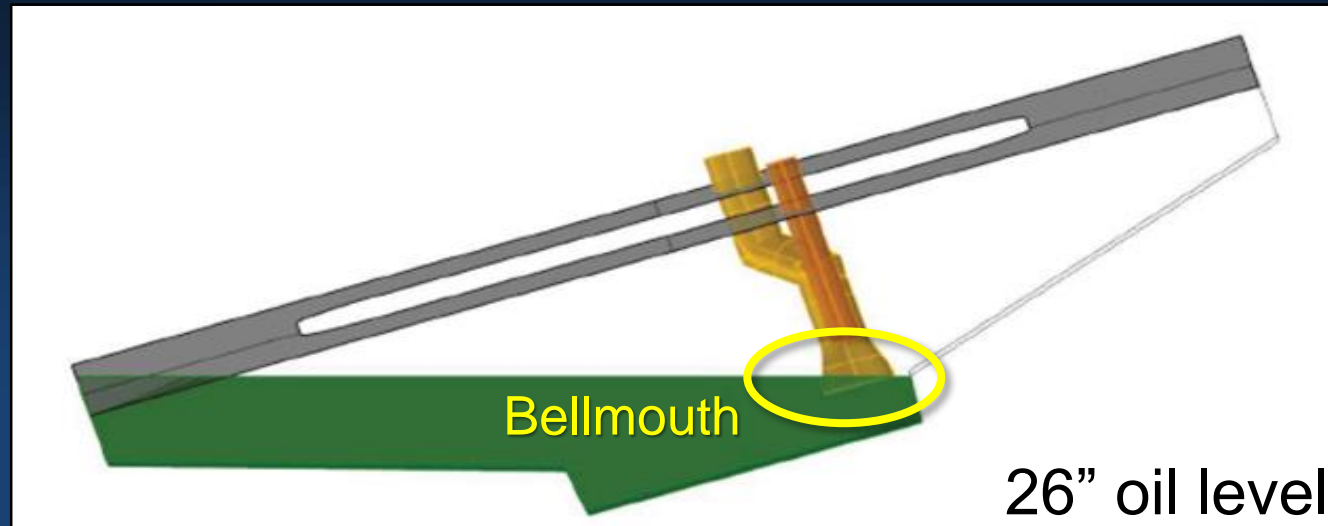
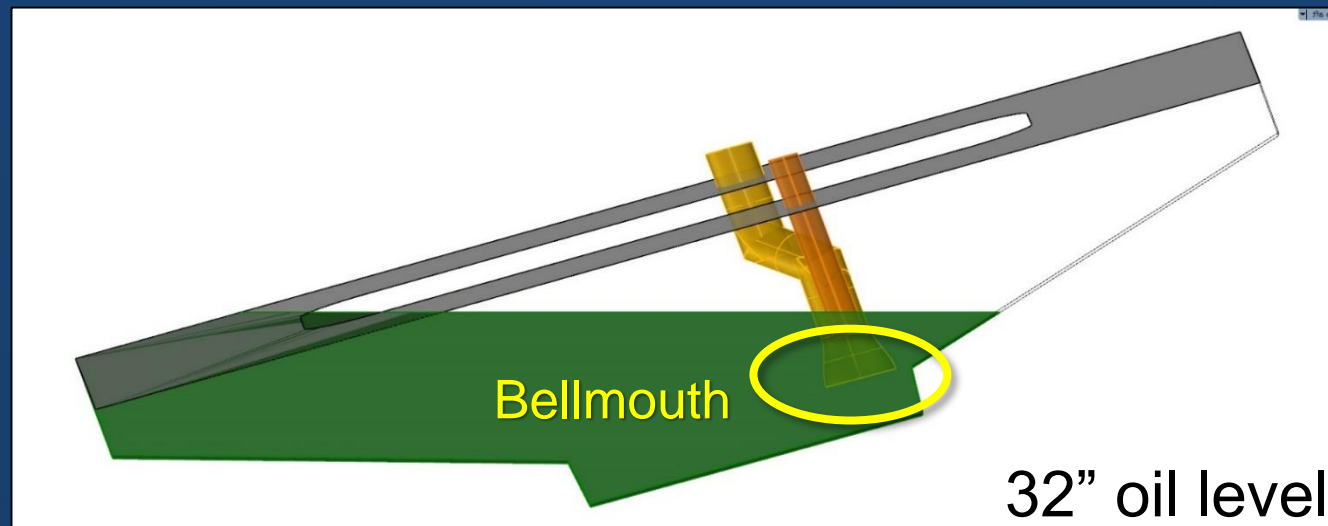
# 18° List to Port

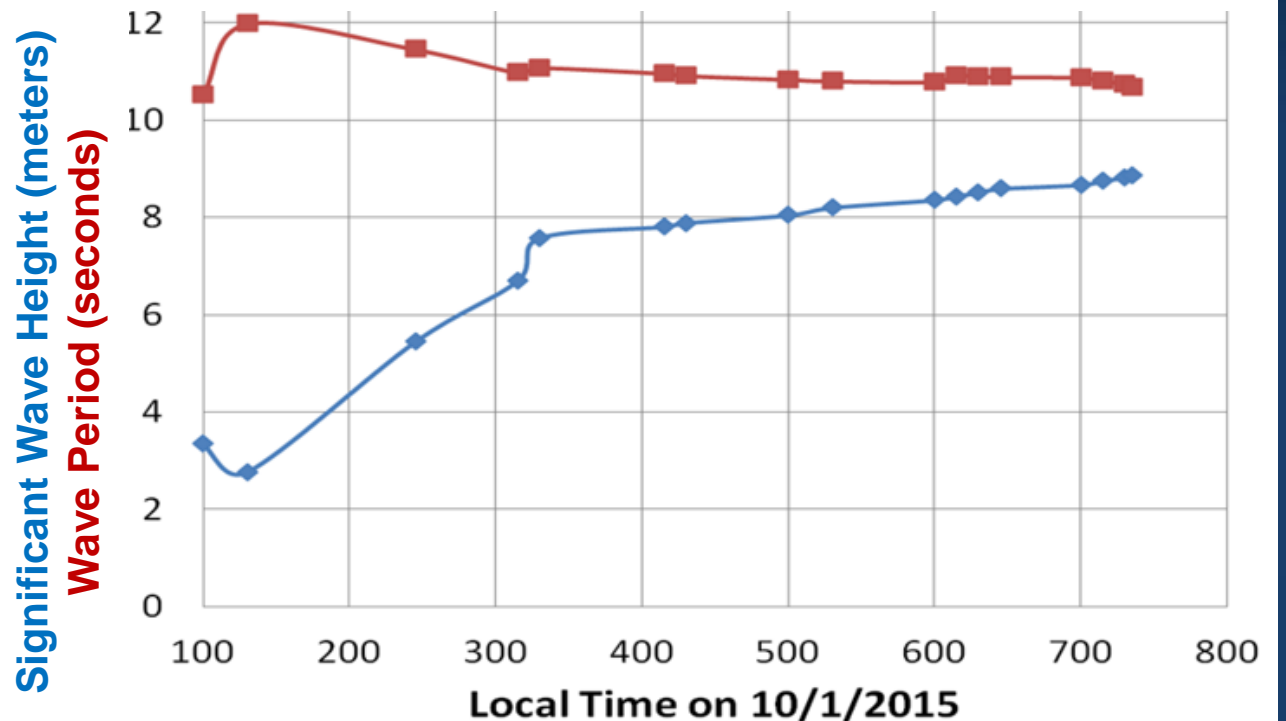
- Seas increase rapidly after 0130
- Over 7 meters (23 feet) by 0300
- Build to 9 meters (30 feet)
- Wave period of 11 seconds

**Analysis of Post-Storm (Hindcast Data) Sea/Weather Models Along *El Faro's* Track**

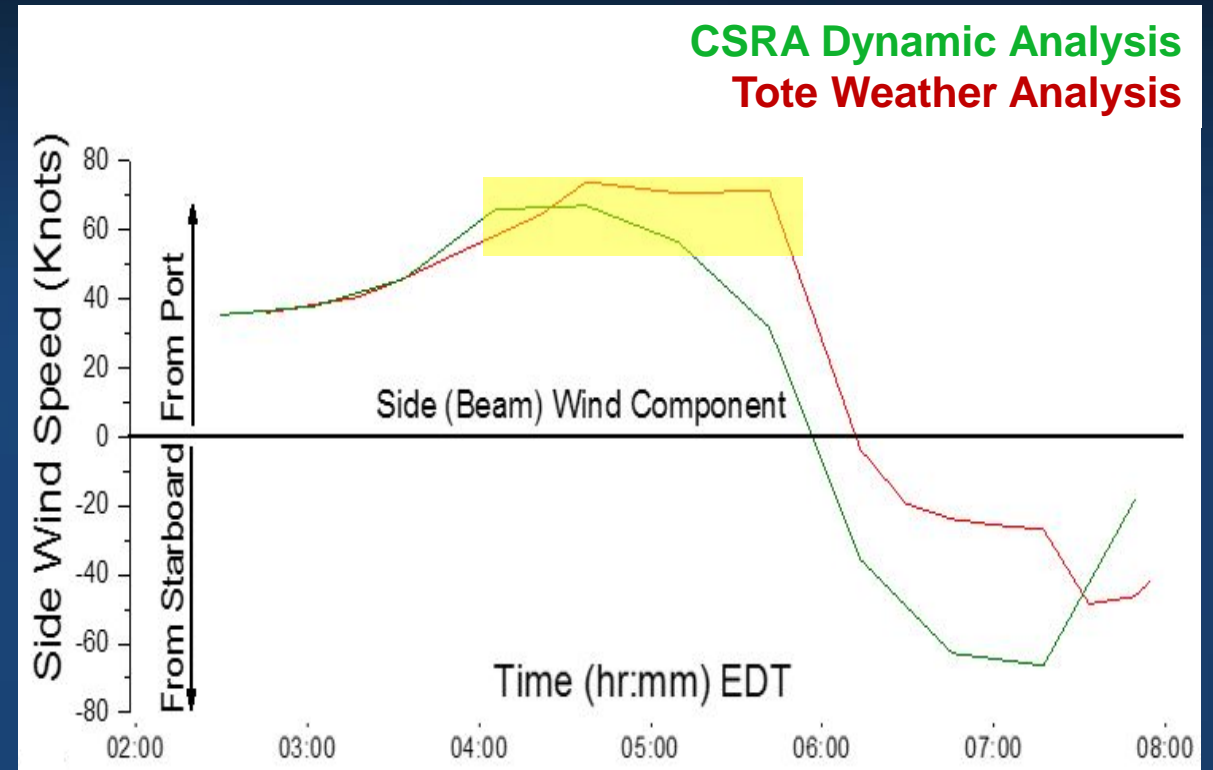
# Sustained Windheel

- Increasing winds after 0200 on vessel's port beam
- Wind near 70 knots by 0400
- Effect: increasing and sustained heel (windheel) to starboard
- Hydrostatic analysis shows heel from 5° to 8° for winds 60 to 80 knots on beam

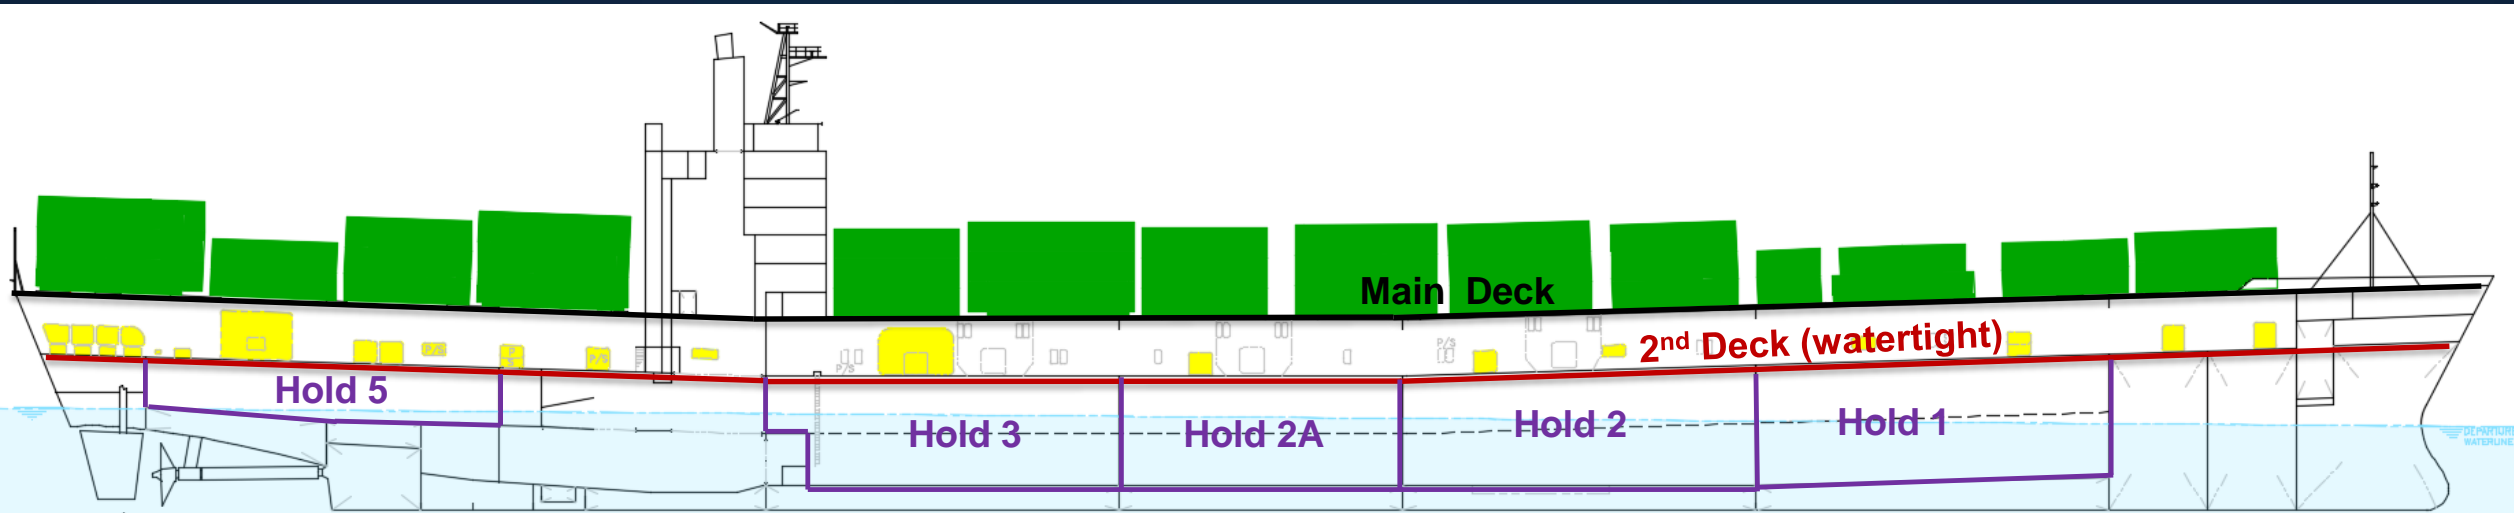
# Watertight Deck

- Boarding seas (green water) was known to enter onto 2<sup>nd</sup> deck in past
- Partially enclosed 2<sup>nd</sup> deck was watertight

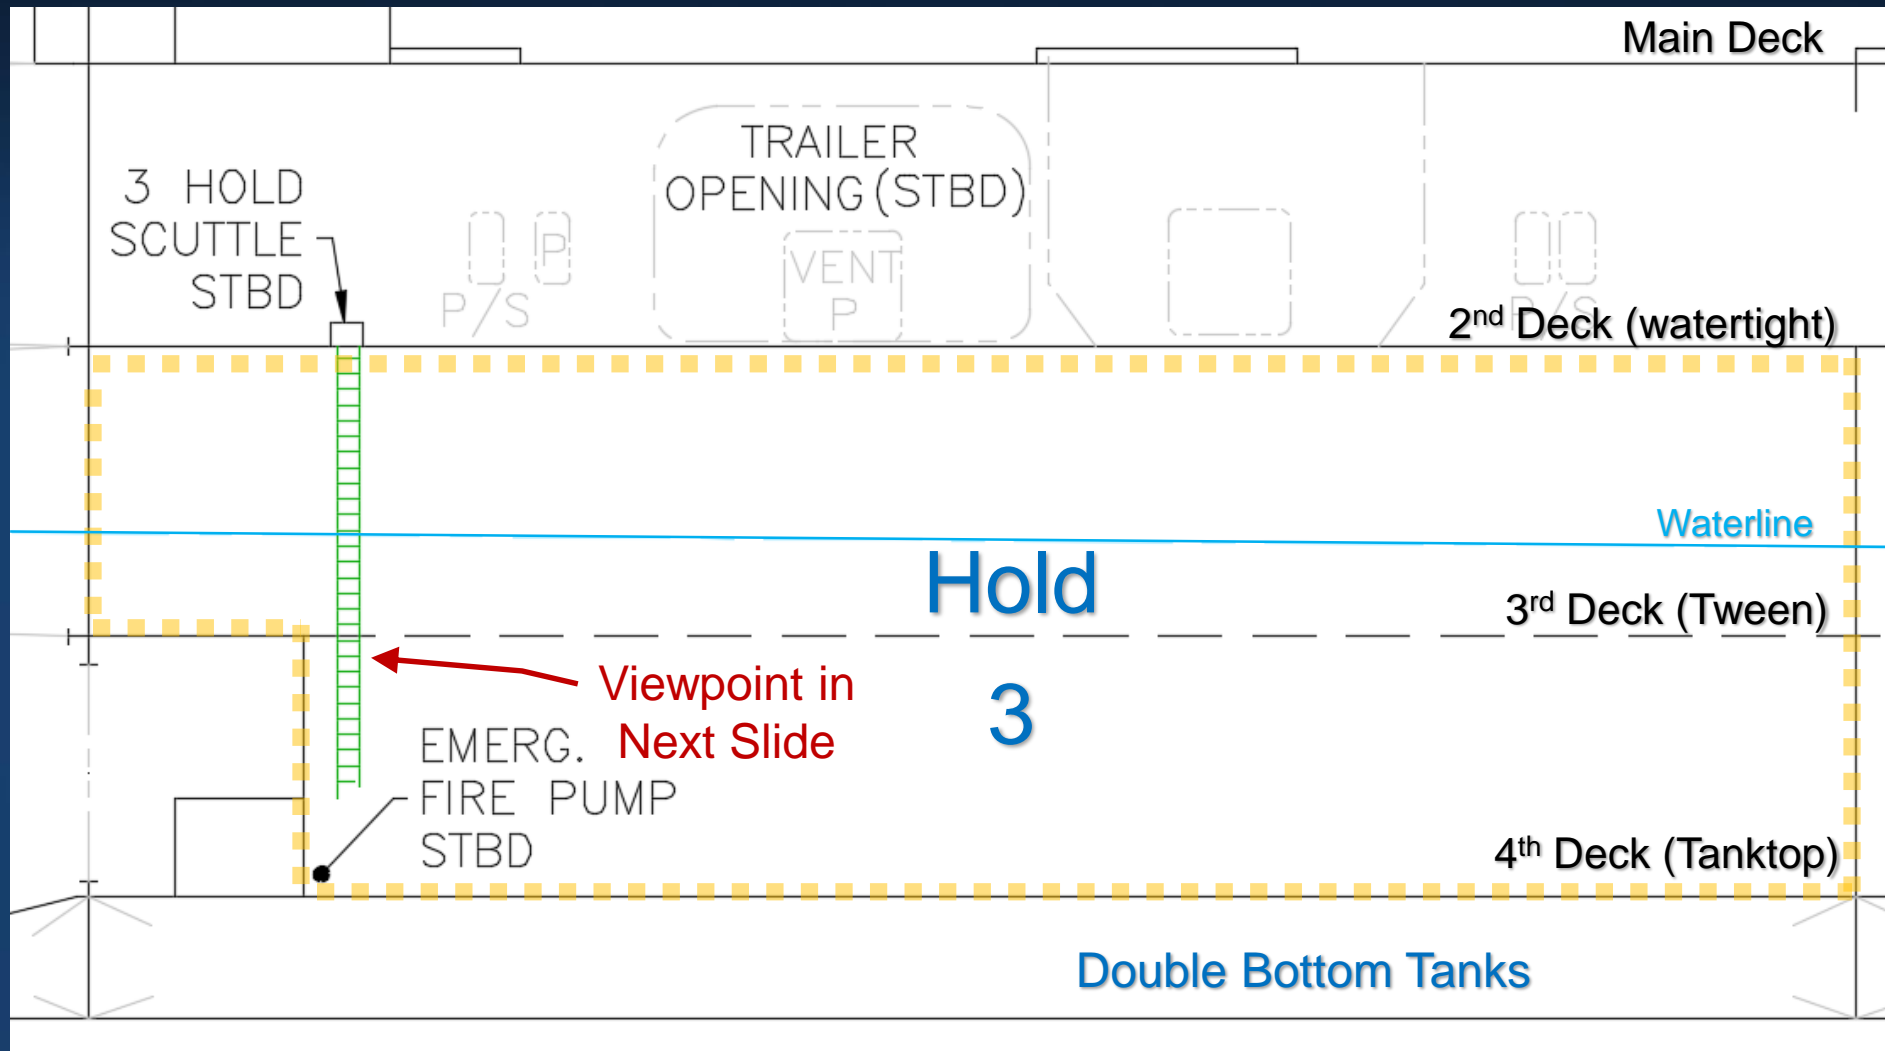
- Hold 3 was flooding at 0543 per VDR
- Small watertight deck hatch (scuttle) to cargo hold 3 on second deck was open
- Open scuttle allowed downflooding through ship's watertight envelope

# El Faro Cargo Hold 3

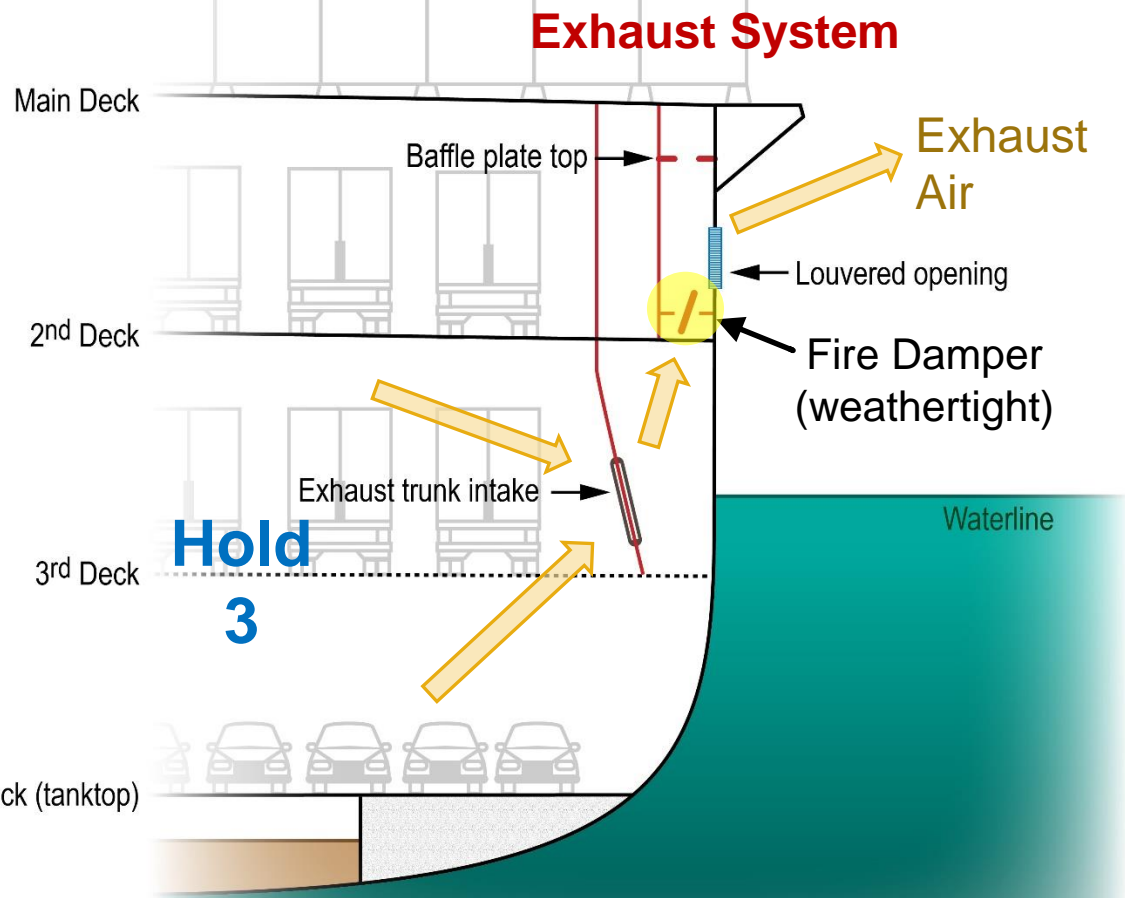
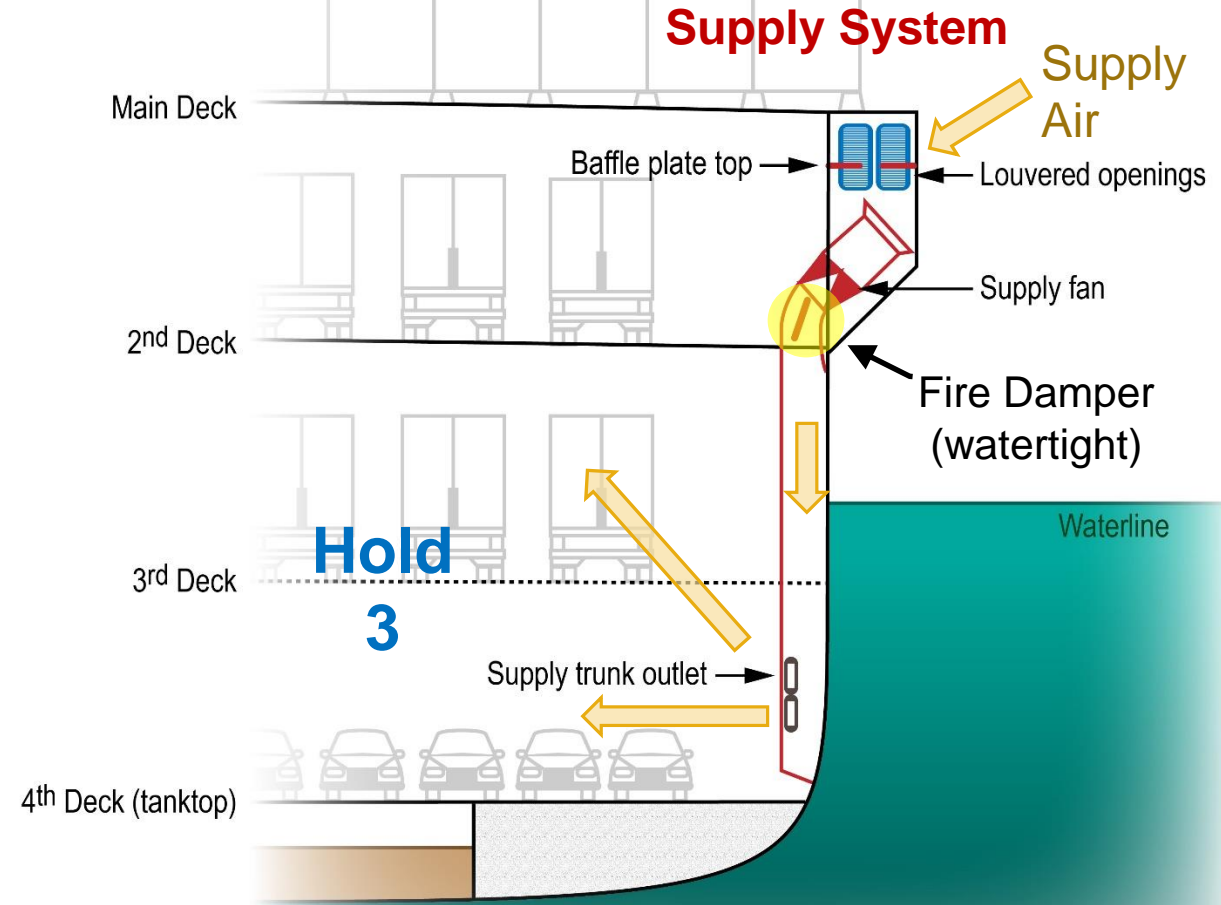
# Cargo Hold Ventilation System

- Ventilation closures most likely remained open throughout sinking
- COI required ventilation of holds at sea
- Intact and damage stability standards consider ventilation openings to be closed
- Vessels should not have conflicting requirements

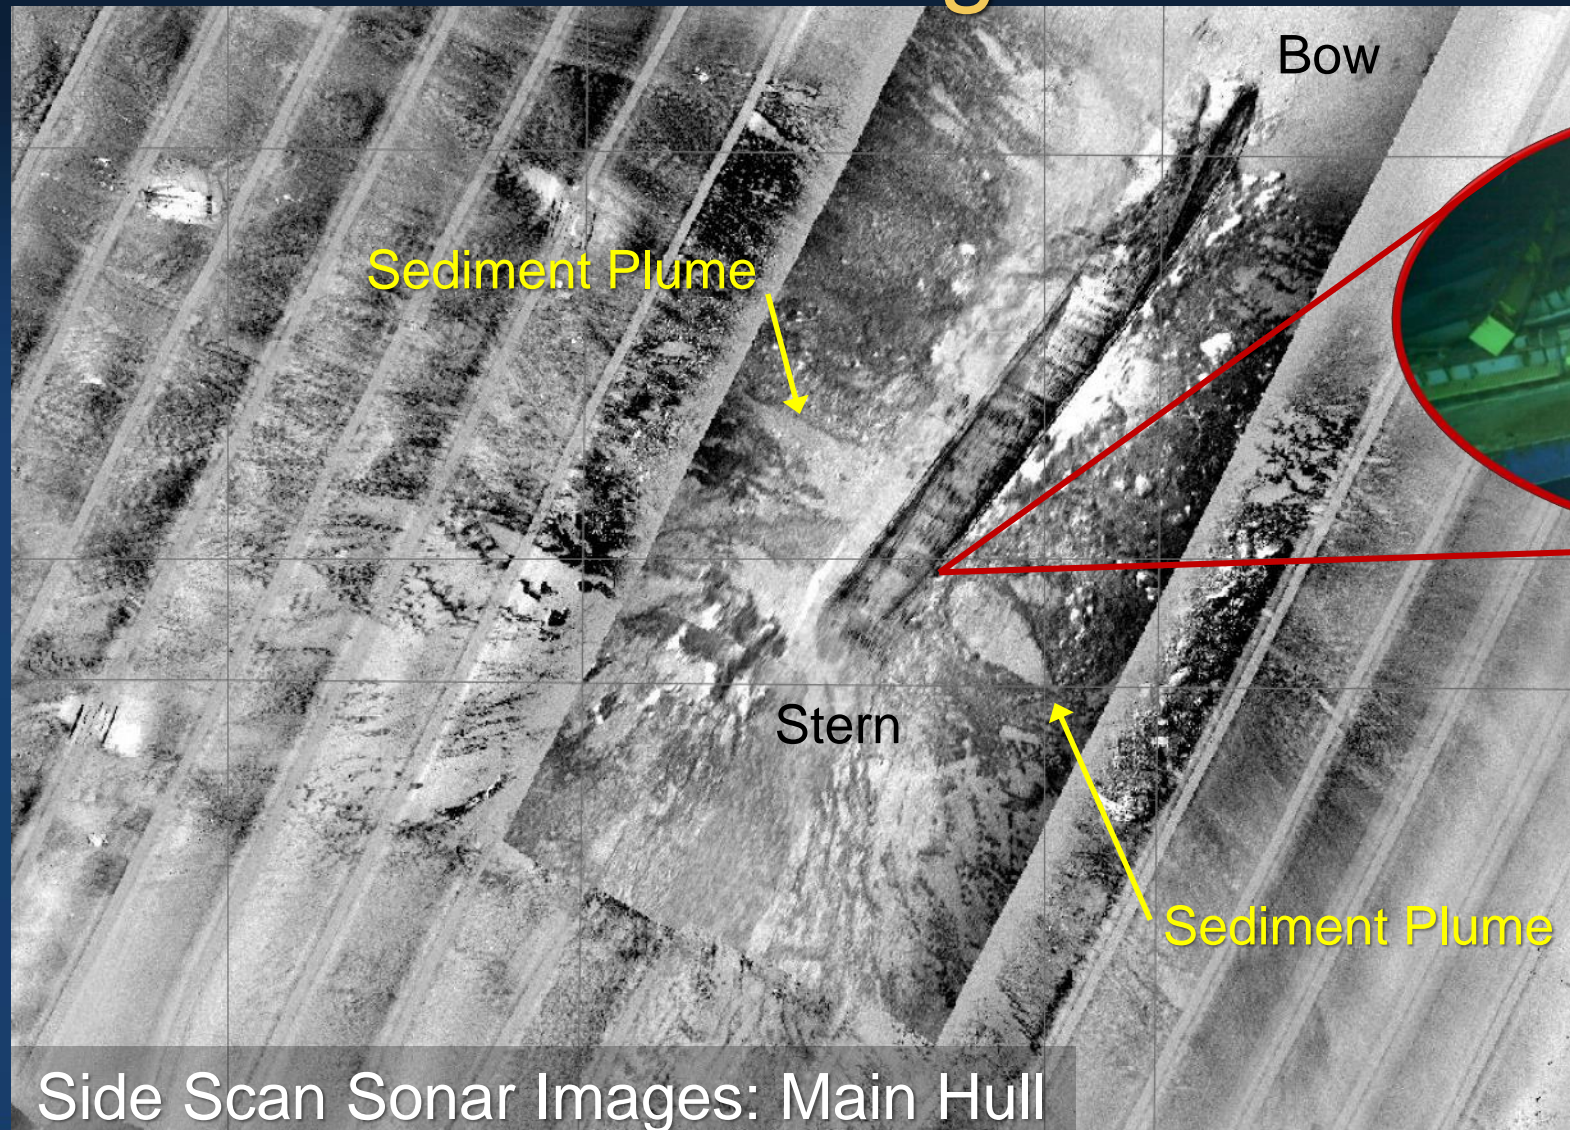
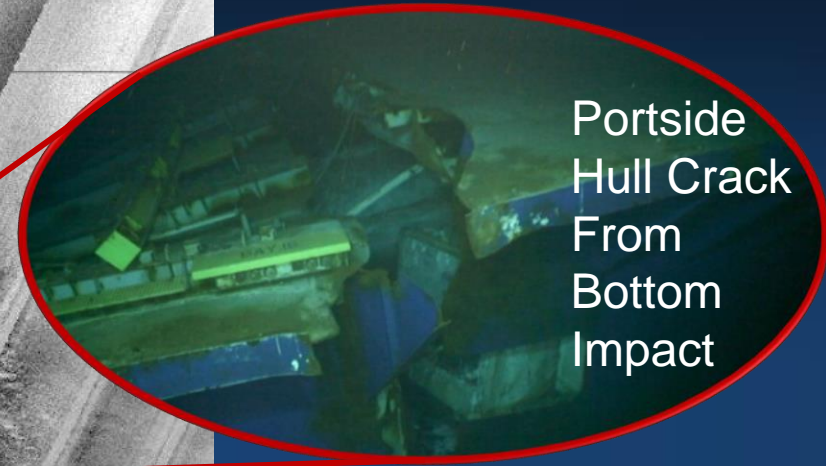
# Examination of Wreckage

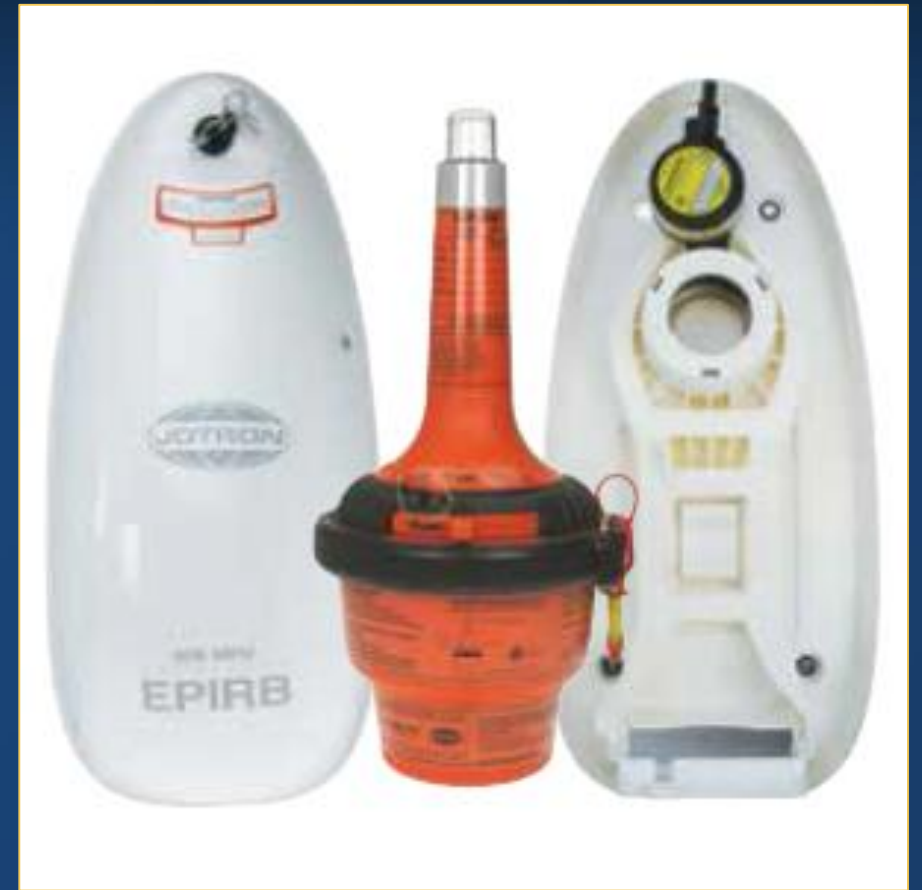
# Emergency Position Indicating Radio-Beacon (EPIRB)

- *El Faro's* EPIRB
  - Detected at 0736
  - Location not determined
- GPS-enabled EPIRB – sends an accurate position with the first transmission
- *Lady Mary* accident in 2009
  - 6 of 7 crew perished
  - Delayed sending SAR assets

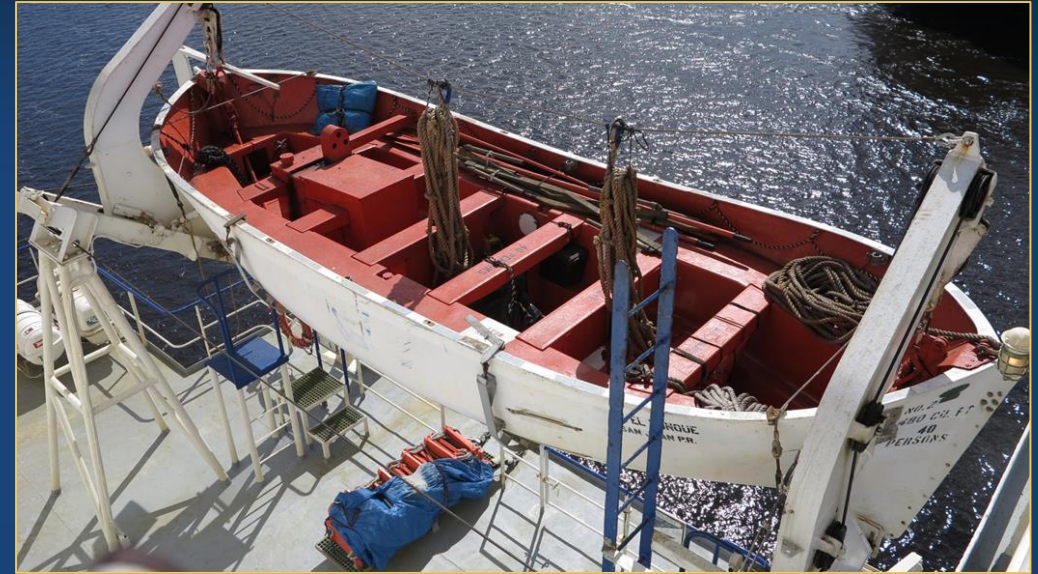
# Survival Craft – Open Lifeboats

- 1980s: recognized as inadequate
- Does not protect crew from elements
- Not allowed on new vessels since 1986
- Allowed to remain if maintained

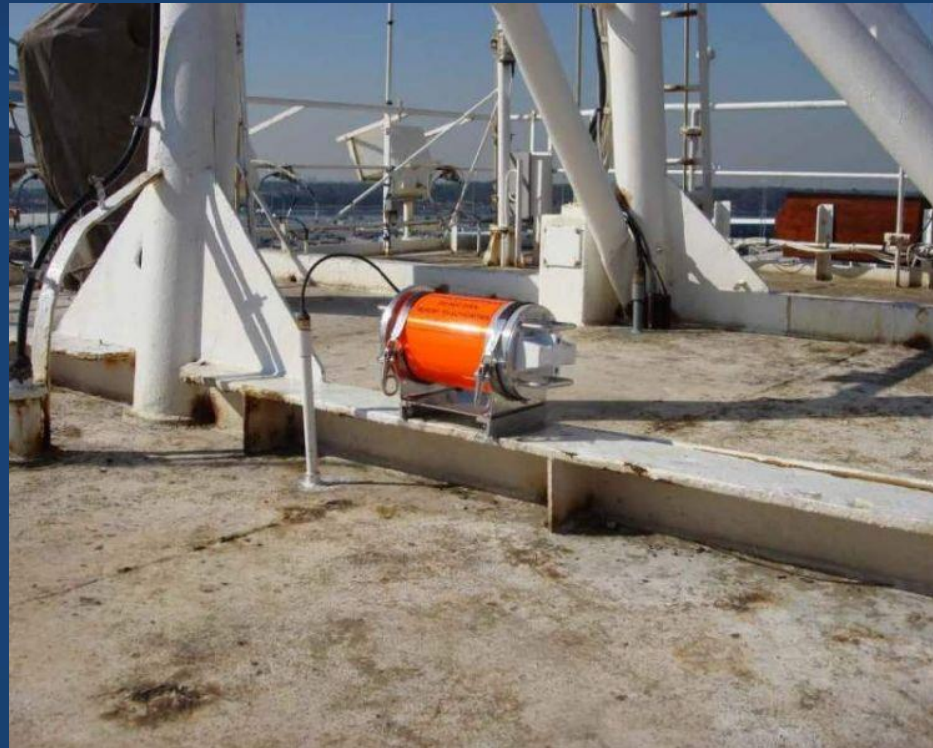
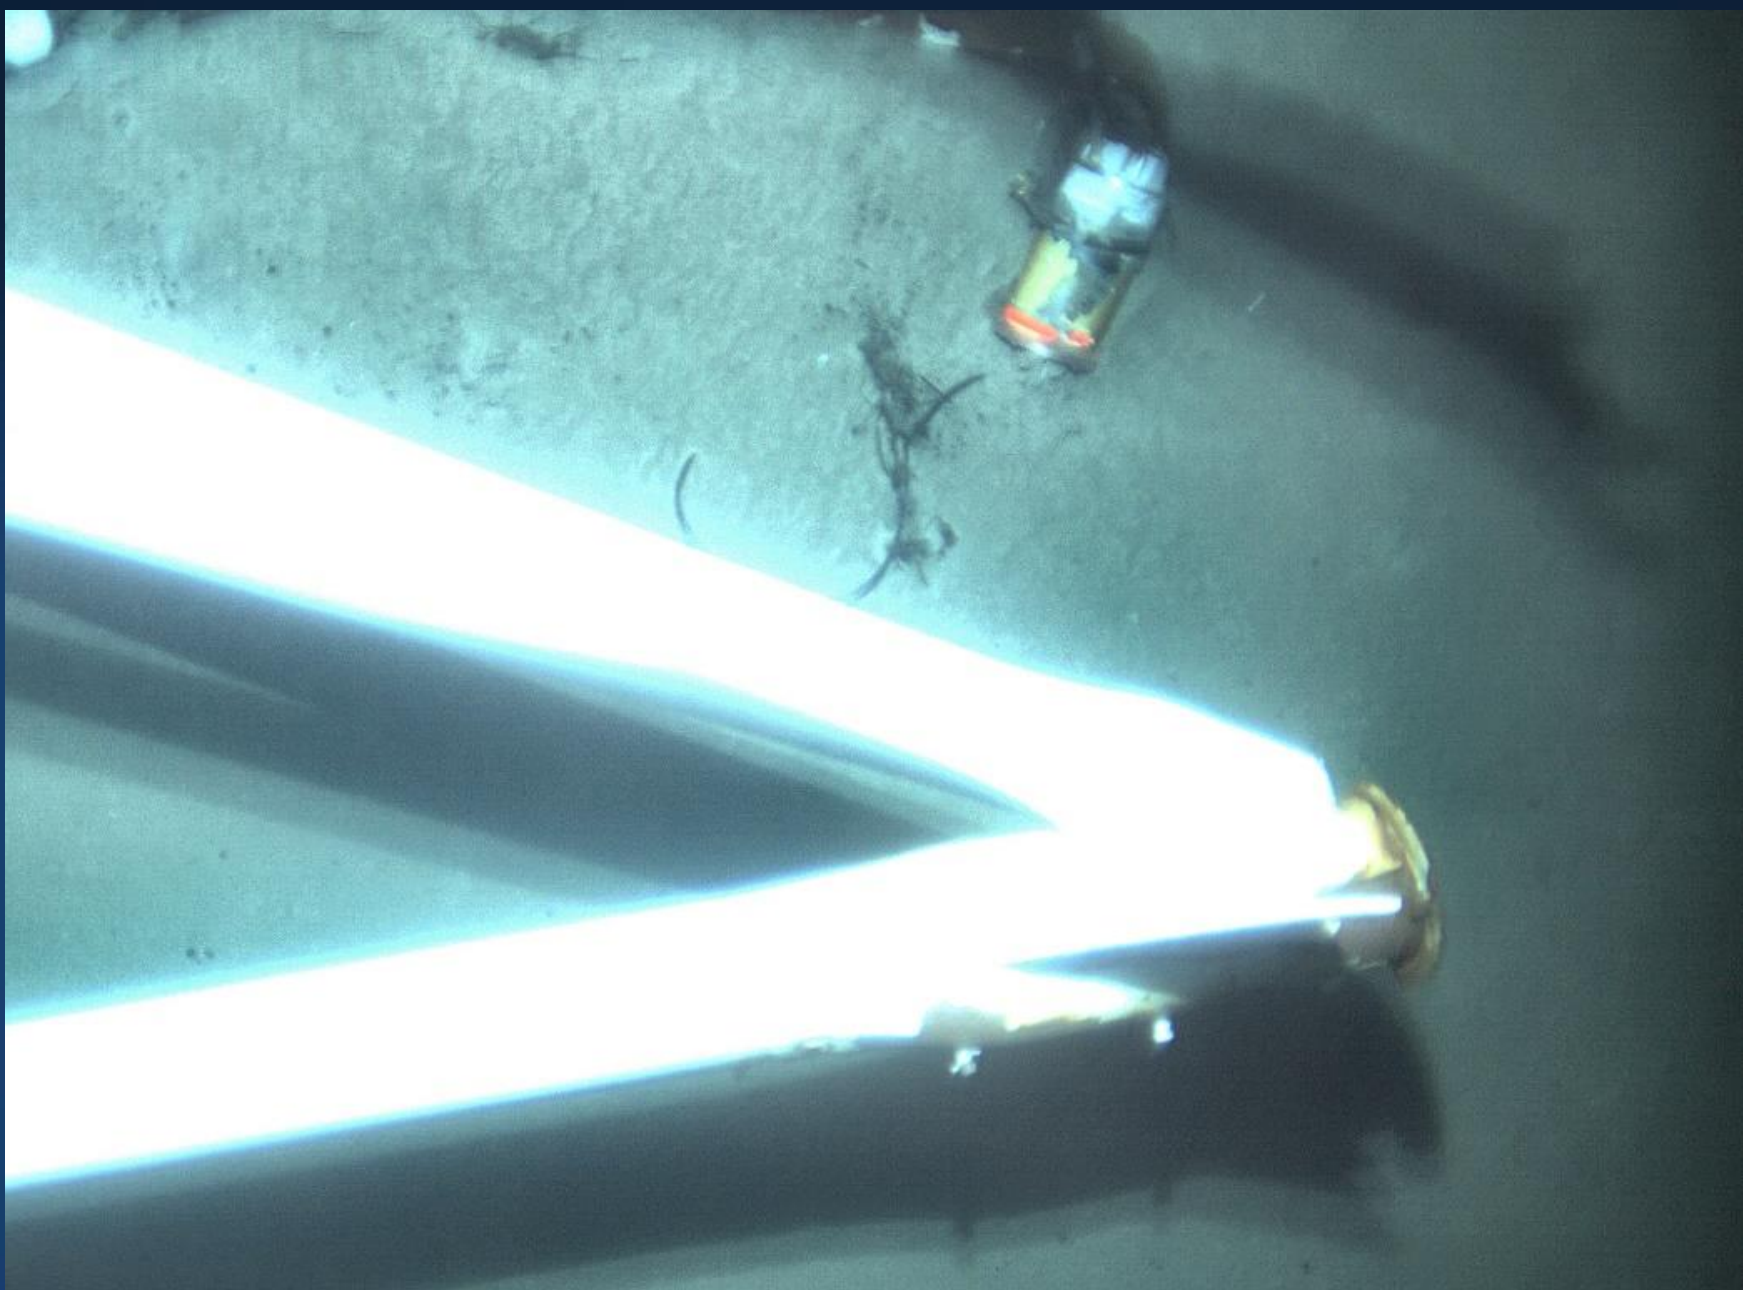
# VDR Annual Performance Testing

- Expired locator beacon battery
- VDR capsule recovery hampered

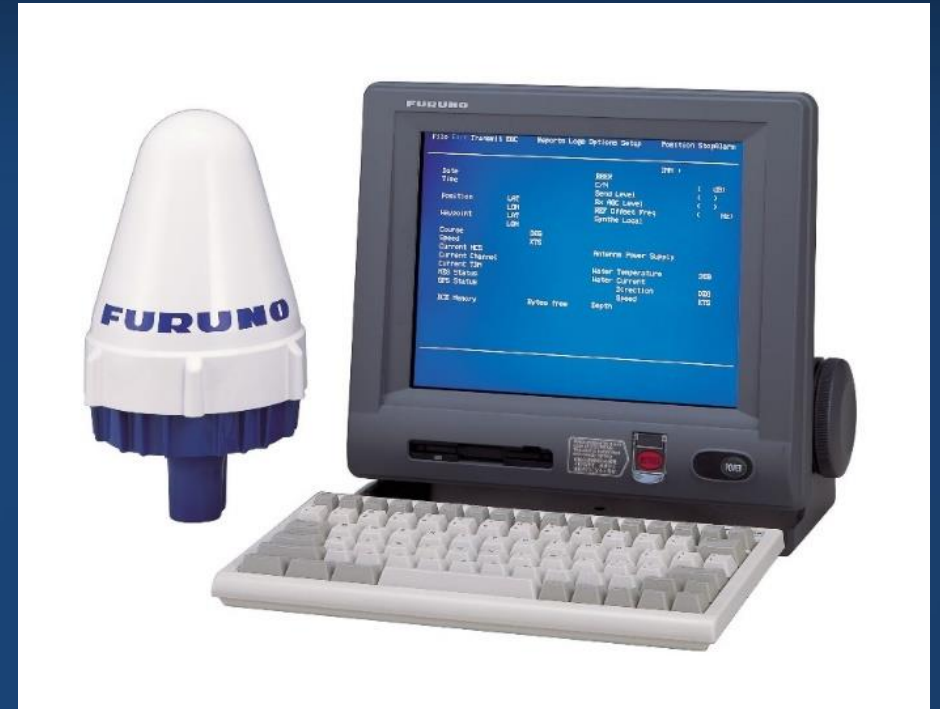
# GMDSS Formatting Issues

- GMDSS – Global maritime distress and safety system
  - Inmarsat-C distress alert interface
  - User modifiable distress position
  - System does not update distress position at time of sending
