Sinking of Cargo Vessel *El Faro*  
Atlantic Ocean, Northeast of Acklins and  
Crooked Island, Bahamas  
October 1, 2015

## Accident Overview Sinking of Cargo Vessel *El Faro*

## Accident Narrative: Sinking of Cargo Vessel *El Faro*

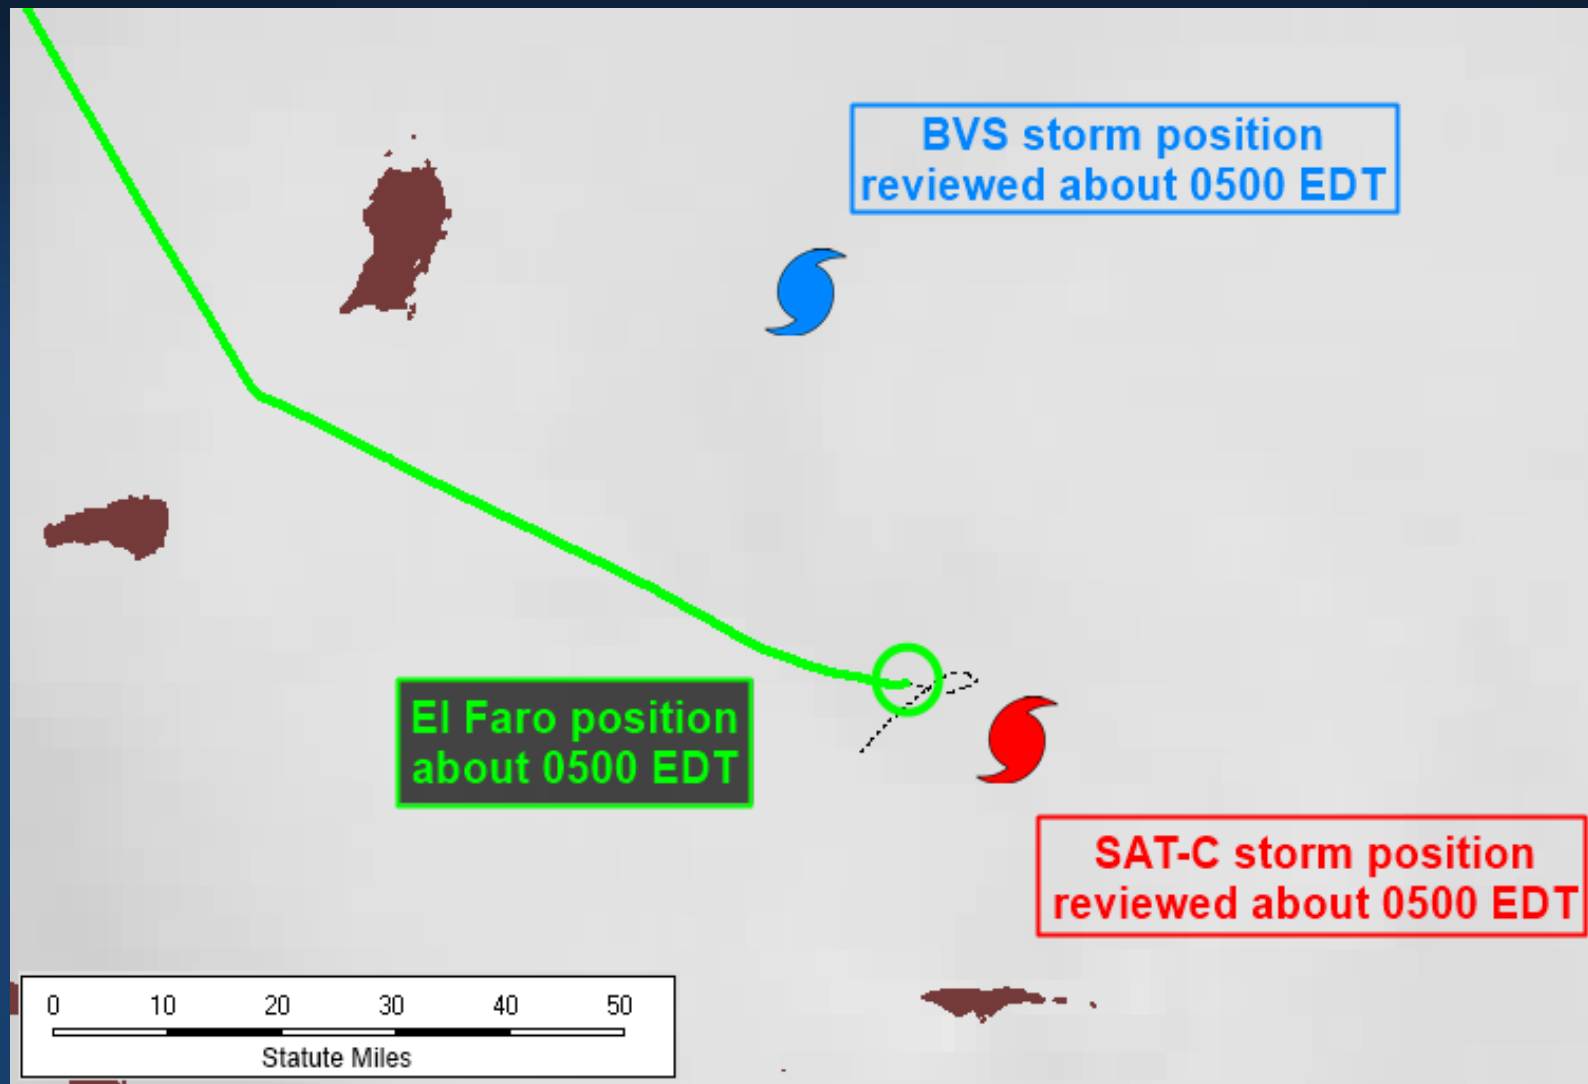
# Onboard Weather Information

- BVS provided a storm position and forecast track 6 hours behind SAT-C
- Old storm information was due to processing limitations at the vendor
- Mitigation options were published by the vendor but not acted upon
