NATIONAL TRANSPORTATION SAFETY BOARD

ELT SWITCH EXAMINATION SUMMARY

WPR16FA040

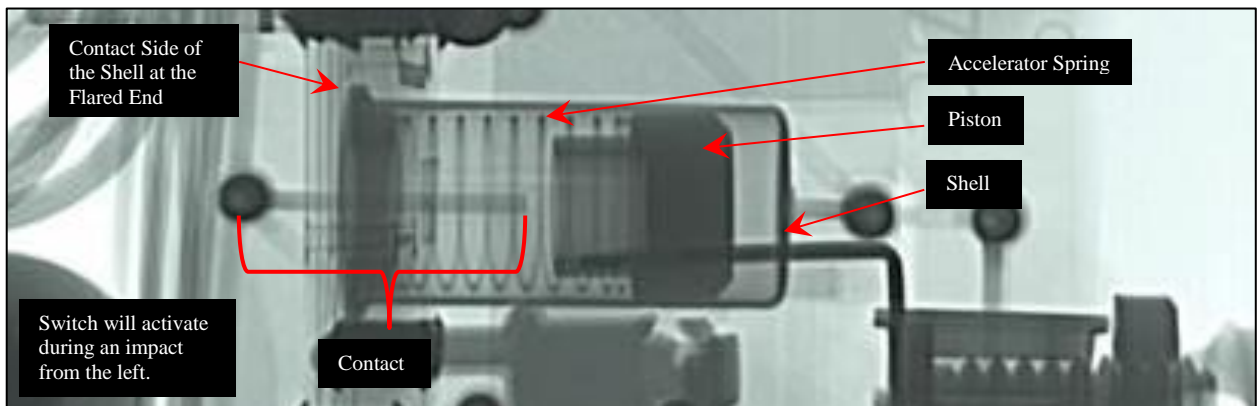
Figure 3, X-ray of 5-Axis G-Switch, Parts Description

The X-ray images of the primary G-switch revealed the acceleration spring was bent to one side of the switch's housing, resulting in the spring not sitting centered on the ball. No other anomalies were noted.

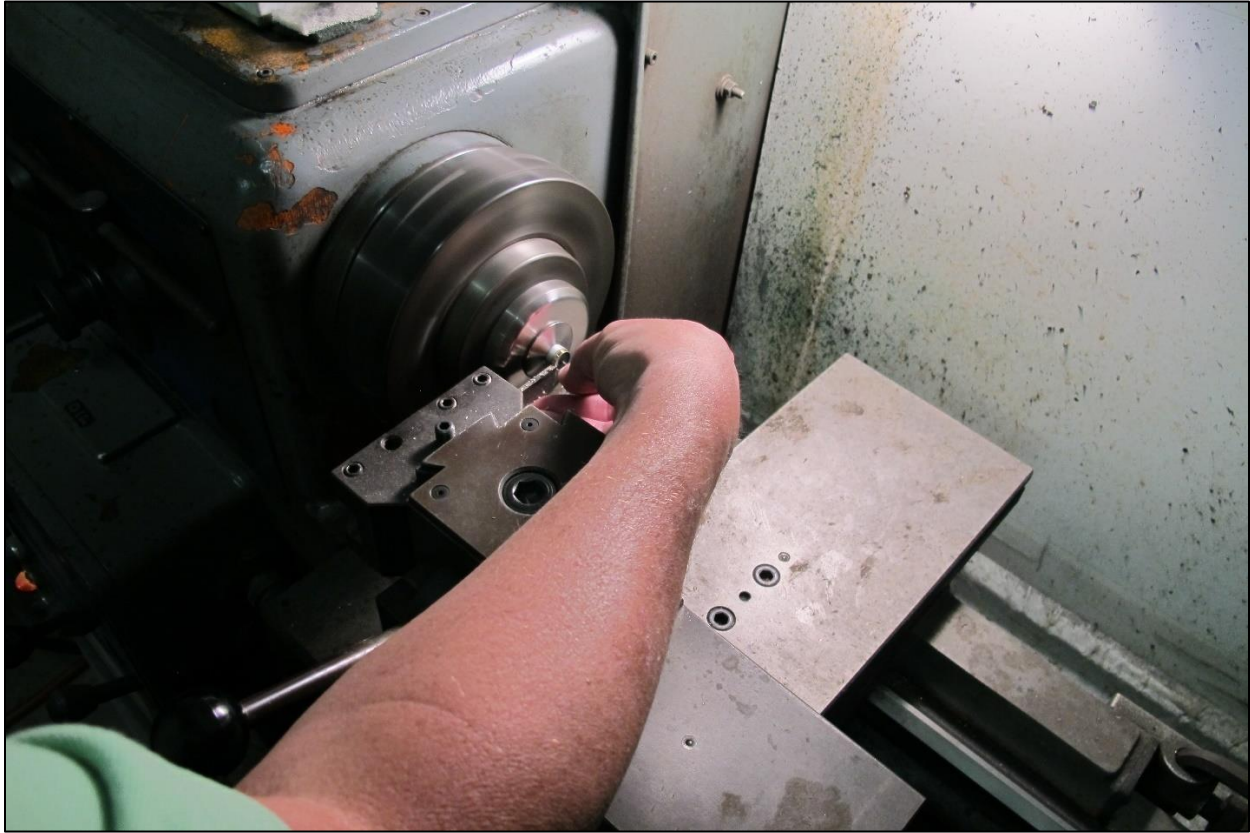
Figure 5, Opening of the Switches

The internal examination of the primary G-switch revealed a black powder residue on the ball, contact area and the housing's internal surface areas. The spring was covered in the black powder residue and was unremarkable. Due to the method on how the switch was opened, the ball could not be removed completely from a small portion of the housing.
