NATIONAL TRANSPORTATION SAFETY BOARD

AIRFRAME AND ENGINE EXAMINATION

WPR12LA302

N718JT, Bunch, Cozy 3

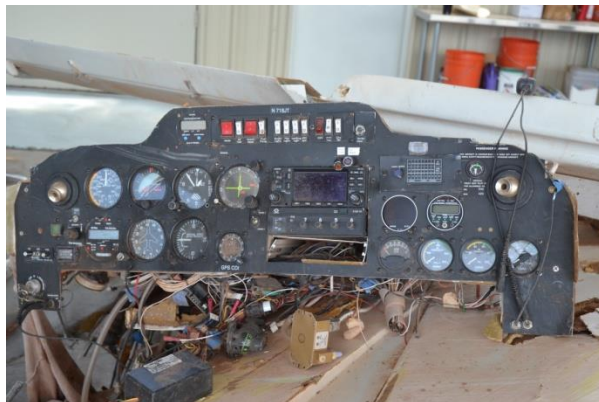
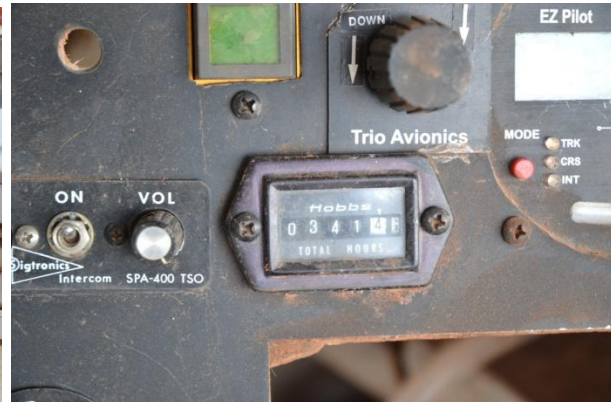
1.1 Airframe Exam Photos

Examination of the airframe revealed that control continuity could not be established to all of the flight control systems. All flight control surfaces were accounted for in the debris field by the FAA and identified during the examination.
