**NATIONAL TRANSPORTATION SAFETY BOARD
OFFICE OF AVIATION SAFETY
WASHINGTON, D.C. 20594**

POWERPLANTS GROUP CHAIRMAN'S ENGINE TEARDOWN REPORT

NTSB ID No.: CEN-14-LA-278

Location: Duluth, Minnesota
Date: June 7, 2014
Time: 1123 Central Daylight Time
Aircraft: Lancair IV, Registration: N86NW

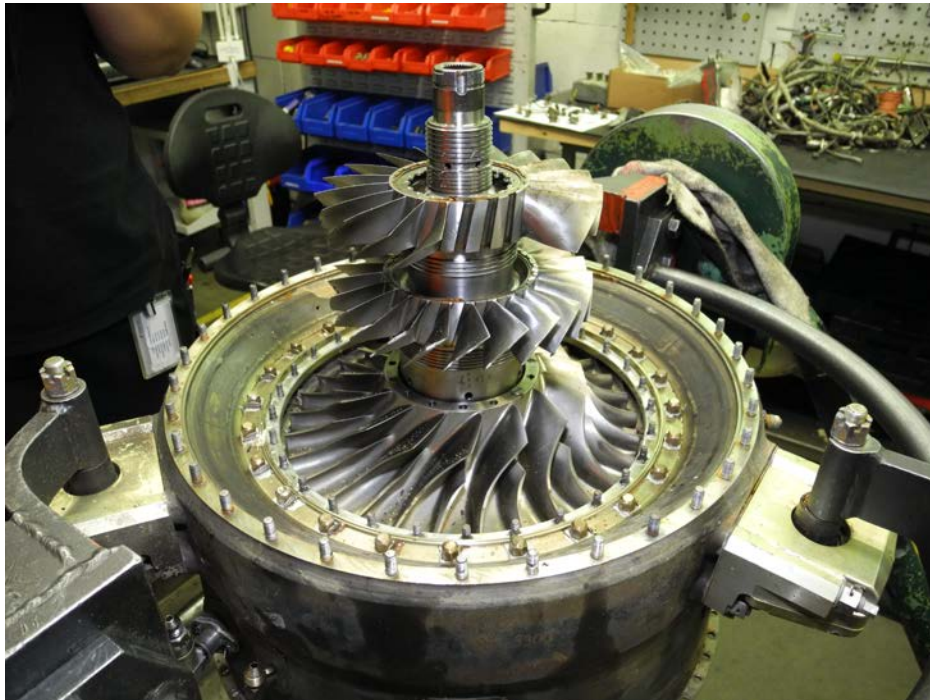
Figure 23 - 1st and 2nd Stage Axial Compressor Shrouds

The compressor rotor, consisting of the two axial compressors and one centrifugal impeller was intact (Figure 22). The 1st and 2nd stage axial compressor blades were intact, however the tips were circumferentially scored consistent with contact against their respective shroud segments. The 1st and 2nd stage axial compressor shrouds were rotationally scored (Figure 23) from the 3 to 8 o'clock location (ALF). The impeller vanes were rotationally scored, consistent with contact against the impeller shroud. The impeller shroud was rotationally scored () from the 3 to 8 o'clock location (ALF), consistent with contact against the rotating impeller.
