National Transportation Safety Board

Marine Accident Brief

Fire aboard Cargo Ship *Chipolbrok Moon*

Accident type	Fire/Explosion	No. DCA18FM025
Vessel name	<i>Chipolbrok Moon</i>	
Location	Industrial Terminal West, Greens Bayou, Port of Houston, Texas 29°44.94'N; 95°10.07'W	
Date	May 23, 2018	
Time	0010 central daylight time (coordinated universal time – 5 hours)	
Injuries	None	
Property damage	\$12 million est.	
Environmental damage	None	
Weather	Partly cloudy, light east winds, air temperature 73°F	
Waterway information	Greens Bayou is located at about mile 43 on the north side of the Houston Ship Channel, which extends from Galveston across Galveston Bay to the city of Houston.

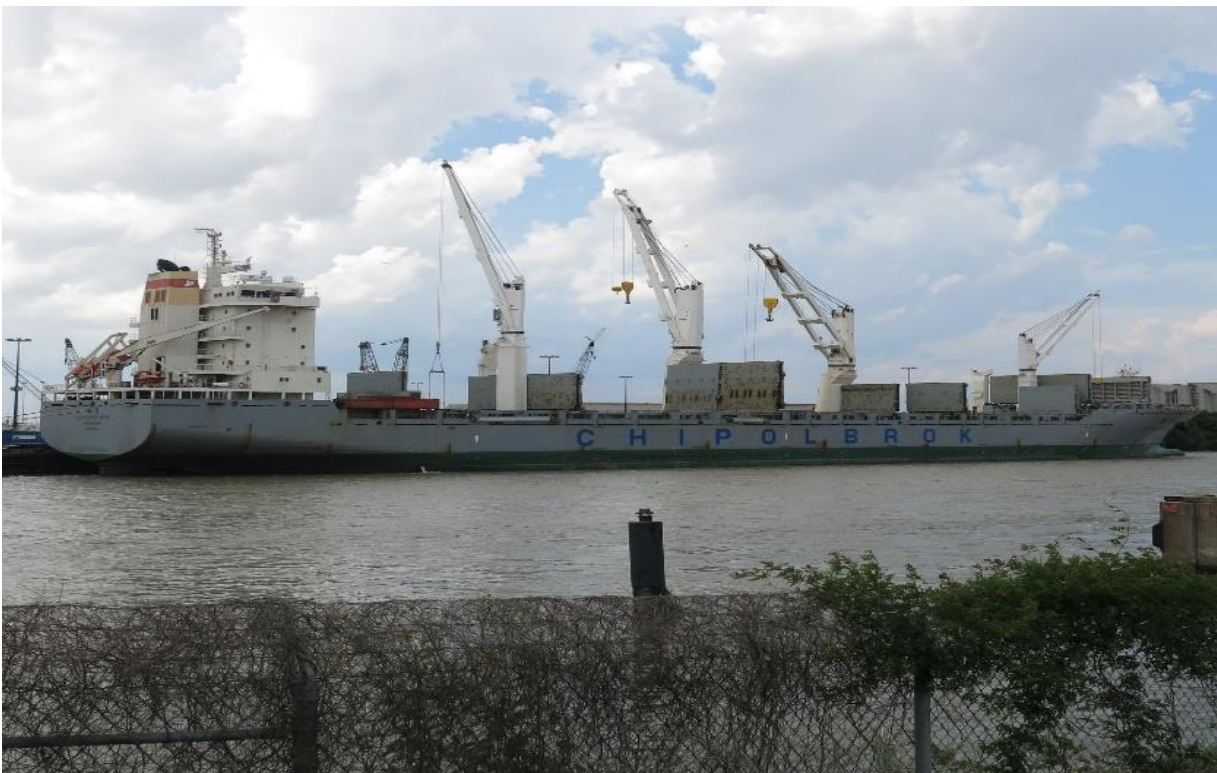
Cargo vessel *Chipolbrok Moon* docked in Houston after the accident.

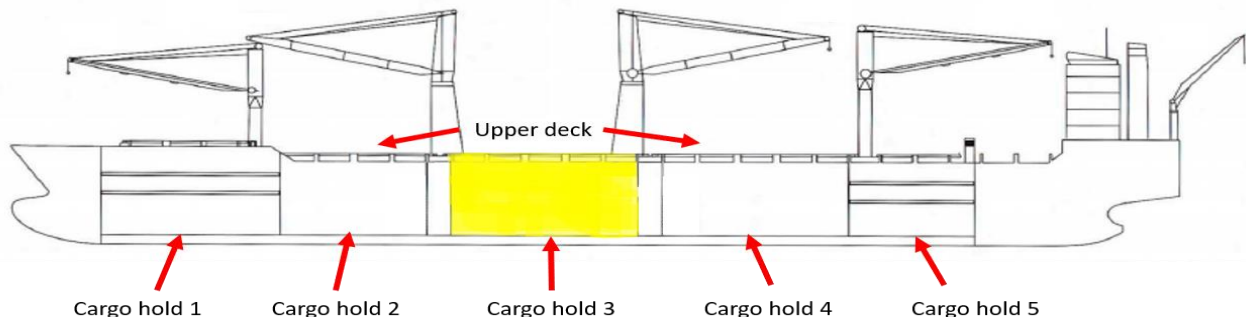
To accommodate the cargo, the pontoon decks in port cargo hold no. 3 were set up to form the lower tween deck at a height of 12.8 feet off the tank top. The port lower tween deck was loaded with four nacelle units, which were rectangular-shaped and filled about 90 percent of the deck. Another set of pontoons were positioned 15.1 feet above the lower tween deck to form the

upper tween deck. Four nacelle units were stored on this deck below the hatch covers in port cargo hold no. 3. A longitudinal bulkhead separated the port cargo holds from starboard holds, and there were two openings in the lower hold between the port and starboard holds. Four transmission hubs, along with several pieces of cylindrical steel bars, and other piping systems on a skid were loaded at the bottom of the cargo hold, on the tank top.

Portside profile of *Chipolbrok Moon* with cargo holds identified.
