**NATIONAL TRANSPORTATION SAFETY BOARD
OFFICE OF AVIATION SAFETY**

OPERATIONS FACTUAL REPORT

WPR16FA040

Operator: Air Methods Corporation
Location: Superior, Arizona
Date: December 15, 2015
Time: 1723 mountain standard time
Aircraft: Airbus AS350B3 ASTAR

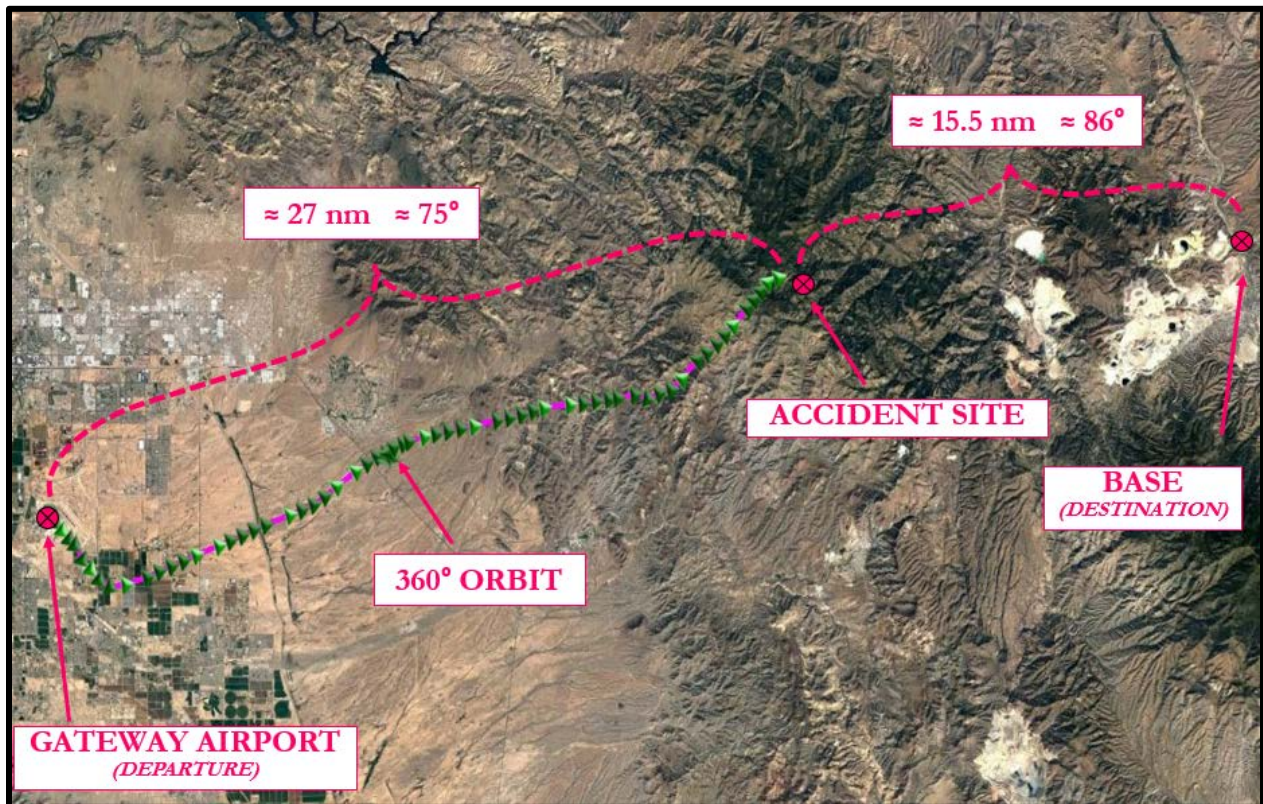
Figure 03: Accident Flight

The medical crew were diligently looking outside as they approached the mountains because in the valley there were several remote-control aircraft parks and they would regularly watch for high-flying drones. As the helicopter transitioned into mountainous terrain, around 1719 the medic had his laptop balanced on his knees and was working on charting¹⁰ and the nurse was completing paperwork from the patient pickup as well as using his cell phone.¹¹ According to the medic, nothing seemed out of the ordinary and the conversation was more idle chatter. He recalled all of them talking about cardiac patients and discussing how, because time was more critical in those situations, they needed to strategize how they could move more quickly.

[After entering the mountainous terrain], the height of the helicopter above the terrain (agl) varied considerably, as the terrain elevation rose and fell. Between 1718 and 1720, the agl altitude varied between 240 ft and 1,150 ft. Between 1720 and the end of the flight, the agl altitude varied between 30 ft and 770 ft. During this period, the agl altitude dropped below 100 ft on three occasions: at 1720:30 (60 ft agl); 1721:28 and 1723:07 (both 30 ft agl). At these points, the airspeed was between 108 and 114 knots indicated airspeed (KIAS).

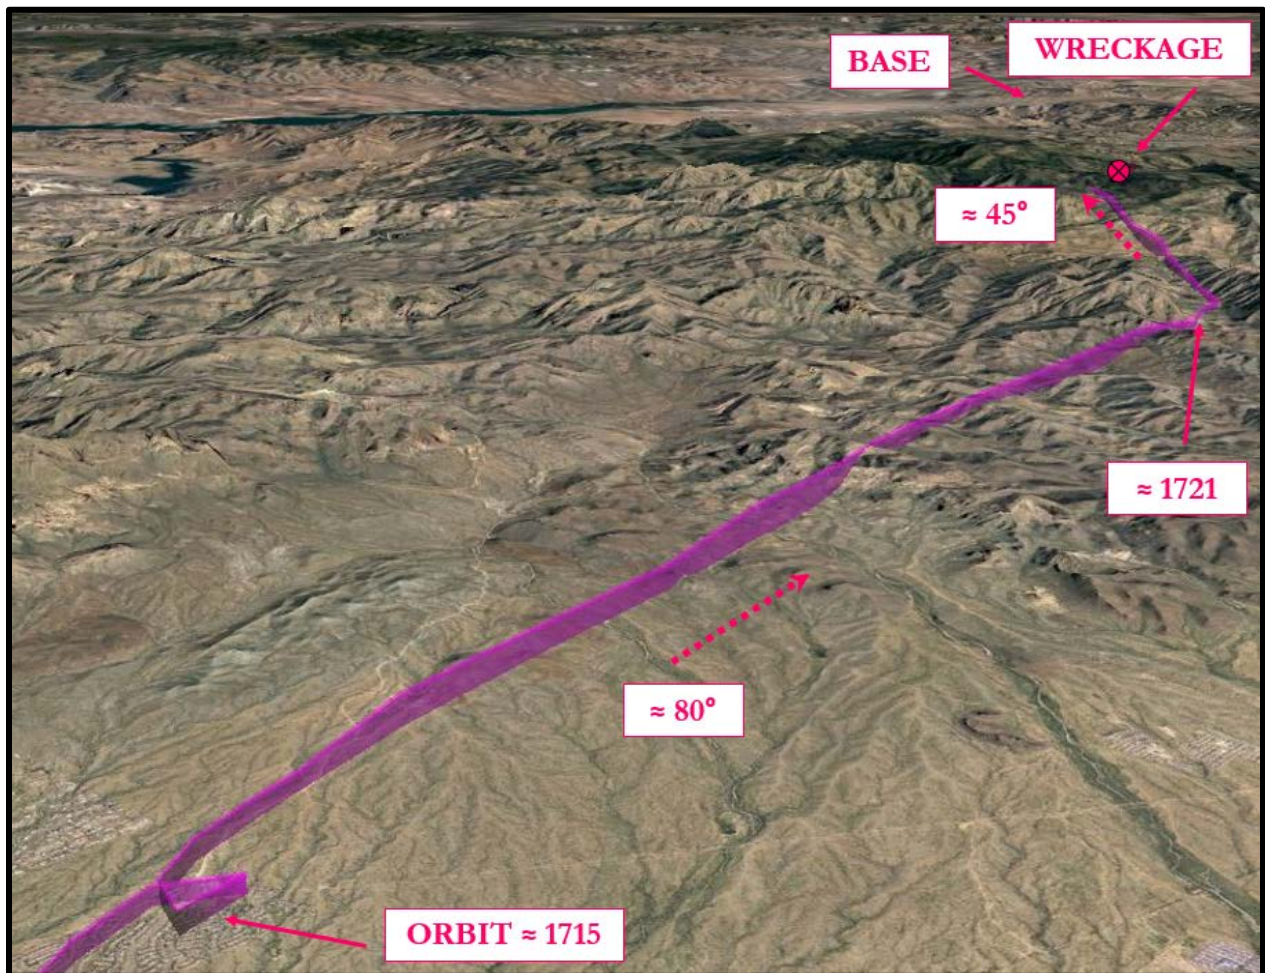
Figure 04: Flight Path from Gateway Airport Approaching Mountainous Terrain

The medic later recalled that during this portion of the flight everything appeared normal and they continued east past a rock formation that the pilot would routinely fly past and look at. He described that each pilot had their own route back to the base and the accident pilot's route would normally be more scenic and pass by that rock formation. About 1721 the helicopter passed the rock formation and began on a more northerly heading following a canyon maneuvering lower as it passed over ridgelines.

The helicopter flew nearly perpendicularly over the north-south oriented Rogers Canyon and at 1723:07 it continued through a saddle on the canyon's easterly wall, clearing the terrain by about 30 ft agl. As it passed over the eastern ridgeline, the helicopter banked to the right, changed from a ground track of about 43° to 76°, and reached a ground speed of about 120 kts.¹² According to the medic, the pilot was talking to the nurse about hunting and they discussed how there was a lot of game in the area they were flying over. The conversation then turned to the pilot reminiscing about his time in the Army and being overseas. The medic recalled the pilot was talking about having been deployed and the different helicopter attacks they would do during those times. The pilot reminisced about seeing the enemies on the ridgelines and telling them about firing on the enemy troops. He told them what it would feel like when the attack helicopter shot off rocket pods and how they would light up the skyline.¹³ Immediately before the accident, the pilot was talking about the different types of helicopters that they used while engaging with enemy forces and described using rockets and guns, while making machine gun noises to add effect to his story.

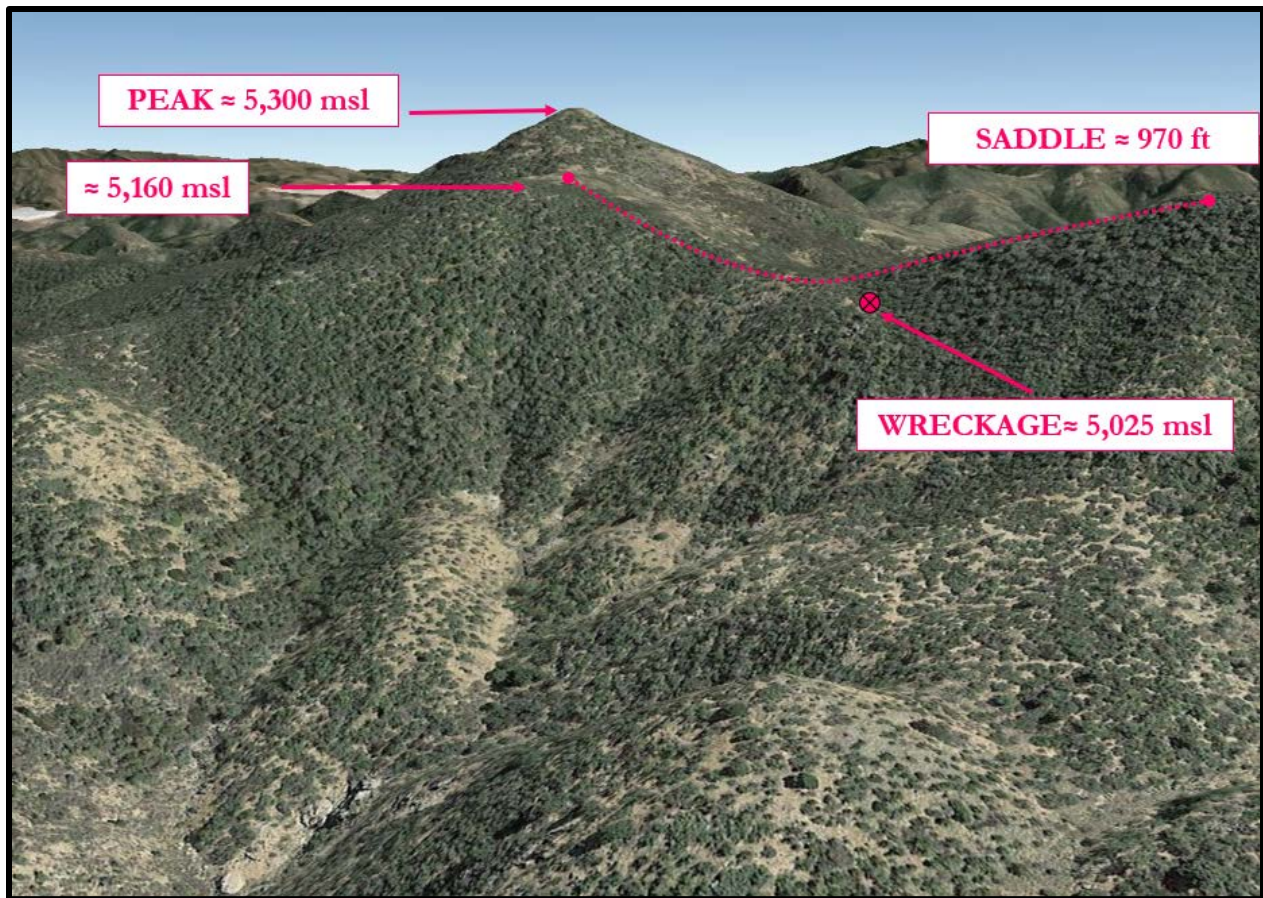
Figure 08: Accident Site Relative to the Surrounding Terrain

The helicopter impacted terrain and the medic stated that he felt as if they tumbled. The windscreen blew inside the cockpit and he could feel the vegetation scrape alongside him. The medic stated that he never lost consciousness and the helicopter came to rest with him hanging off the left side of the fuselage suspended by the straps of his seatbelt harness. His helmet and glasses had come off and he cut himself out of the harness and slid down to the snow.

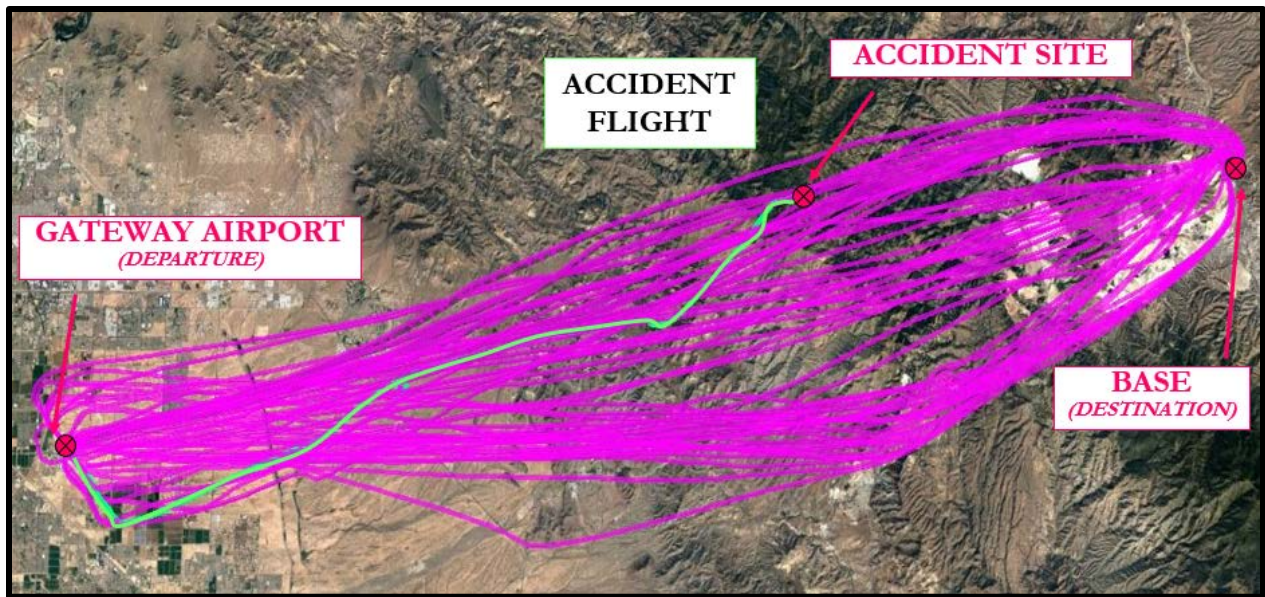
Figure 09: All 96 Flights from Gateway to Base (accident flight in green)

The recorded radar data was recovered for all Native 5 flights between the Gateway Airport and Globe Base between September 15, 2015, and the accident, which consisted of 96 flights, 25 of which were conducted by the pilot.¹⁶ The direct 43 nm flight leg was on a course of about 79°. The flights paths chosen varied with the most northerly path and the most southerly path 10 nm apart. Other pilots at the base reported that they did not have a specific method for deciding which path to take back to the base, but would vary the routes to make the flight less monotonous. A majority of the flights were conducted at an en route altitude between 6,000 to 7,000 ft msl, which would provide about 1,000 to 2,000 ft clearance above the peaks and valleys of the Superstition Mountains. In comparison the other flights, the accident flight was conducted considerably lower in altitude, at a higher ground speed and on a less direct path. There were two other flights that showed the helicopter performed an orbit while en route over the area of the nurse's house.

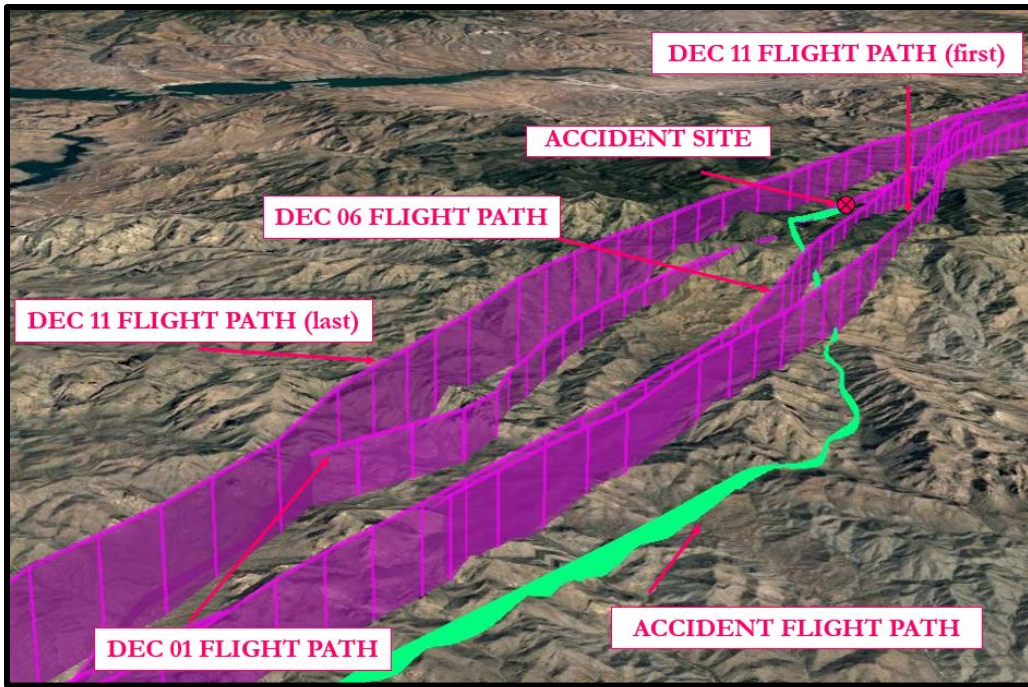
Figure 12: Accident Pilot's December Flight Paths

In December 2015 the pilot had flown the flight leg on four separate occasions all in the morning hours: December 01 (departed about 1050), December 06 (departed about 0420), and twice on December 11 (departed at 0120 and 0702). The December 01 flight was similar to the accident flight where the helicopter passed over the Roger's Canyon ridgeline and descended into the canyon, lower than the accident flight path. The nurse on that flight did not recall anything abnormal and did not think the pilot flew the leg lower than any of the other flights.

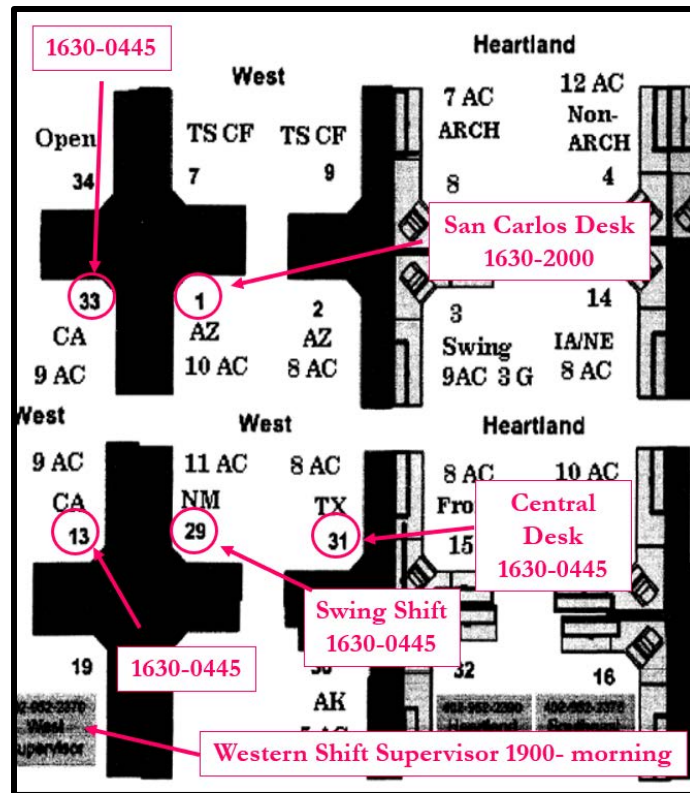
Figure 24: Desk Occupancy and Shifts During Accident.

On the day of the accident, the San Carlos desk shift was from 0430-1630 and 1630-2000.³¹ The specialist handling the accident helicopter worked the shift from 1630-2000 and was situated at console 1³². On the day of the accident, she arrived before 1630 and noted that the specialists at the consoles were not able to give their normal pass down information³³ because they were too busy. She pulled up the flights covered by Console 1 and immediately began to start taking lift and landing information.

The specialist quickly became busy with numerous aircraft calling in to the point where she began to physically write down the lift times and planned to later enter that information in the computer when flight activity slowed. She received so many calls that other specialists in the Western bank began to answer some of the calls for her. One of the specialists in her bank left for the day at 1650 and the other left at 1700, both commenting that she would be okay because all the aircraft were in the air, returning back to base³⁴ and the on-call person would be arriving later. She estimated she was handling 6-8 flights when they left, which was abnormal since she normally would only be handling 1-2 flights. Even with a partner she would normally be sharing a load of 6 flights. As the night progressed, she continued to physically write down the flights and times and reasoned that when it slowed down she would go back in the system and enter the correct liftoff and land times.

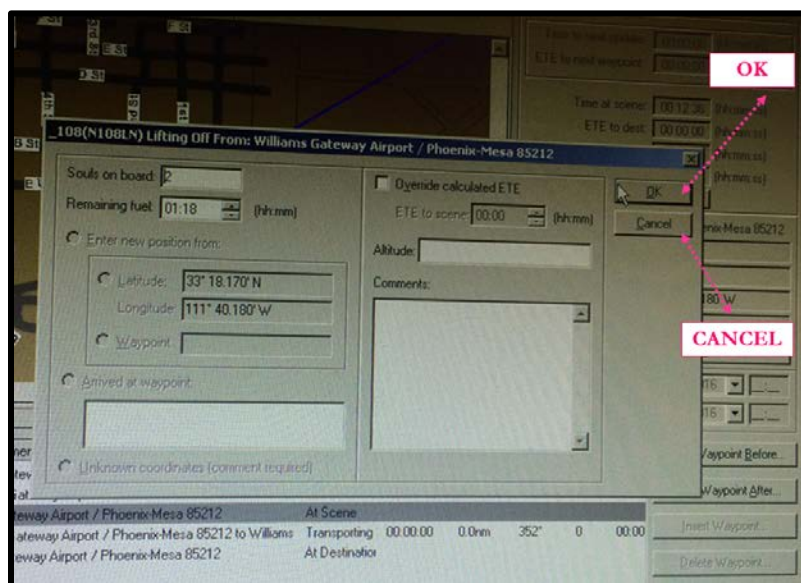
Figure 25: Example of Pop-Up Notification of Landing Aircraft

helicopter's status and then clicked "Cancel" to stop the notification and keep the helicopter within its required time.³⁶
