# **National Transportation Safety Board**

## **Radar Performance Study**

### **Specialist Report**

| NTSB Number: | CEN14FA110 |

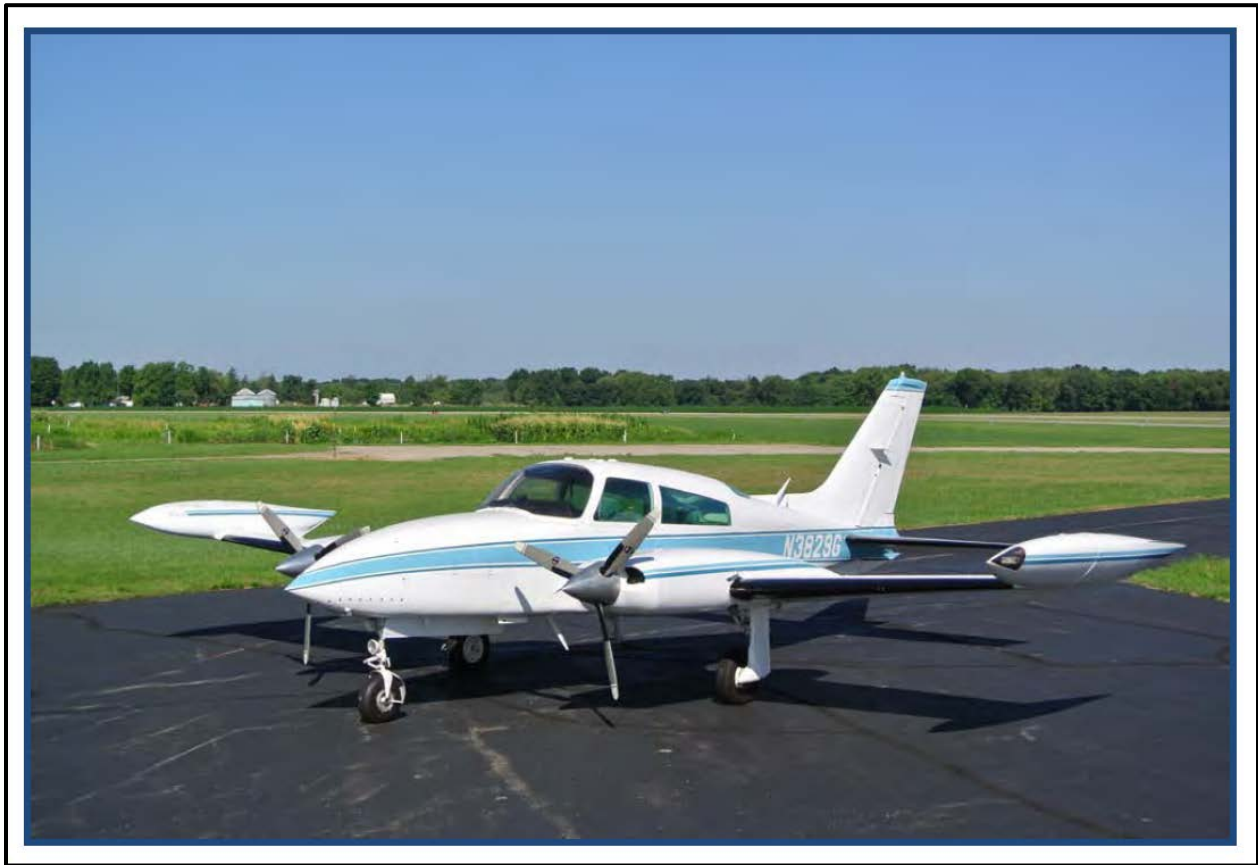
**Figure 1: Accident Airplane N3829G, a 1977 Cessna 310R**

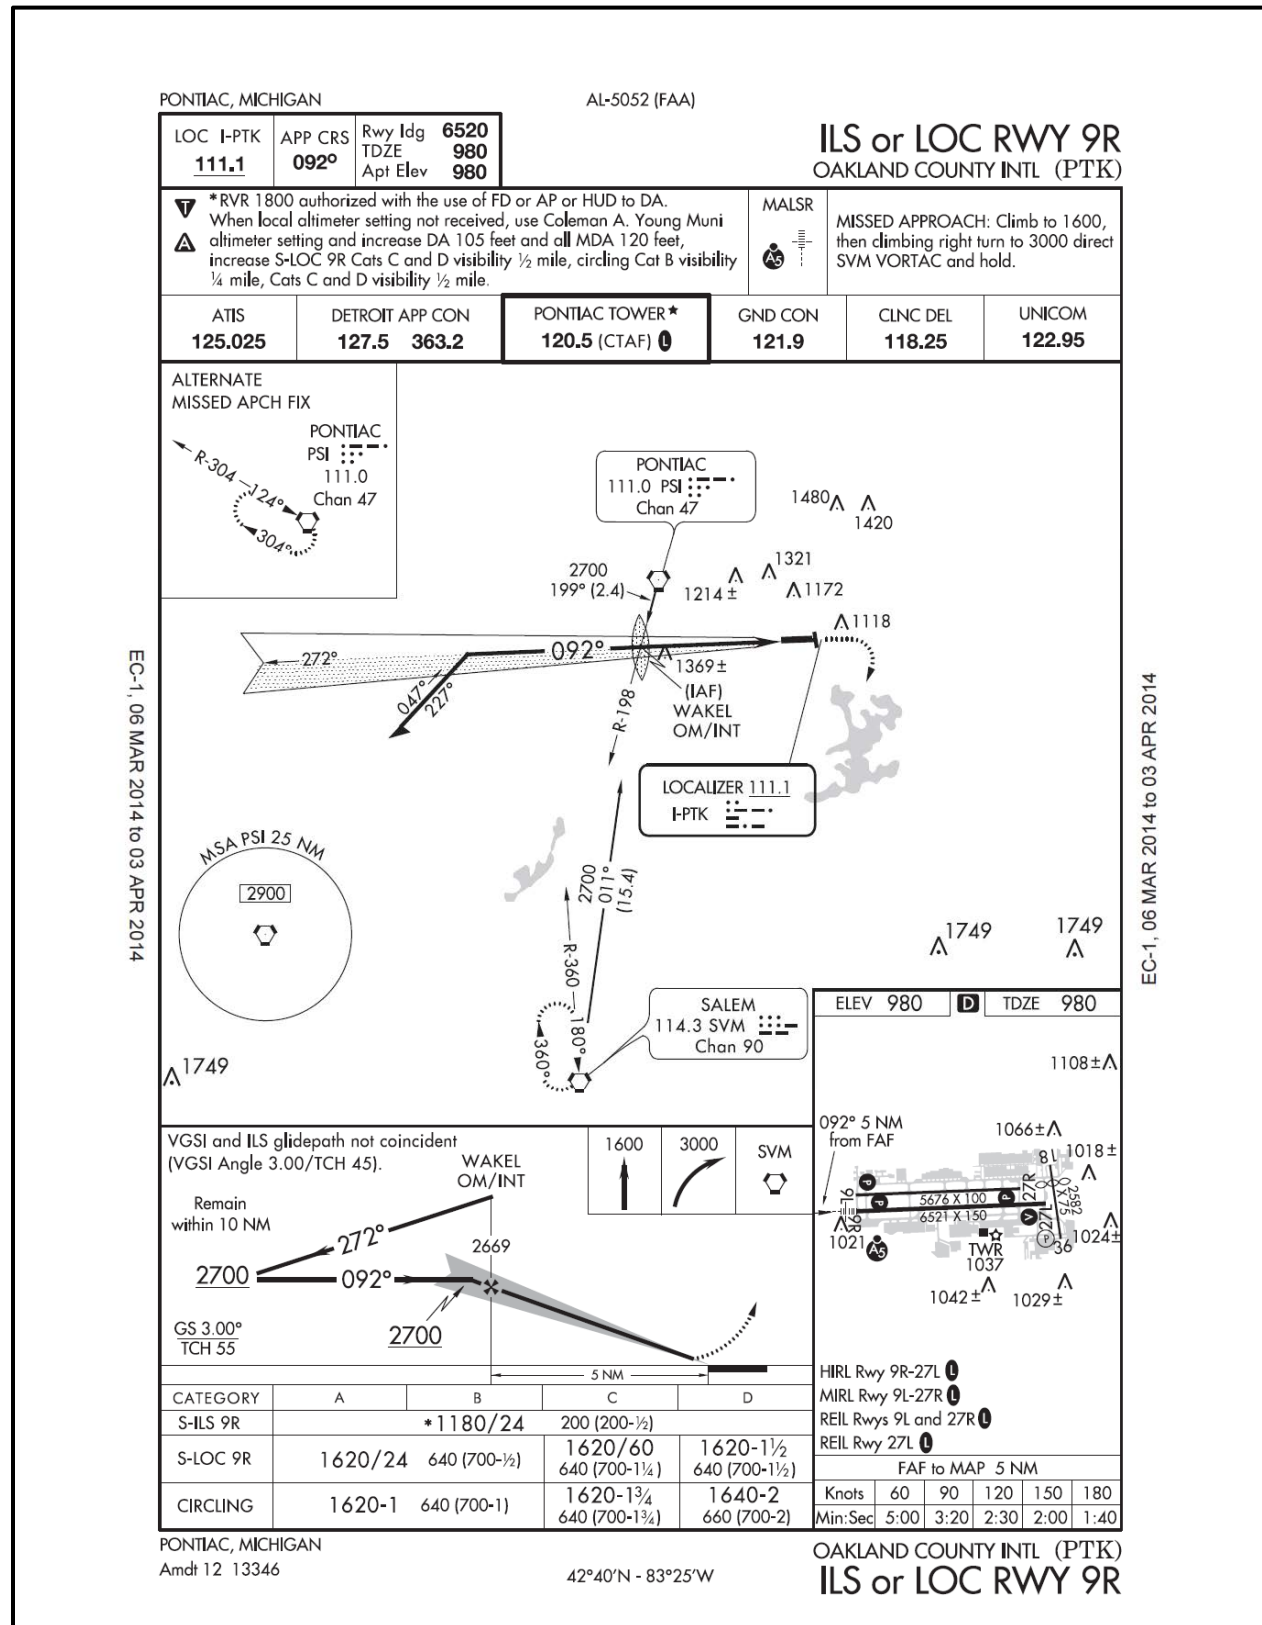
Figures 2 and 3 show the radar ground track for N3829G's approach into KPTK. Figure 4 is the approach plate for Oakland County's ILS 9R.

**Figure 4: Oakland County ILS 9R Approach Plate**
