# **National Transportation Safety Board**

## **Radar Performance Study**

**Specialist Report**  
**Timothy Burtch**

Location:	Bellevue, TN
Date:	February 3, 2014
Time:	1655 CST
Airplane:	Gulfstream Commander 690C, Registration N840V
NTSB Number:	ERA14FA112

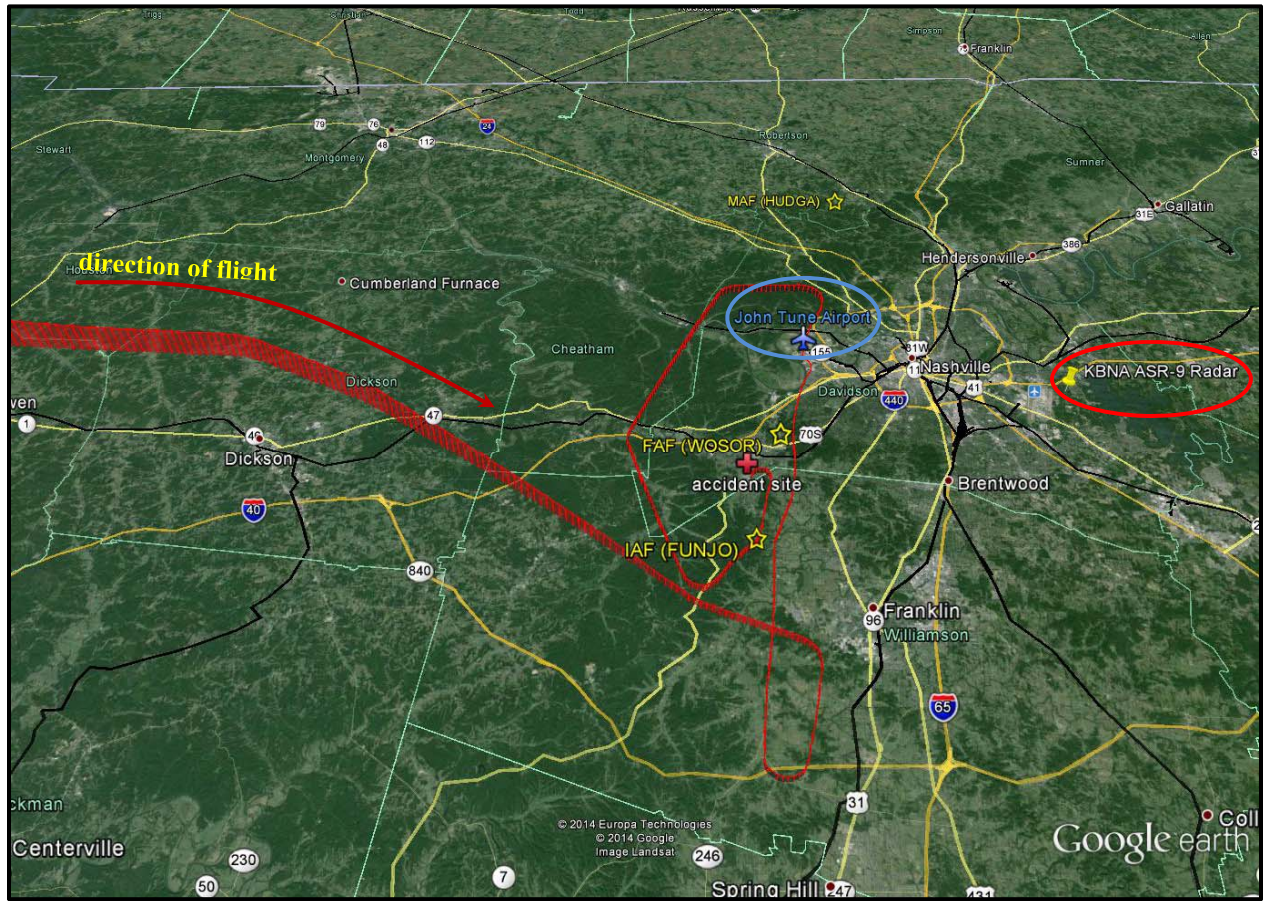
**Figure 2: Study Based on Radar from Nashville International (KBNA ASR-9 Radar)**

The radar data used in the study are secondary returns (transponder code 1166) from the short-range Airport Surveillance Radar (ASR-9) located at Nashville International airport (KBNA), Nashville, TN. Figure 2 shows the radar site location (labeled “KBNA ASR-9 Radar” in the figure) relative to KJWN and the accident site. The radar data have approximately a 60 nautical mile (NM) range and an inherent uncertainty of  $\pm 2$  Azimuth Change Pulses (ACP) =  $\pm (2 \text{ ACP}) \times (360^\circ/4096 \text{ ACP}) = \pm 0.176^\circ$  in azimuth,  $\pm 50$  ft in altitude, and  $\pm 1/16$  NM in range.

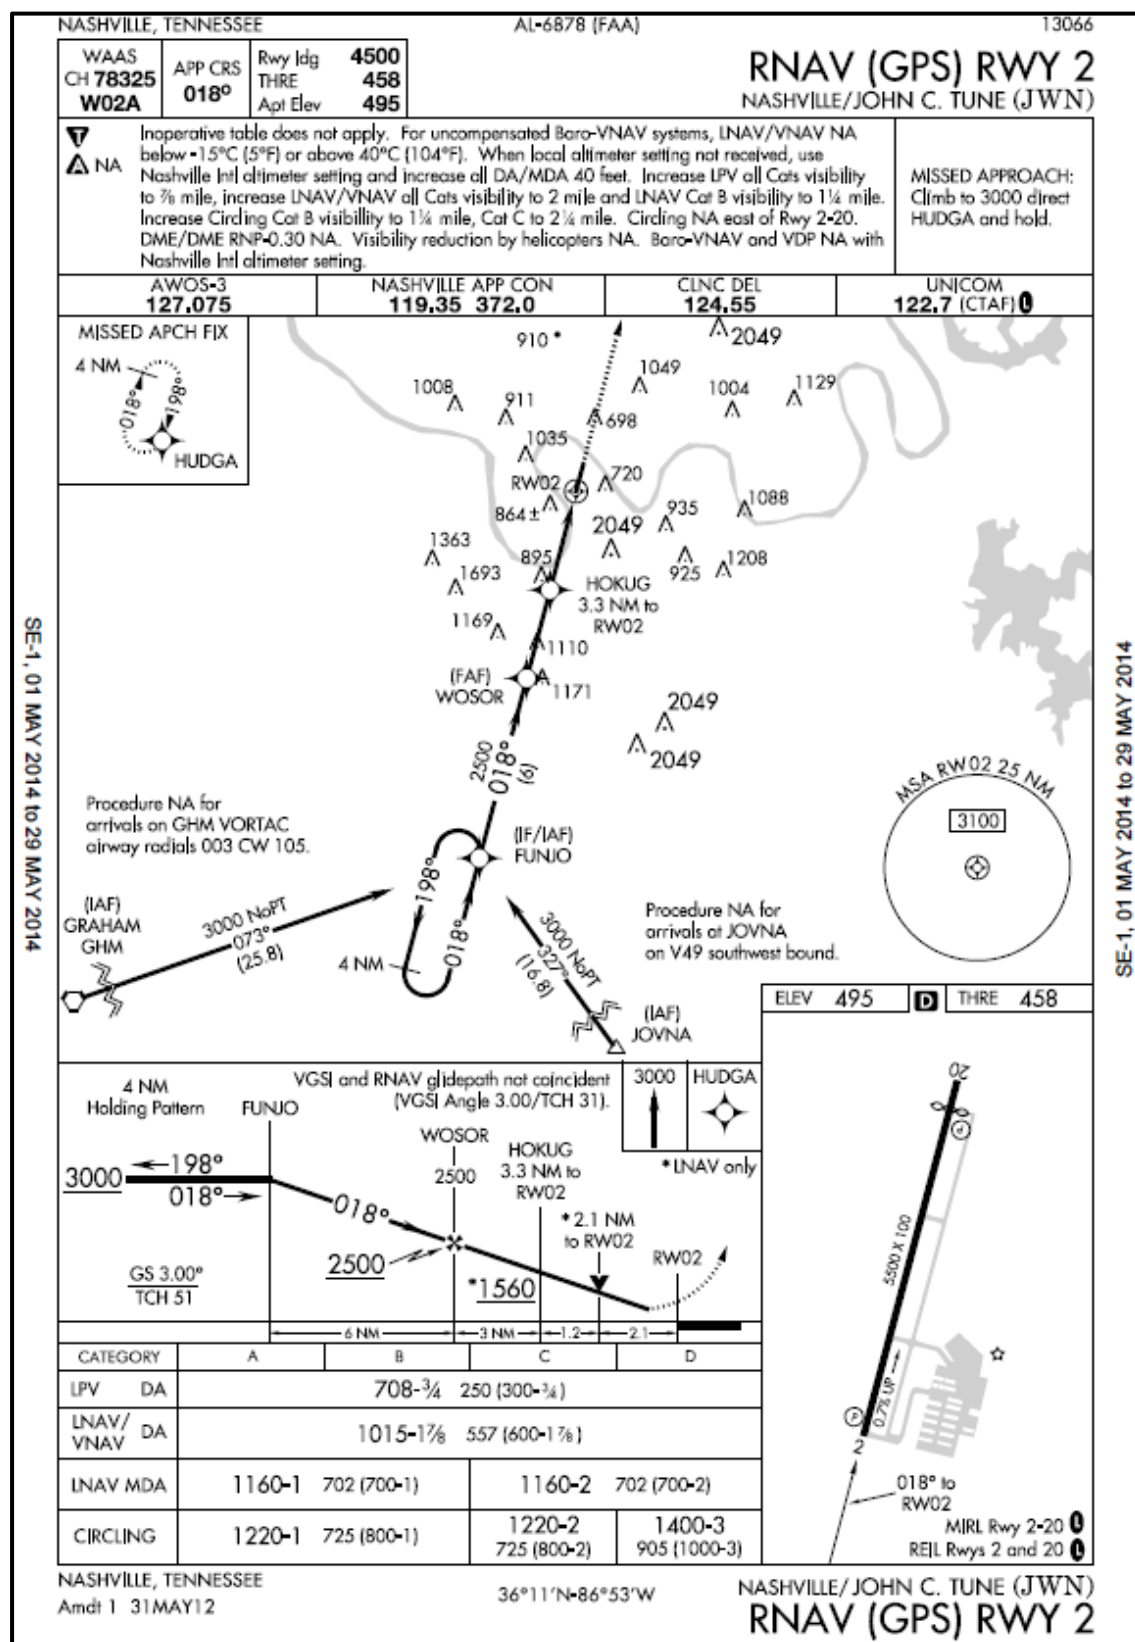
**Figure 7: Oakland County ILS 9R Approach Plate**

The estimated airspeed and altitude for the final 30 sec of flight are highlighted in Figure 4. From 22:56:3.3 until 22:56:21.7, the radar data indicate that the airplane was at the 2500 ft altitude prescribed for the RNAV (GPS) runway 2 approach procedure (as shown in Figure 7). However, the airplane was turning to the left. The airspeed decayed to approximately 108 kt<sup>3</sup> in the turn and, at 22:56:21.7, began increasing rapidly while the airplane descended at over 10,000 feet per minute. The airplane impacted the ground approximately 11 sec later.

The published missed approach procedure for the approach calls for a climb to 3000 ft and a route that proceeds directly to the HUDGA waypoint, 12 NM along the runway 2 extended centerline. See Figures 2 and 7. The accident flight climbed to approximately 3000 ft after declaring a missed approach and was given radar vectors by ATC for a second attempt at the GPS approach to runway 2. The airplane crashed in between the initial approach fix (IAF) and final approach fix (FAF) for the GPS runway 2 approach in about a 25° left bank turn. This is shown in Figures 2-5.
