National Transportation Safety Board

Railroad Accident Brief

CSX Transportation Coal Train Derailment Killed Two Individuals

Accident No.:	DCA12MR009
Location:	Ellicott City, Maryland
Date:	August 20, 2012
Time:	11:54 p.m. eastern daylight time
Train:	CSX Transportation coal train U81318
Railroad:	CSX Transportation
Property Damage:	\$1.9 million
Injuries:	0
Fatalities:	2
Type of Accident:	Derailment

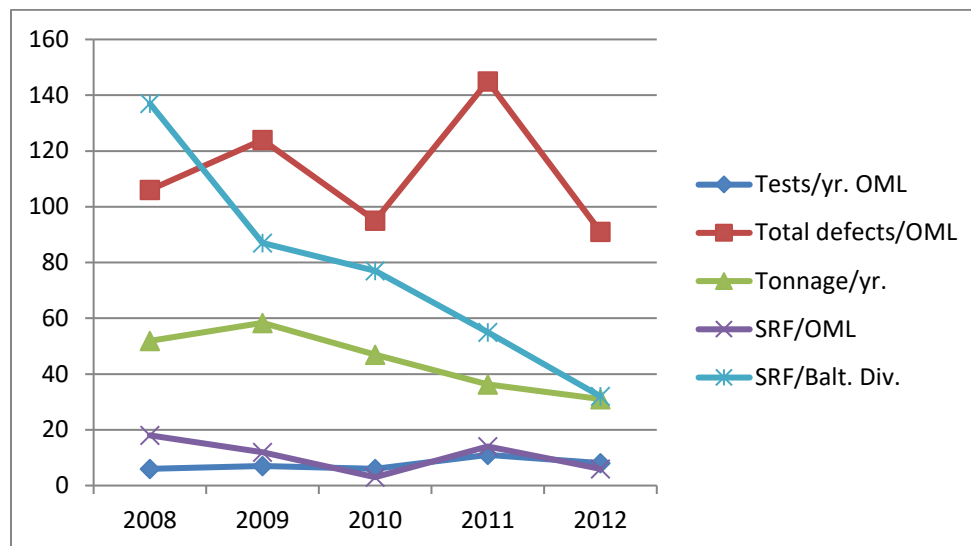
Table 4. Annual tonnage data, internal rail flaw detection tests, defect numbers, and service rail failures for Old Main Line Subdivision and Baltimore Division.

Investigators requested and received the rail defect data and the service rail failure report data from CSXT. Tables 3 and 4 show the annual inspection details (from 2008 to the test just before the derailment). A test cycle is representative of multiple test dates to cover the OML Subdivision. In table 3, the transverse detail fracture type defects for the OML are listed in the fourth column; the fifth column shows the number of transverse detail fractures that were located in curves. The last sixth and seventh columns show the number of service rail failures that occurred and were reported on the OML Subdivision and the Baltimore Division, respectively.
