NATIONAL TRANSPORTATION SAFETY BOARD

TRACK & ENGINEERING FACTUAL REPORT

RRD18MR003

**CSX Railroad, Amtrak Passenger Train/Freight Train Collision with Derailment
and Crew Fatalities**

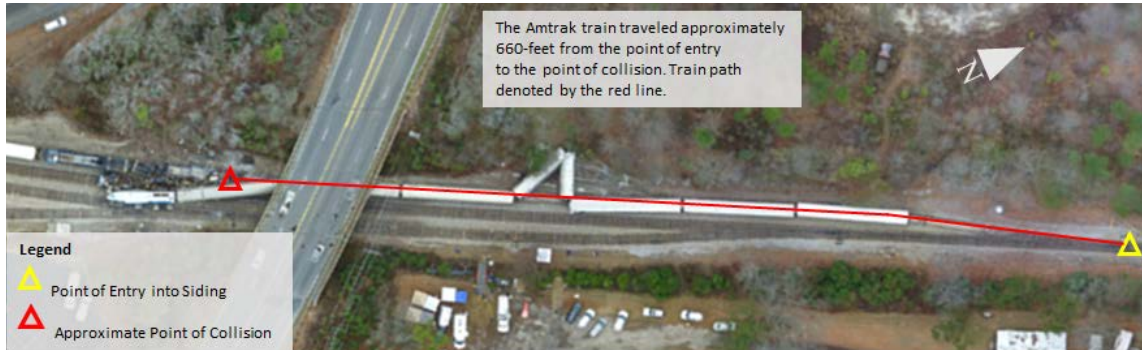
Figure 1. Aerial drone image of accident location. The Amtrak train was traveling in a railroad timetable-south direction; from the bottom-right toward the top-left corner of the photo. The CSX train and point of collision was on the west side of the highway overpass. (Photo: South Carolina Department of Public Safety)
