NATIONAL TRANSPORTATION SAFETY BOARD

METALLURGIST'S FACTUAL REPORT

Report No 94-34

Place : Provincetown, Massachusetts
Date : August 2, 1993
Vehicle : Piper PA-28-181, N2093
NTSB No. : NYC 93-F-A140
Investigator : Al Yurman (ASI-NYC)

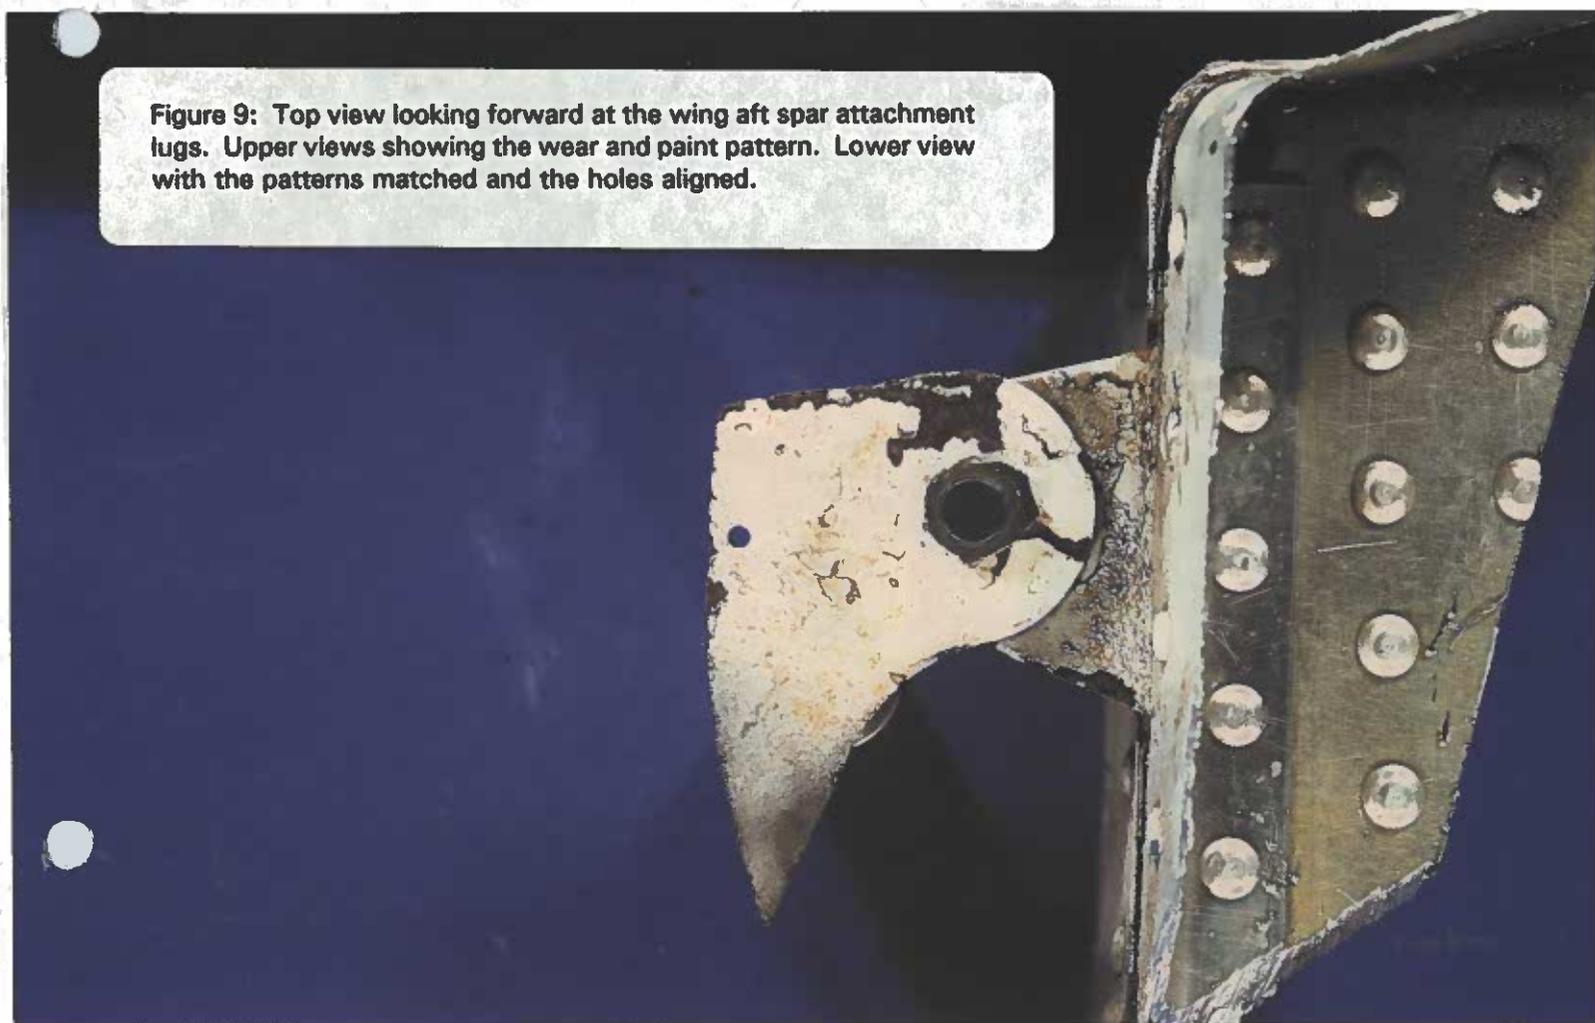
The fuselage and wing lugs of the wing aft attachment fitting were received cut from the aircraft structure. As shown in the upper view of figure 9, the lugs did not appear to be damaged. The Maintenance Manual shows that for this s/n aircraft, the two lugs are connected by an AN5-7A bolt through the holes in each fitting. The investigator was not lugs during assembly. Matching paint and wear patterns on the faying surfaces of each lug, as depicted in the lower view of figure 9, indicated that the lug surfaces had been in direct contact with each other with the bolt holes aligned. Visual inspections also showed that the holes were approximately round showing no appreciable deformation.

Figure 9: Top view looking forward at the wing aft spar attachment lugs. Upper views showing the wear and paint pattern. Lower view with the patterns matched and the holes aligned.
