SUBJECT: ACCIDENT OF N509AM (NTSB WPR10FA371) ON JULY 28, 2010

OPERATIONS GROUP CHAIRMAN'S FACTUAL REPORT, WPR10FA371

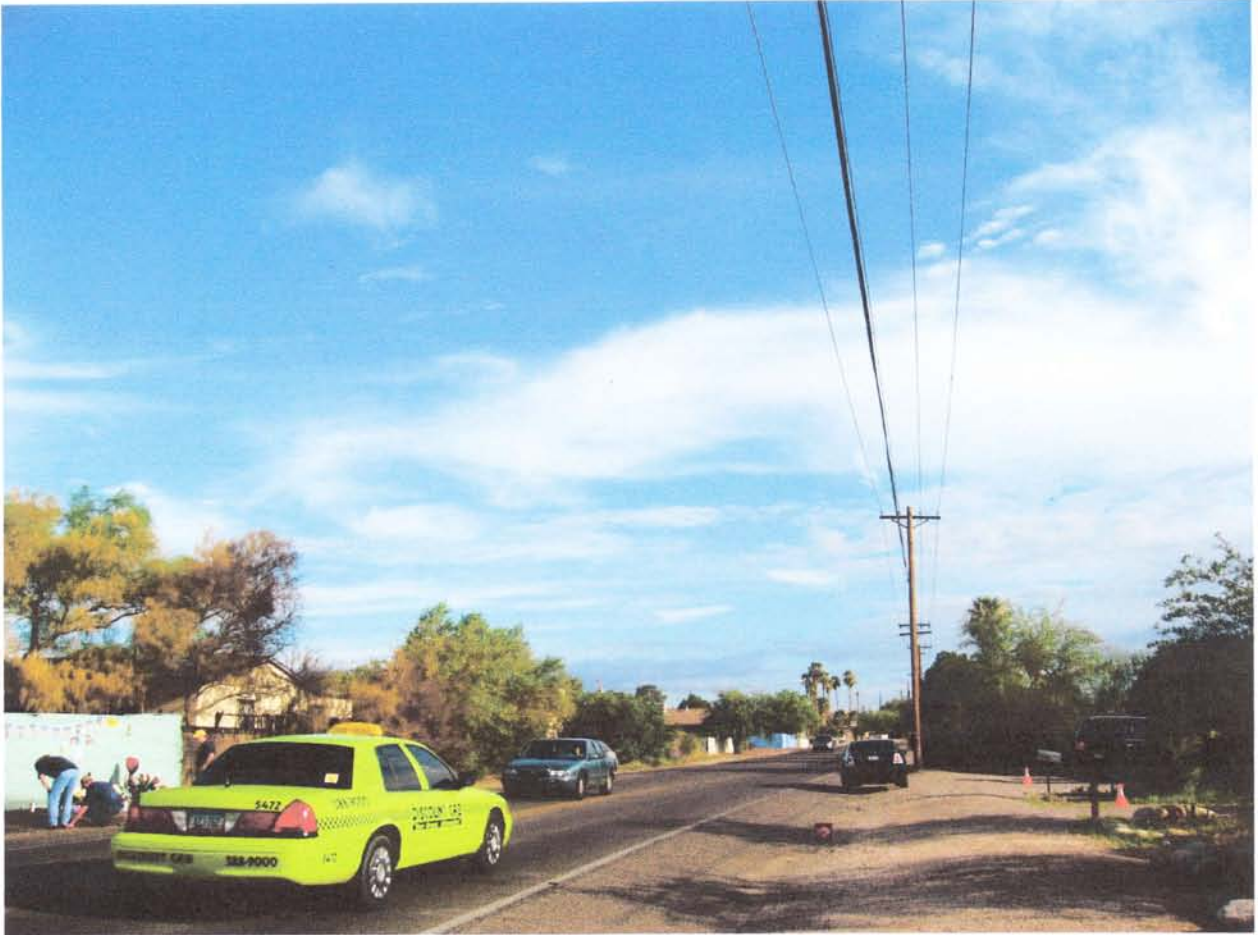
FIGURE 5.

As indicated in both images, there were few suitable emergency landing areas in this urban environment. Inspection of the area revealed numerous power lines and closely placed houses. As Kelley continued toward a possible landing area (depicted by a yellow circle on **FIGURE 4**) it is believed he saw a set of five wires that ran north and south across the flight path on the west side of the accident scene street (See **FIGURE 5**). At this point he flared the aircraft and applied up collective to clear the wire obstacle. This maneuver may have bled the RPM to a very low level that provided reduced controllability. Consequently the helicopter developed a high rate of descent, marginal directional control, possibly coupled with left yaw. This resulted in the aircraft landing very hard, on top of a six foot high brick wall rather than in the street. The main and tail rotors were rotating very slowly, and there was a slight left drift (See **FIGURE 6**). Post impact fire destroyed much of the helicopter. The accident site was on the extreme right east side of a residential street oriented north and south. As indicated above, electrical power lines were connected to wooden poles on the west side of the street.
