NATIONAL TRANSPORTATION SAFETY BOARD
Vehicle Recorder Division
Washington, DC 20594

Onboard Image Recorder and Ground Video

Specialist's Factual Report
By Sean Payne

Location: Summerfield, Florida
Date: April 6, 2014
Aircraft: Vans Aircraft RV-7, N57DC
Operator: Private
NTSB Number: ERA14FA182

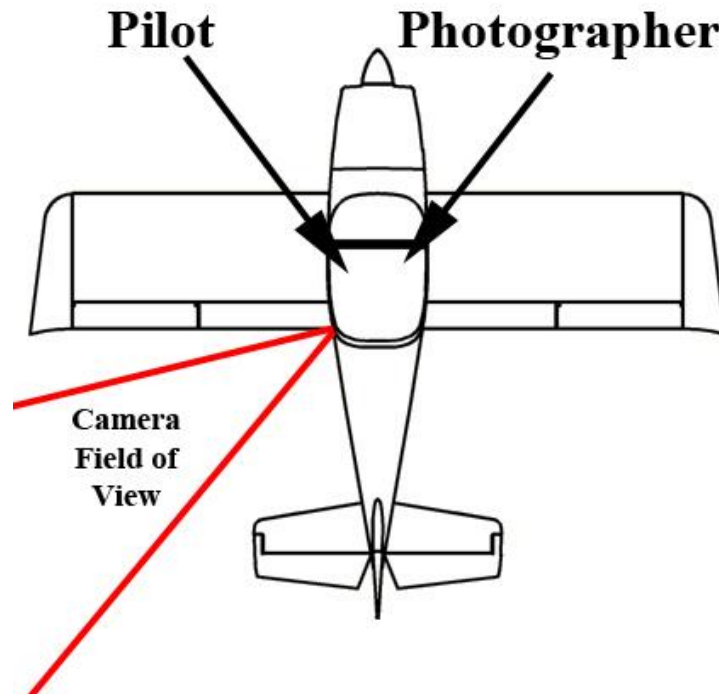
Figure 5. A diagram of the aircraft's occupants as well as the camera's field of view.

An onboard recording began at 7:33:09 PM EDT taken from the right seat passenger's position pointing toward the left rear quarter of the aircraft. Figure 5 describes the camera operator's position and the field of view during most of the onboard recordings. The aircraft began its takeoff roll and engine power was heard being advanced smoothly to a high power setting. The aircraft began rolling down a grass airstrip.

¹⁷ Referring to figure 5, the camera's field of view was still in the direction of the left rear of the aircraft. As the aircraft rolled left with the camera still pointed outside of the aircraft, ground features were seen moving up in the camera's frame. There were no indications that the camera operator's intended positioning of the camera had changed considerably. This suggested the aircraft rolled left as opposed to the camera having been pointed downward by the camera operator.
