NATIONAL TRANSPORTATION SAFETY BOARD

ON SCENE and POST RECOVERY INFORMATION

**NTSB Accident: WPR13FA244
Accident Date: May 28, 2013**

Location: Mountainaire, Arizona
Date: May 28, 2013
Aircraft: Beech A36, N999PK, Serial # 3380
NTSB IIC: Michael Huhn

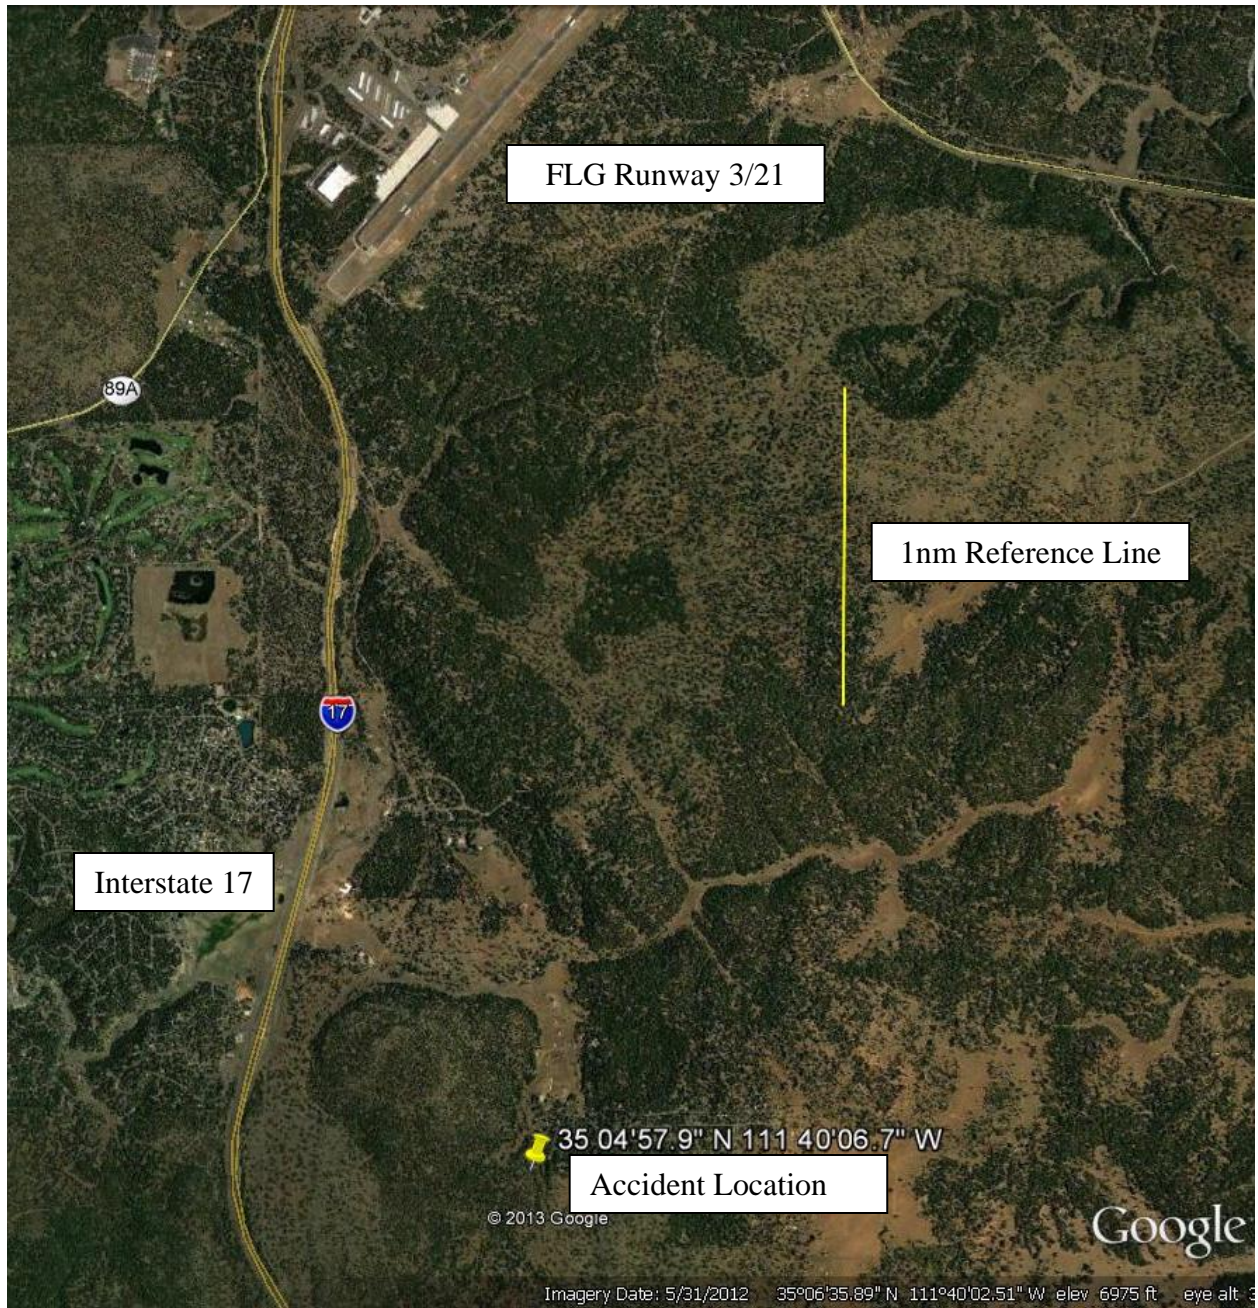
Figure 1 - Accident Site Location

- The nose of the airplane was situated about 5 feet beyond the depression
- When plotted using Google Earth, the impact location was 2.94 nautical miles from the center of the threshold of FLG runway 3, on a true bearing of 170 degrees from that runway location

- When plotted using Google Earth, the distance from the first tree strike to the main wreckage was 135 feet, on a true heading of 180 degrees
- The wreckage was contained in an approximate 100 ft by 75 ft oval of burned vegetation and forest floor matter, and charred/sooted soil and rock

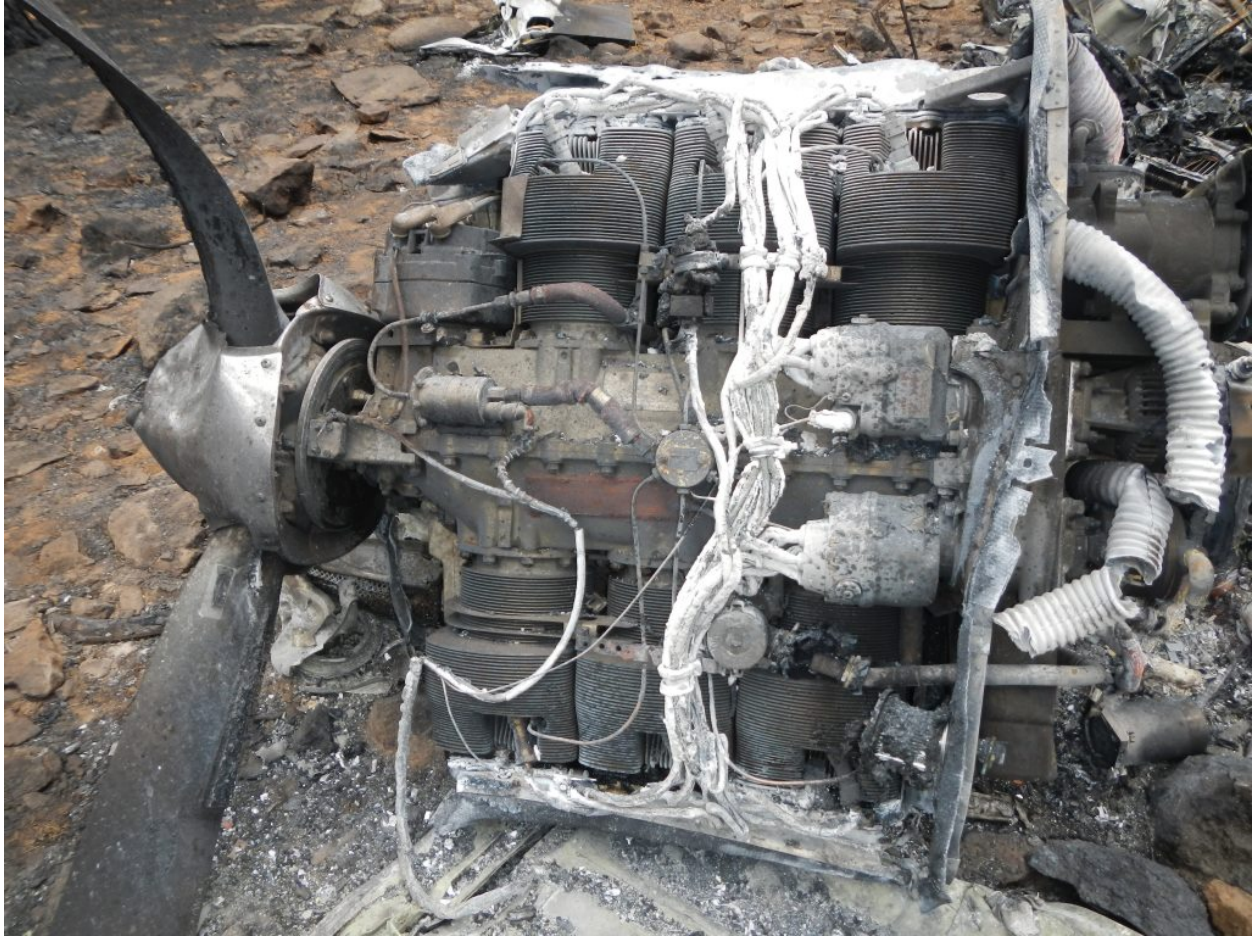
Figure 29 - Top of Engine

The Continental Motors (CMI) IO-550-B39 engine (Serial Number: 684677) came to rest in an upright position, but with the left side (even-numbered cylinders) lying low. The engine was separated from all four engine mounts, but came to rest adjacent to the firewall. The engine throttle, propeller, and mixture control cables remained attached to the throttle quadrant and their respective components. Electrical wires and cables also remained attached to the firewall and engine accessories.

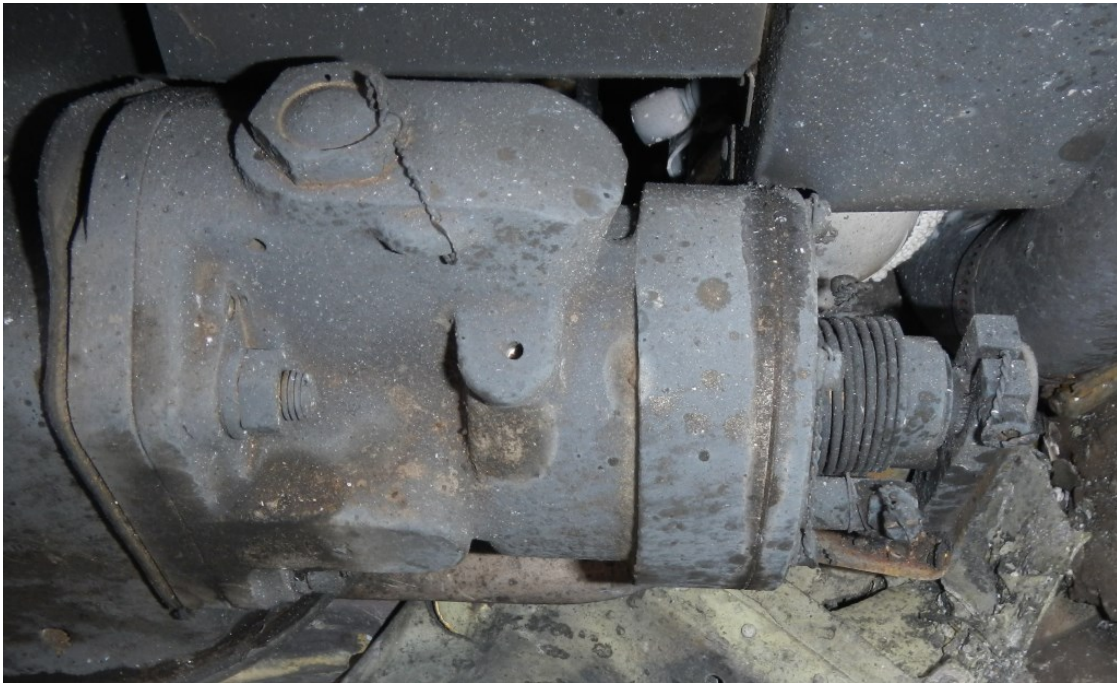
Figure 56 - Propeller Governor

Three 2.5-inch diameter branches and one 4-inch diameter tree displayed fresh cuts consistent with propeller blade strikes. The propeller governor remained attached and secured to its mounting pad and the propeller control cable remained attached to the control lever.
