NATIONAL TRANSPORTATION SAFETY BOARD

ON SITE INFORMATION

**NTSB Accident: WPR14FA132
Accident Date: March 8 or 9, 2014 (Actual date/time uncertain)**

Location: Near Carson City Nevada
Date: Unknown
Aircraft: Cessna 120, N76856, Serial # 11290
NTSB IIC: Michael Huhn

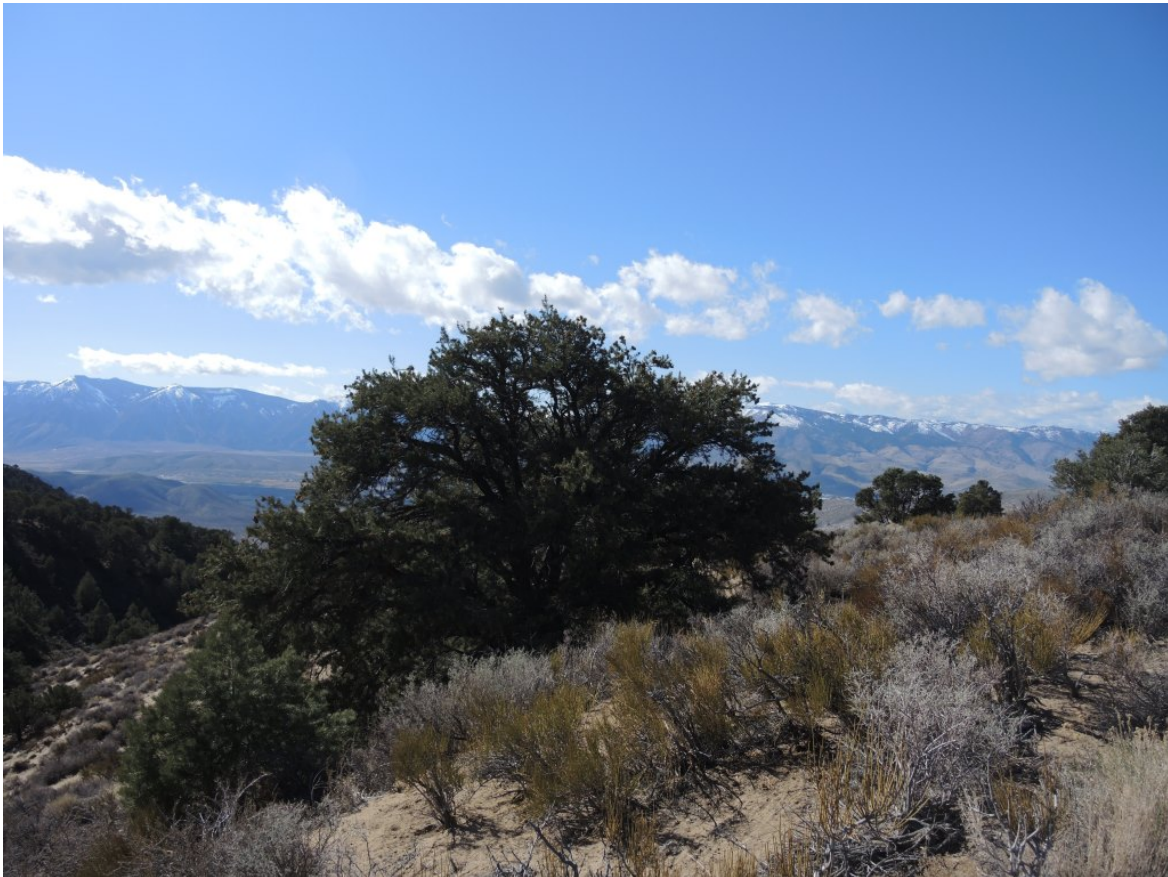
Figure 3 - View West from Wreckage Location

- The wreckage was on the roughly north side of a roughly east-west valley that opened to the west
- The valley width did not change linearly with east-west travel, it narrowed rapidly in the easternmost section
- Lat/Long: 39° 5.880' North; 119° 39.899' West
- Elevation 6,219 feet msl
- According to Google Earth information:
 - The impact site was 6.06 nm on a true bearing of 145° from the center of CXP
 - The impact site was offset about 7,300 (1.2nm) feet southwest of a direct line between CXP and NV33
 - At the impact site elevation and location, the valley was about 300 feet wide
- Wreckage was upright, on sandy slope with partial vegetation
- Slope was approximately 30 degrees, downslope was 160 degrees magnetic
- The wreckage was about 100 feet downslope from a jeep trail

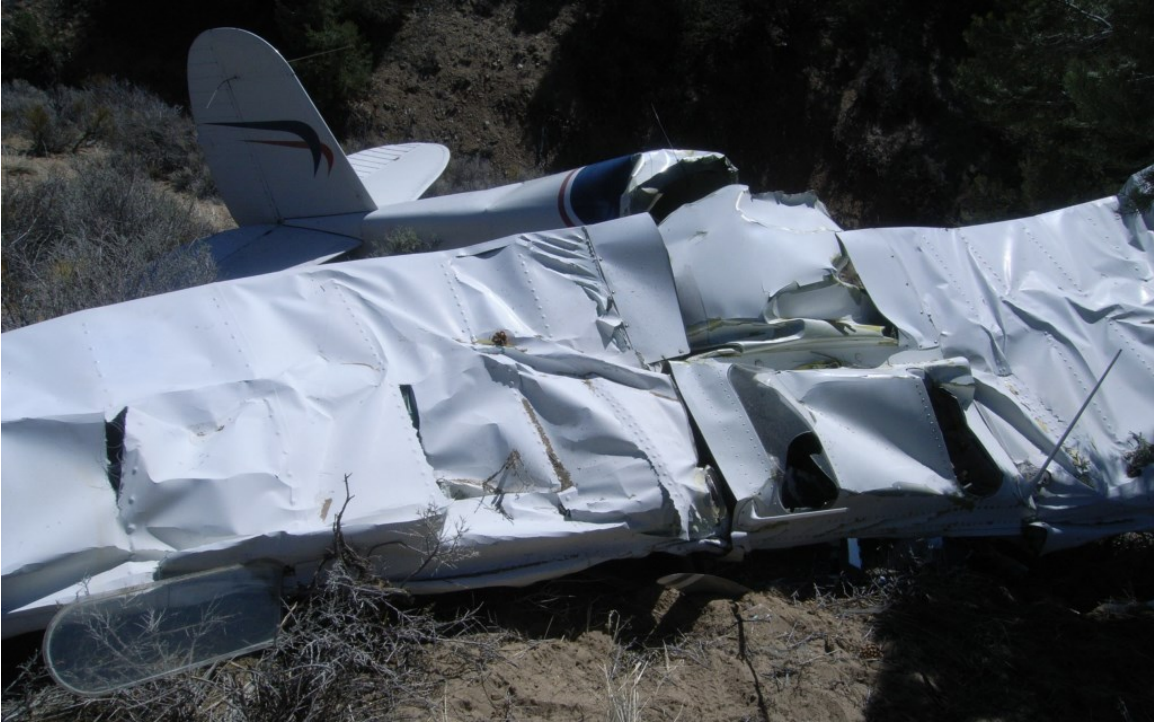
Figure 8 - Top Front Right View (looking SE)

- Wing assembly translated forward and down w/r/t normal position
 - Wing LE was forward of firewall (or vice versa)
- Left wing impacted tree at the span position of the landing light

- Tree damage was consistent with a 50 to 70 degree descent trajectory (relative to local horizontal)
- No evidence of fuselage rotation (spin) at impact

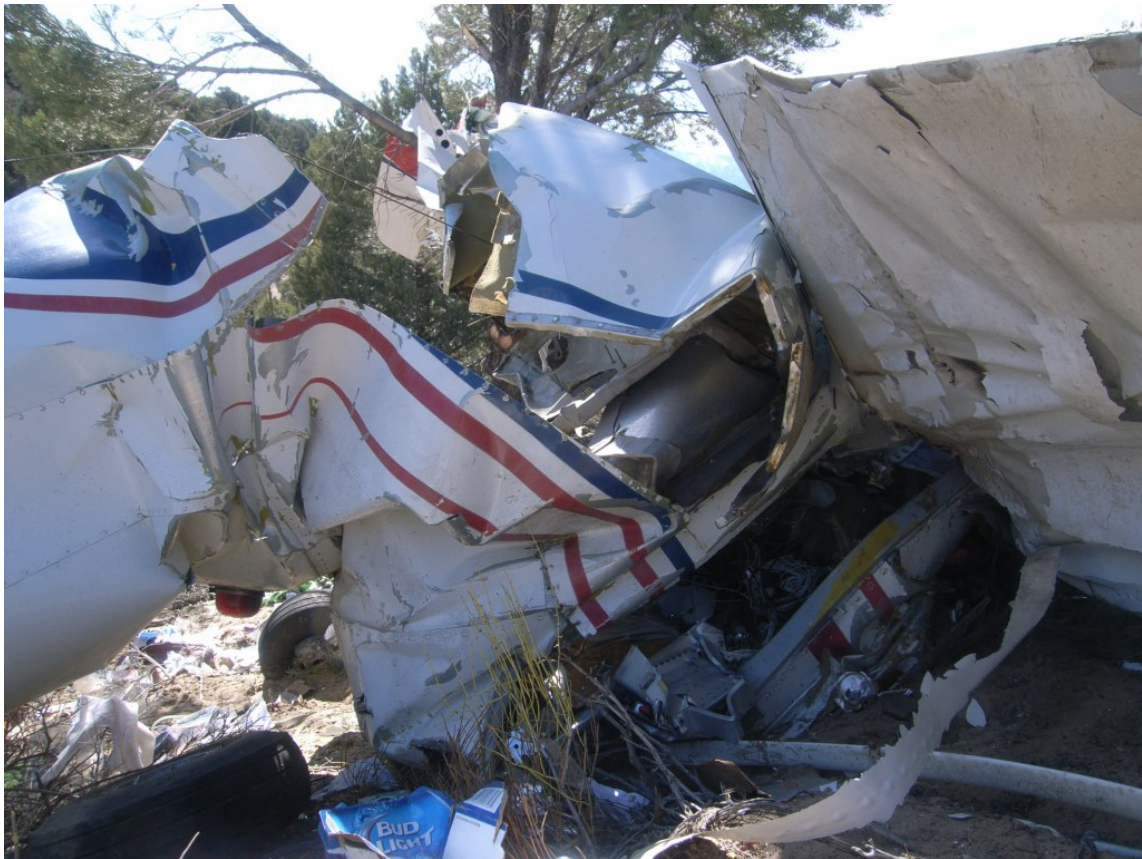
Figure 9 - Right Cabin View

- Engine intruded aft into cabin/cockpit
- Instrument panel severely deformed
- Right wing leading edge crushed aft along its full span
- Left wing significant crush damage isolated to area where wing impacted tree

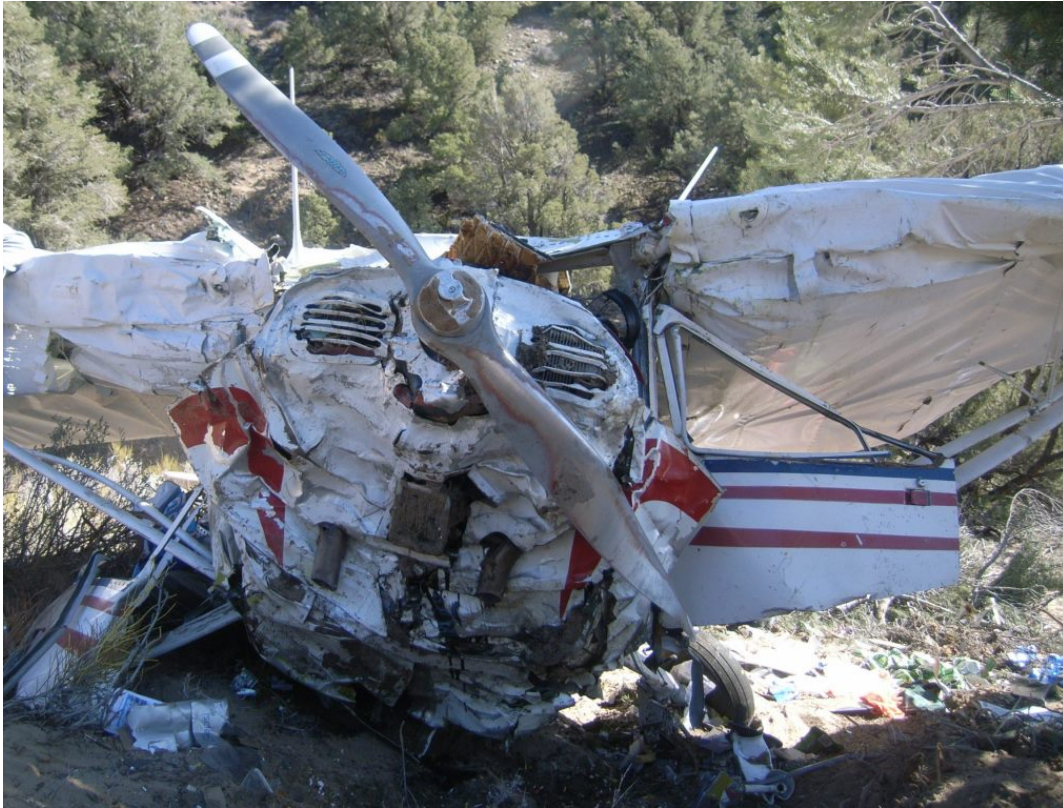
Figure 17 - Front View after Airplane Pulled from Hillside

- Carburetor was fracture-separated from engine at top of carburetor
- Damage precluded checking of engine control cable continuity
- Investigators cut throttle and mixture cables at carb for removal from engine

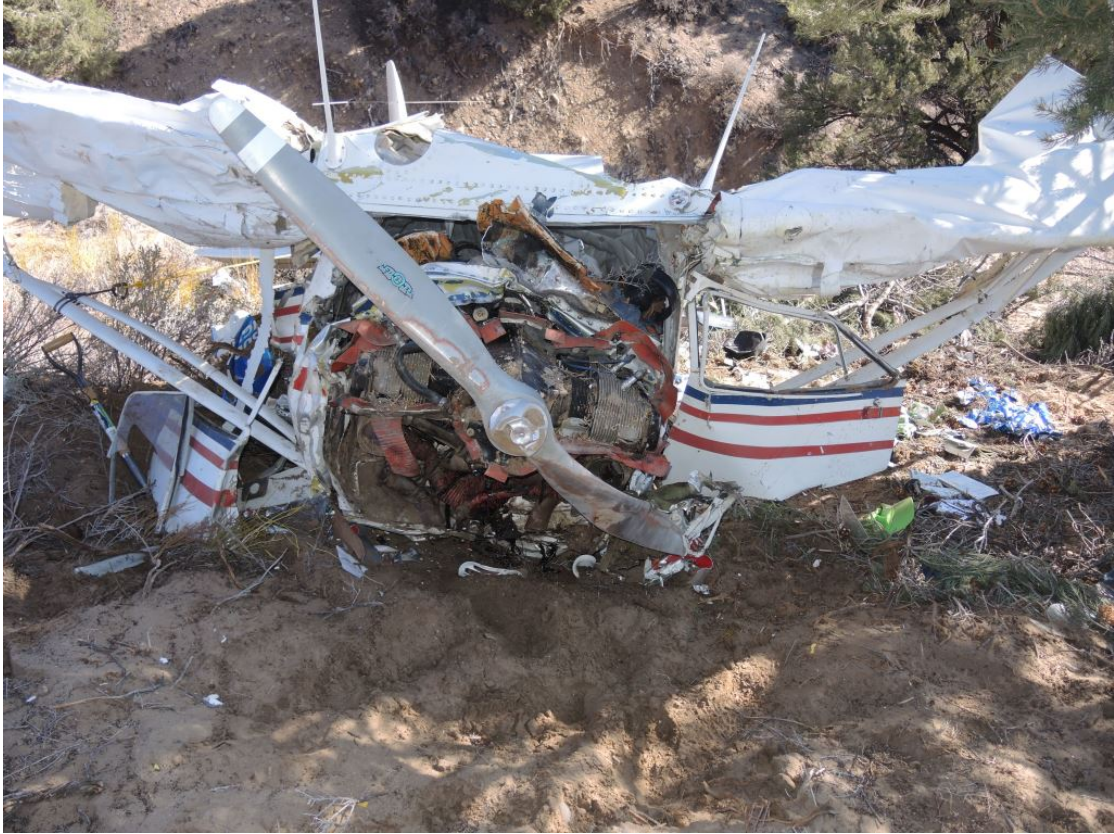
Figure 18 - Front View with Cowl Removed

- Placard: Continental Aircraft Engines Model C-85-12, "QUOTE ENG. NO. 25936-6-12"
- No non-impact anomalies or mechanical failures noted
- 4 top ignition leads attached and appeared intact, exclusive of minor impact damage

- All valve covers were removed
 - all rocker arms and assemblies were observed to be intact
 - No anomalies observed
 - All assemblies were oil-coated
- The condition of the propeller limited the amount of engine rotation possible to approximately 60 degrees

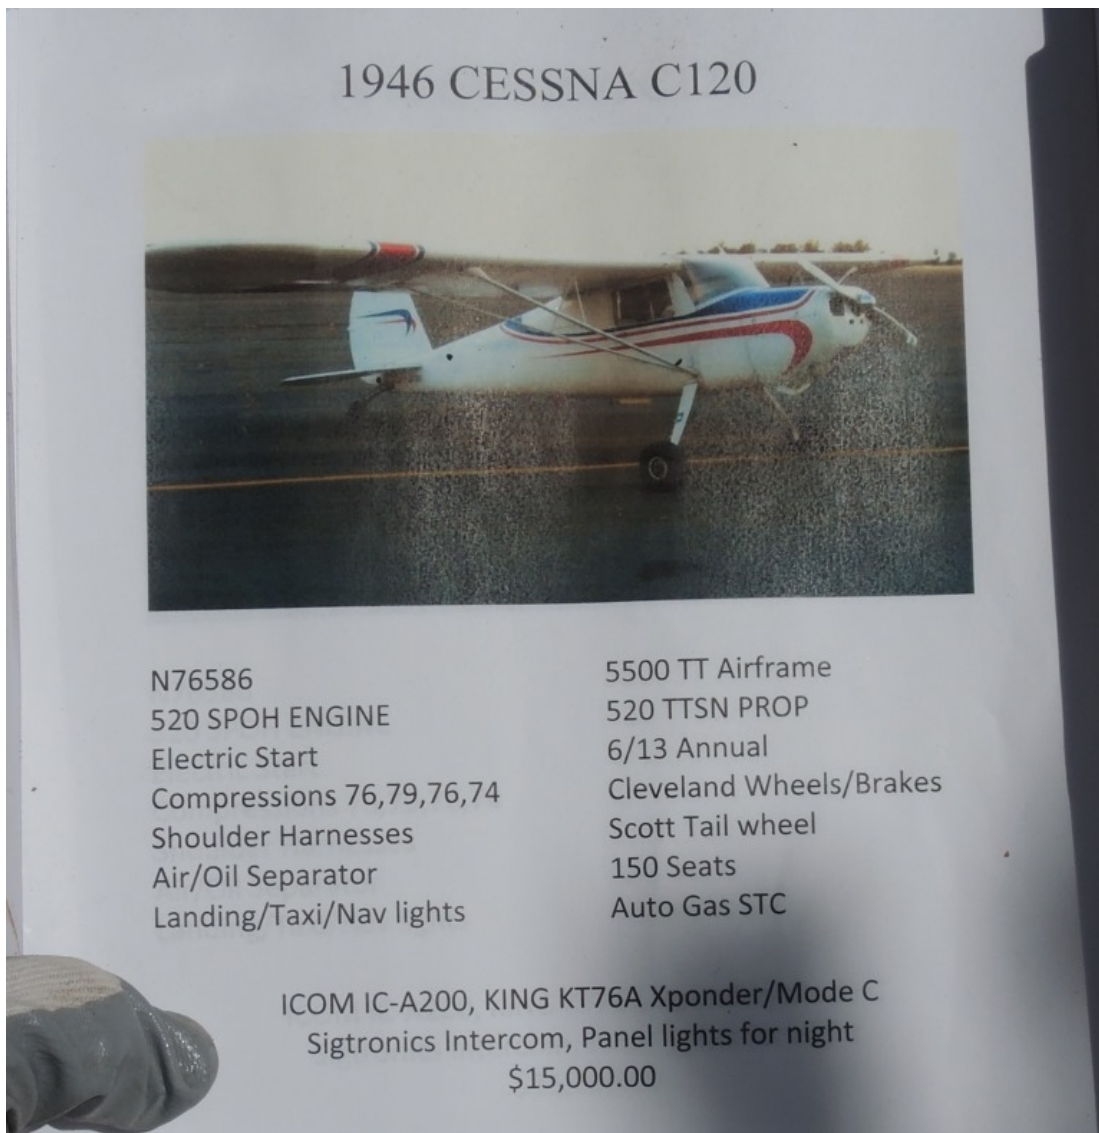
Figure 28 - Airplane Sale Sheet from Wreckage

- One Klamath Falls, expired 11 Feb 2010
- Two different hardcopy sales sheets (marketing airplane for sale, both undated)
 - Both cited KT-76A transponder, wing and panel lights, and intercom
 - One indicated "5500 TT 520 SPOH Engine 520 TTSN Prop" \$15,000 price
 - One indicated "5350TT 380TTSN Prop 5/12 annual"
- Iphone
- Airplane Operation Manual published 7-79
- "Aircraft Flight Log" (see below)
- Copy of handwritten weight and balance sheet
- Bill of sale from the pilot to Sweet Technology (pilot was CEO of same, according to internet)
- A sales receipt from the Carson City Home Depot with the date/time stamp of March 8 2014, 2:12 pm

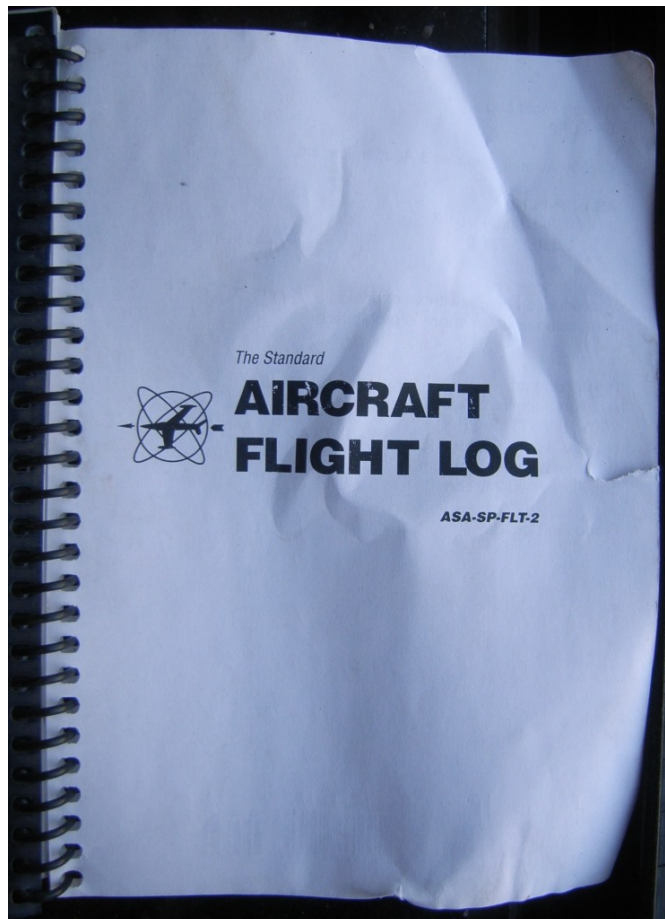
Figure 29 - Flight Log Cover Page

- The 11/29/12 entry listed a time of 3567.51, and contained the annotation "replace fuel selector"
- The 6/4/13 entry listed a time of 3599.66 and contained the annotation "annual"

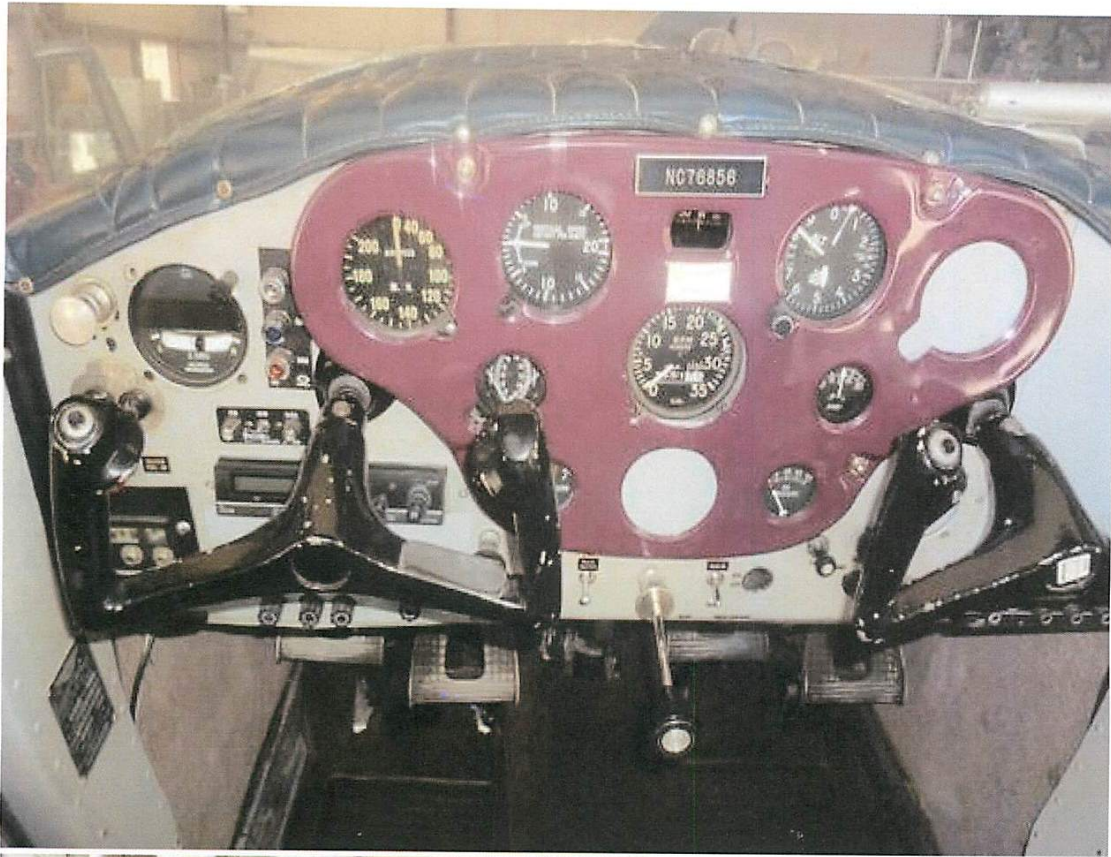
- The FAA inspectors provided a printout of a Craigslist advertisement that they retrieved from the internet on 3/10/14
- One photo in the ad was of the instrument panel
 - The instrument panel contained two avionics units; a transponder and an undetermined radio
 - There was no nav head (eg VOR) in the panel
- The wreckage contained two avionics units; a transponder and an undetermined radio
- No handheld GPS unit or computer tablet (eg iPad) was found in the wreckage
