NATIONAL TRANSPORTATION SAFETY BOARD
Vehicle Recorder Division
Washington, DC 20594

Onboard Image Recorder

Specialist's Factual Report By Sean Payne

Location: Cayce, South Carolina
Date: February 4, 2018
Train/Locomotive: Amtrak PO91, Locomotive AMTK47
Train/Locomotive: CSXT Train F777 03, Locomotive CSXT 130
Train/Locomotive: CSXT Train F777 03, Locomotive CSXT 36
Operator: Amtrak/CSX Transportation
NTSB Number: RRD18MR003
Summary: Refer to the Accident Summary Report, within this docket.

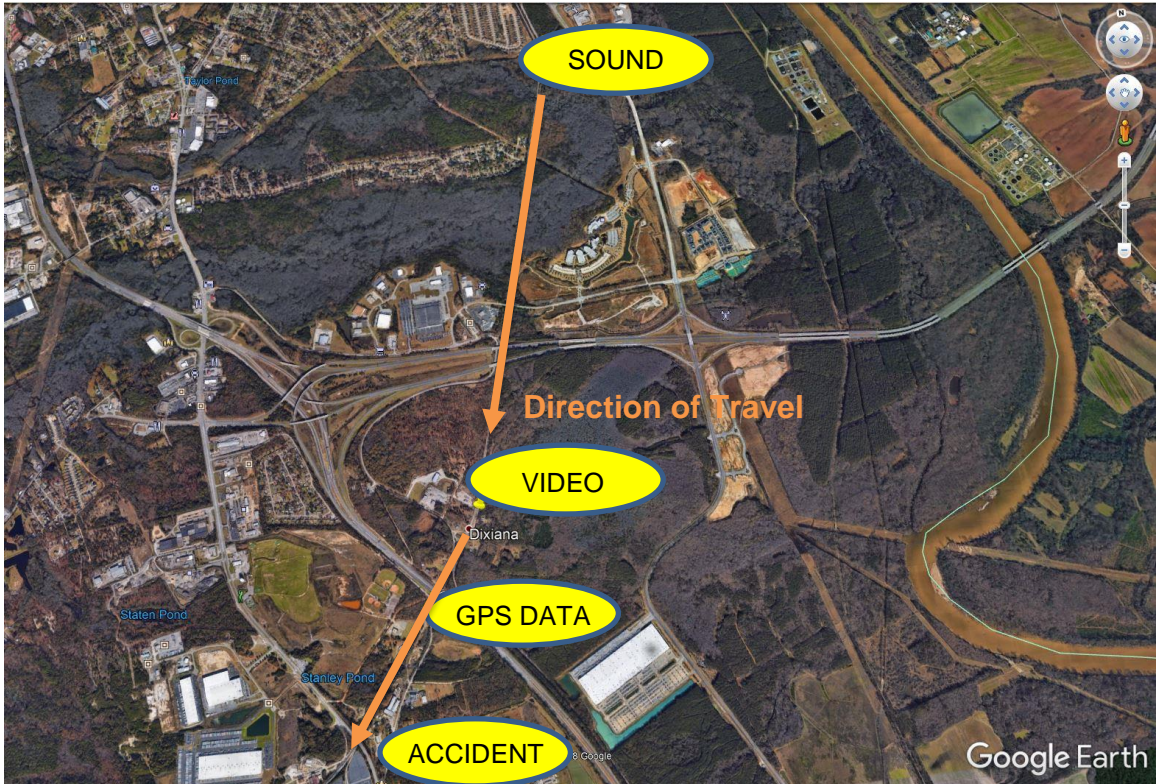
Video ceased being recorded at 2:26:30. The train was approaching the south end of Dixiana as it rounded a right hand curve. The speed was recorded as 55.0 mph and the GPS coordinates showed 33.9202 deg N, 81.0587 deg W. The GPS position is plotted as "VIDEO" on figure 3 which is a Google Earth overview of the accident region.

Only GPS position and derived GPS speed continued to display on the recorder. Timing information ceased as described above at 02:26:30. The last displayed GPS coordinates were given as 33.9150 deg N, 81.0623 deg W. A derived speed was shown as 56.5 mph. The GPS position is plotted as "GPS DATA" on figure 3 which is a Google Earth overview of the accident region.

Figure 3. A Google Earth overview of coordinates in which data streams ceased recording.
