Physical Analysis Report on CEN15FA290

Prepared by Binghamton University
for the National Transportation
Safety Board, September 15, 2015

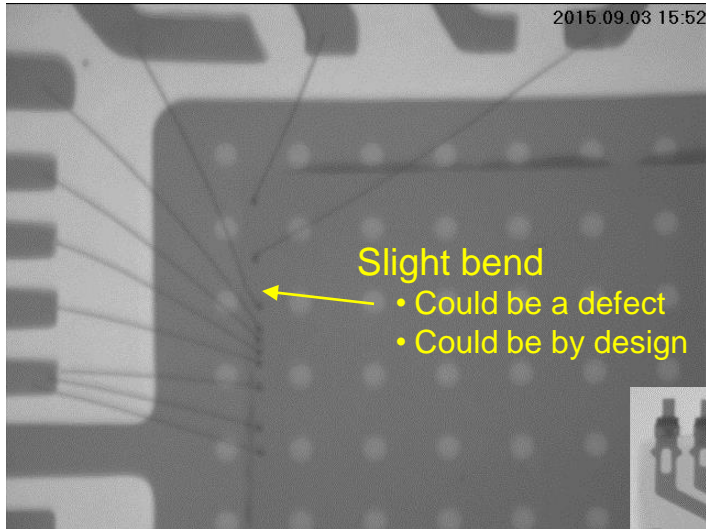
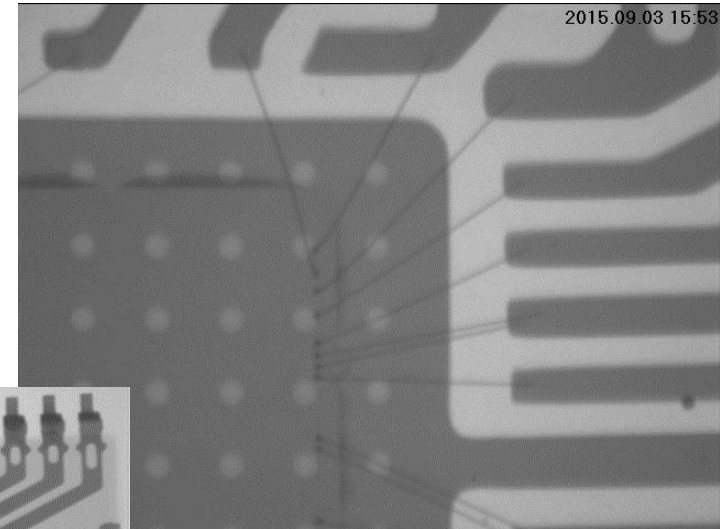
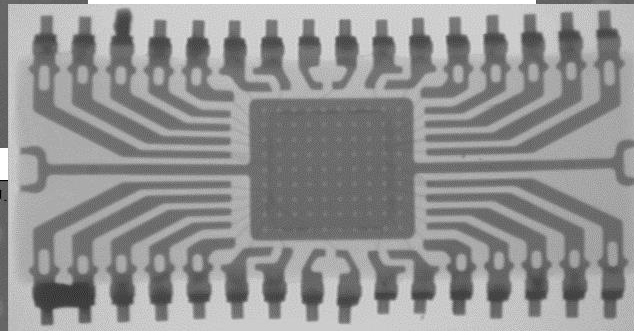
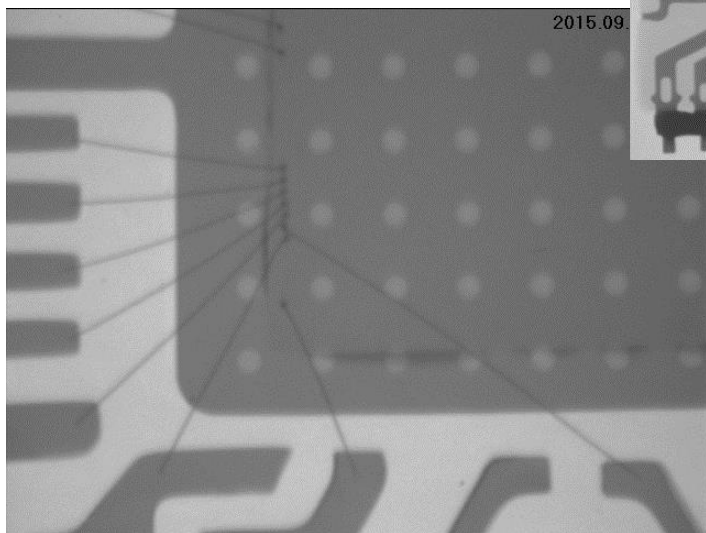
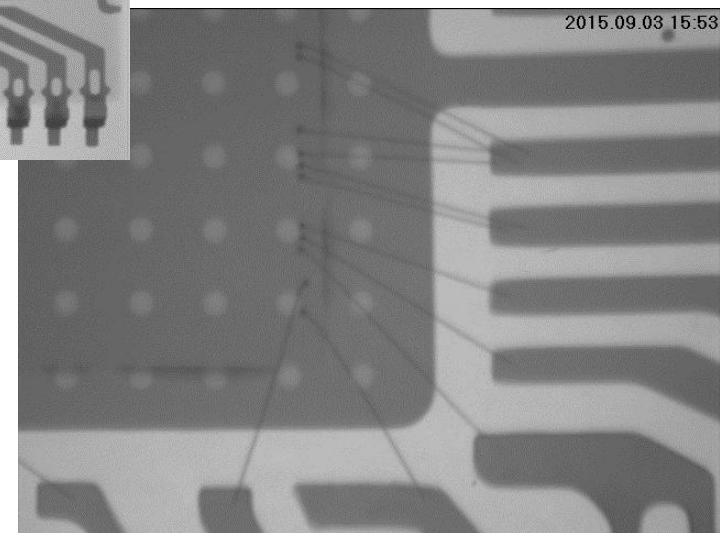
X-rays of DECU Parts, Box 1, cont'd.

- Single chip, wire bond interconnection
- All wire bonds appear to be in tact
- Side view needed to see if balls are pulled from the chip

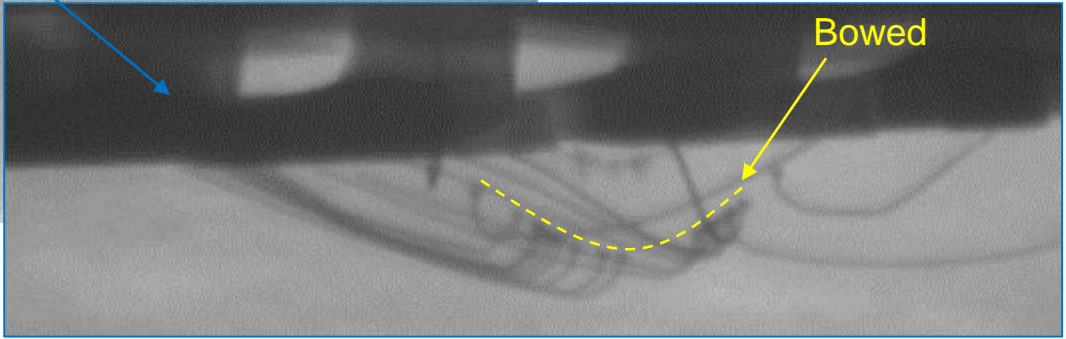
Z direction bowed pattern of the wire bond balls suggests they were pulled from the chip (presumably by the deformation during the thermal excursion)

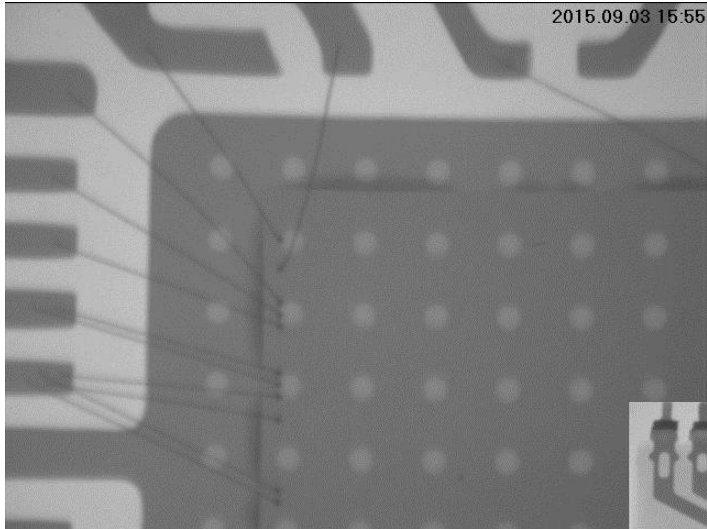
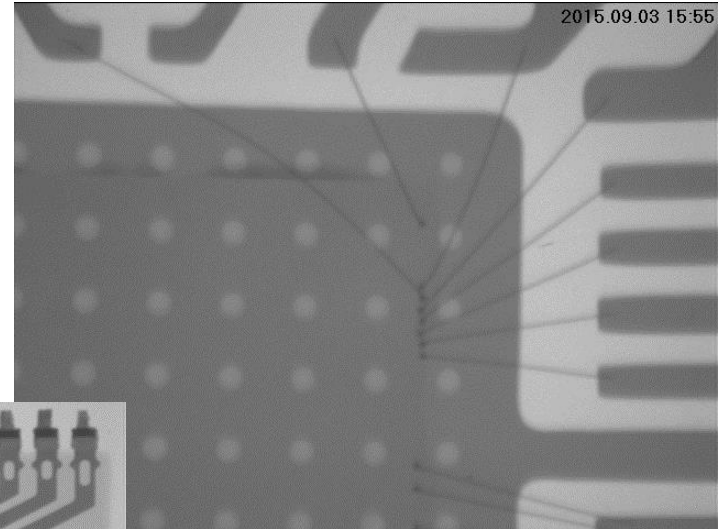
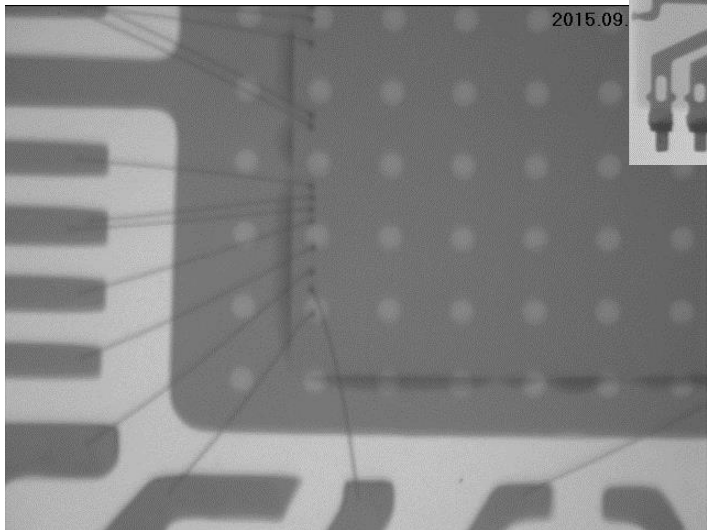
X-rays of DECU Parts, Box 1, cont'd.

- Single chip, wire bond interconnection
- All wire bonds appear to be in tact
- Side view needed to see if balls are pulled from the chip

- Slight bend
- Could be a defect
 - Could be by design

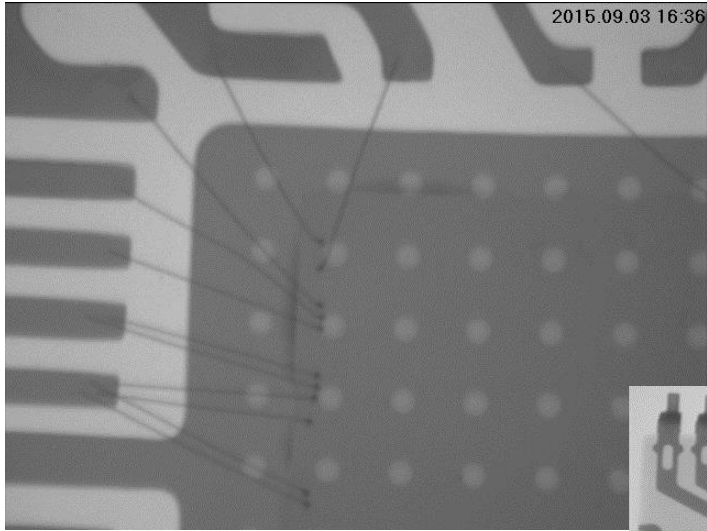
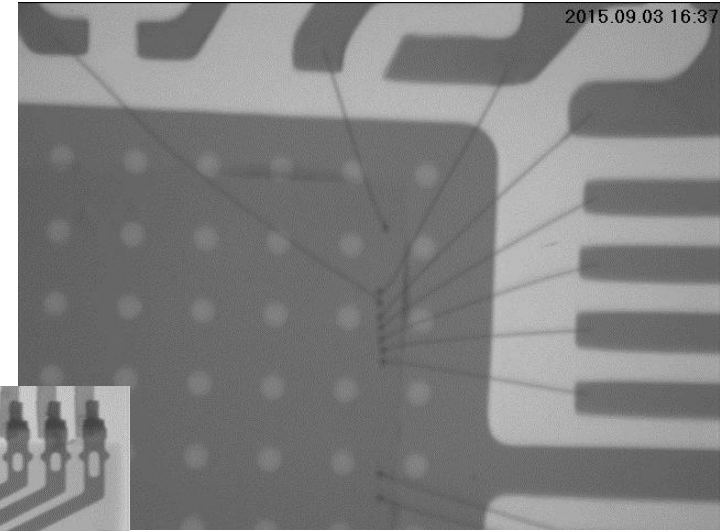
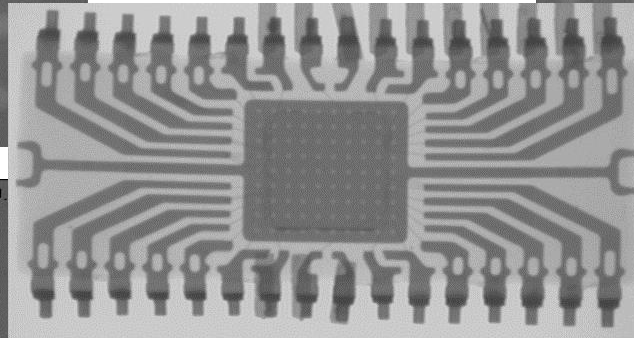
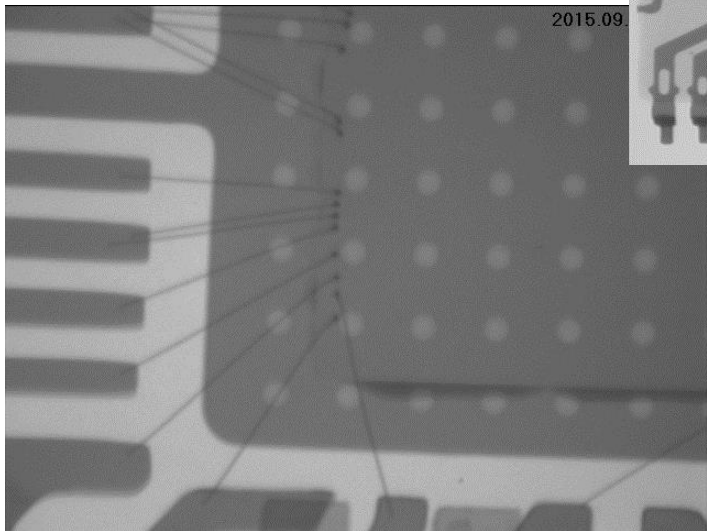
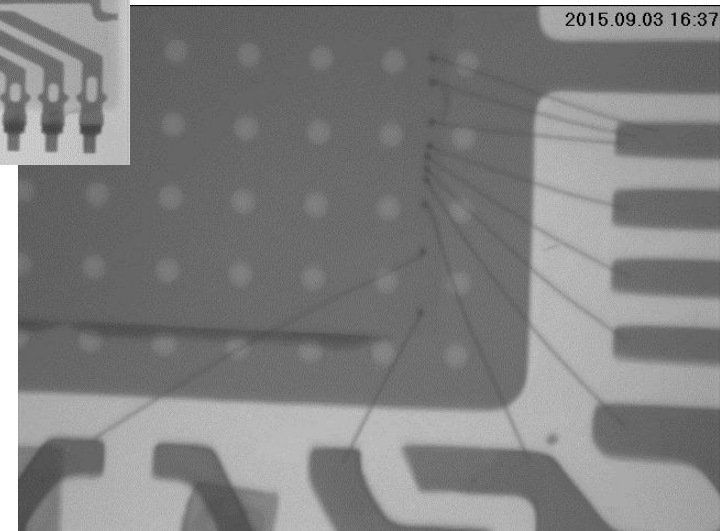
X-rays of DECU Parts, Box 2

- Single chip, wire bond interconnection
- All wire bonds appear to be in tact
- Side view needed to see if balls are pulled from the chip

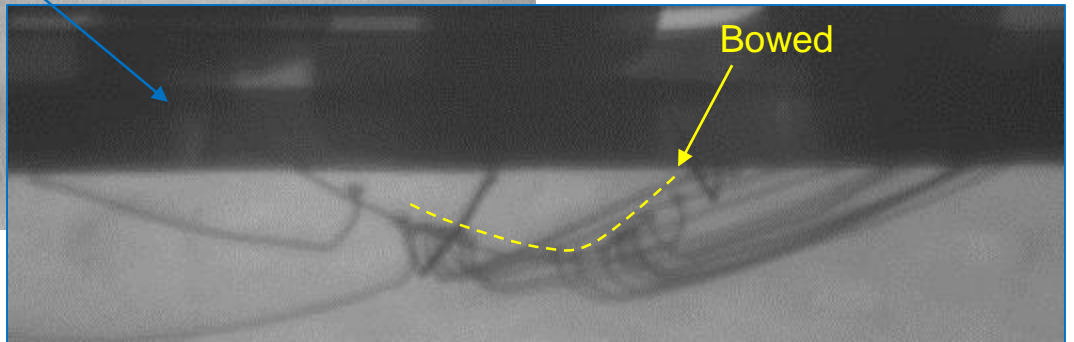
Z direction bowed pattern of the wire bond balls suggests they were pulled from the chip (presumably by the deformation during the thermal excursion)

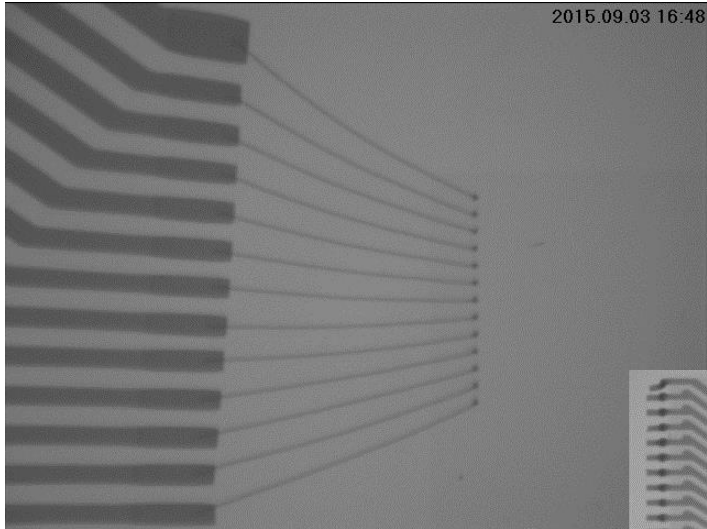
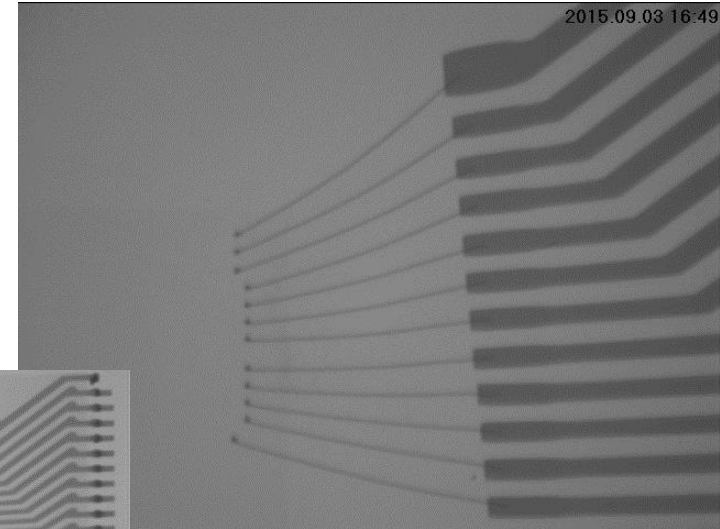
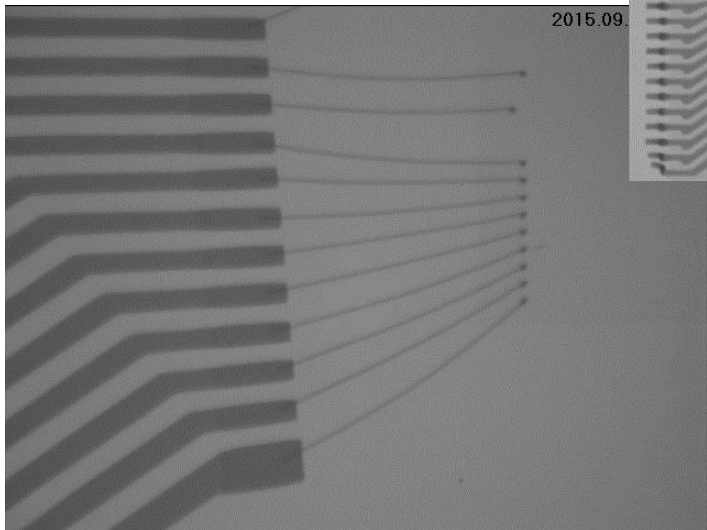
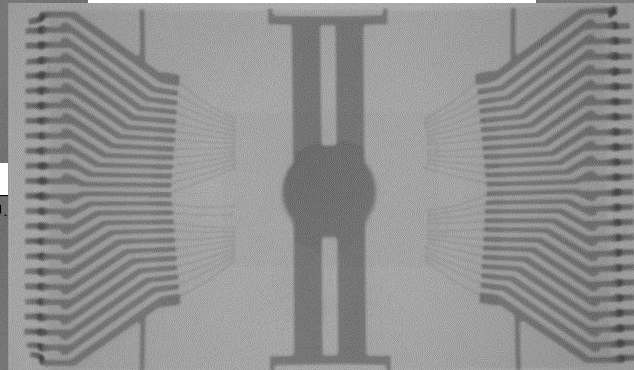
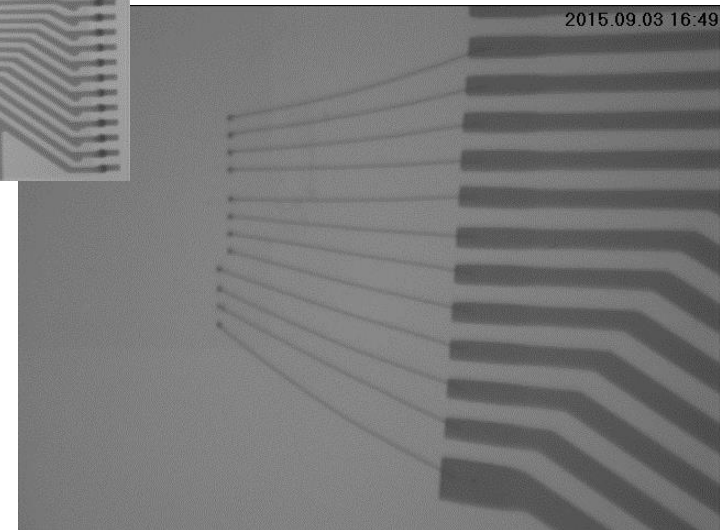
X-rays of DECU Parts, Box 3

- Single chip, wire bond interconnection
- All wire bonds appear to be in tact
- Side view needed to see if balls are pulled from the chip

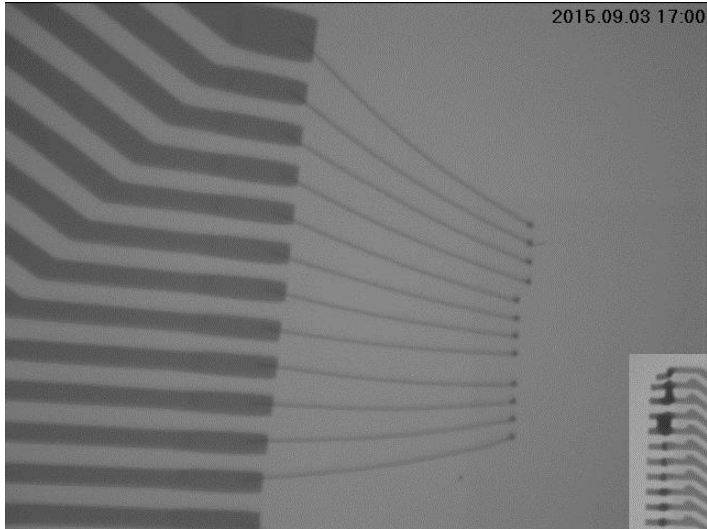
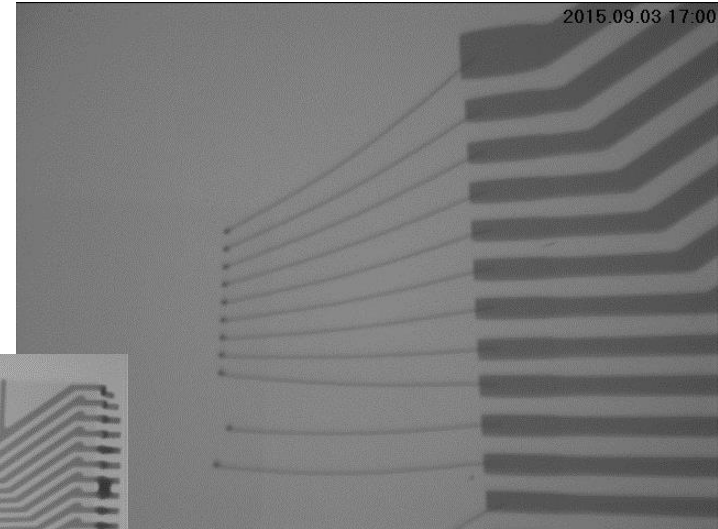
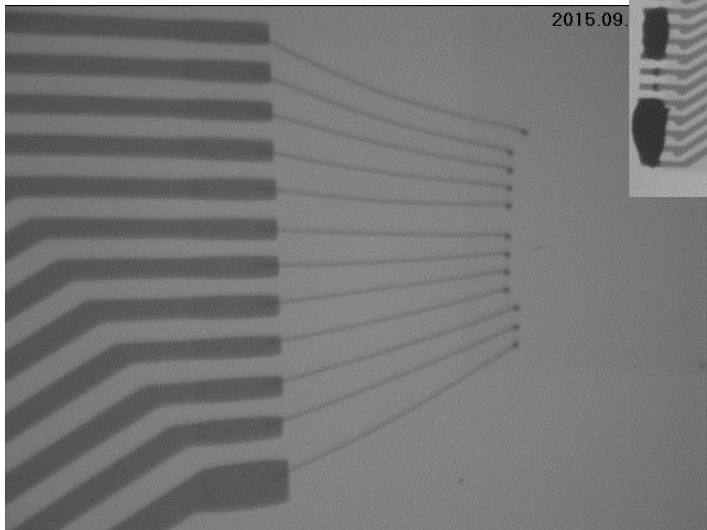
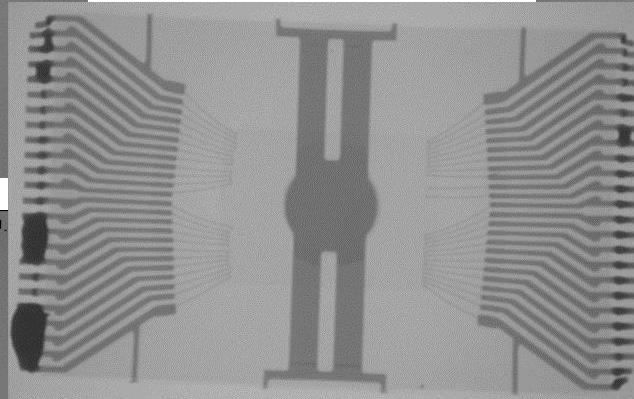
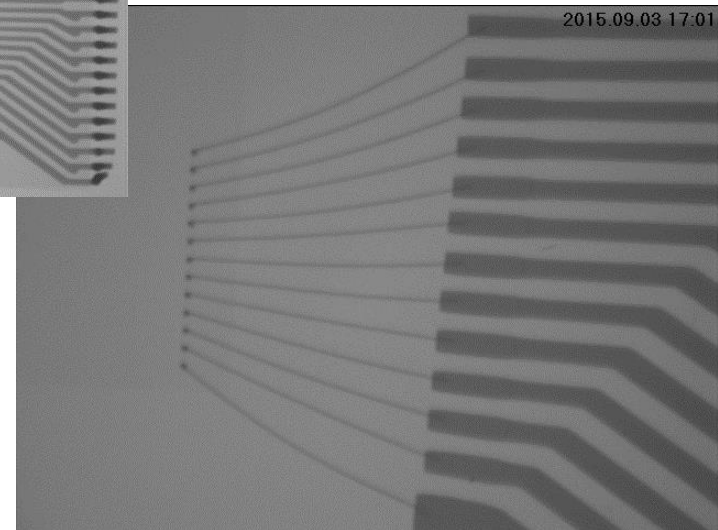
X-rays of DECU Parts, Box 4

- Single chip, wire bond interconnection
- All wire bonds appear to be in tact
- Side view needed to see if balls are pulled from the chip

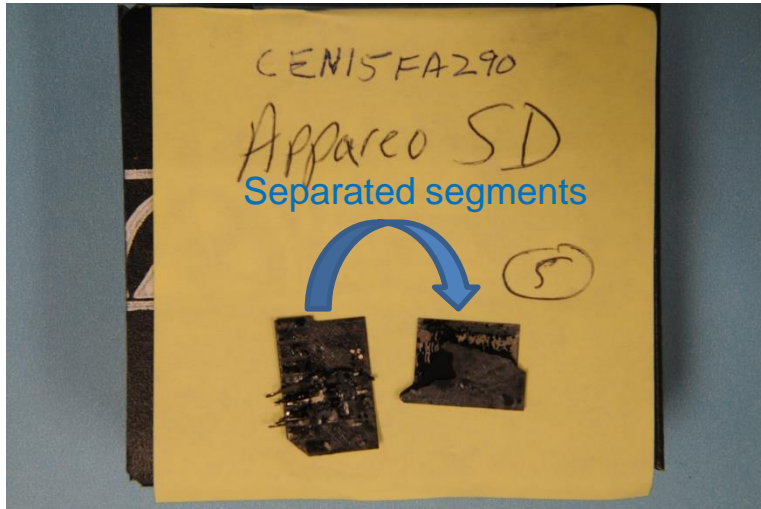
- Box 5
 - APPAREO SD
 - Two sections of the same device
 - Likely decomposed and separated from fire
