# CT scan data from Appareo package #2

# Experimental Details

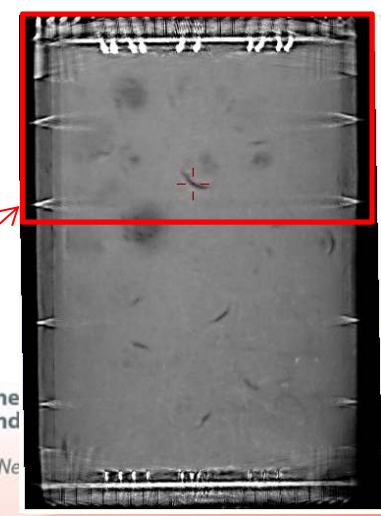
Higher-mag scan area

Cross-hair indicating separation/crack between molding compound and die top

Other areas of such separation/cracks shown by arrows
