NATIONAL TRANSPORTATION SAFETY BOARD

Onsite Examination

WPR18FA139

Aircraft: Beech BE76, Registration Number: N803FC, Serial #: ME-150

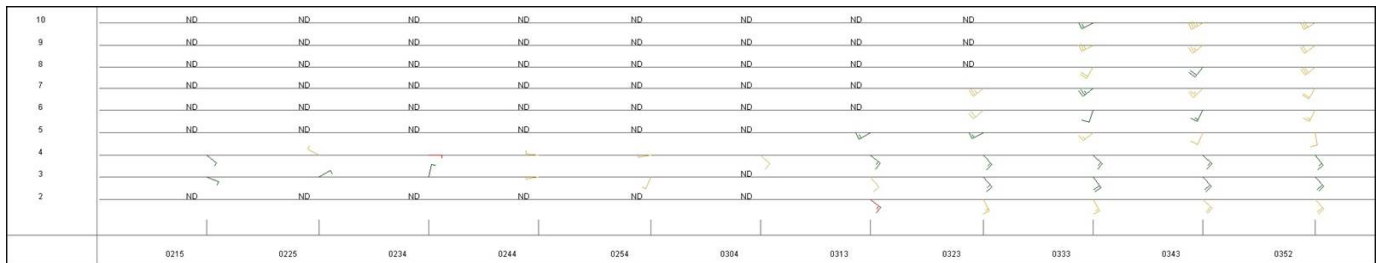
Figure 5: KNKX VAD wind profile.

Doppler winds applicable above a point located about 28 miles west-southwest of the accident location presented shifting wind magnitudes below 10000' during the time surrounding the accident time. The image below is from the KNKX VAD wind profile for the period, where the vertical-axis is thousands of feet and the horizontal-axis is time (UTC) on 11 May 2018.

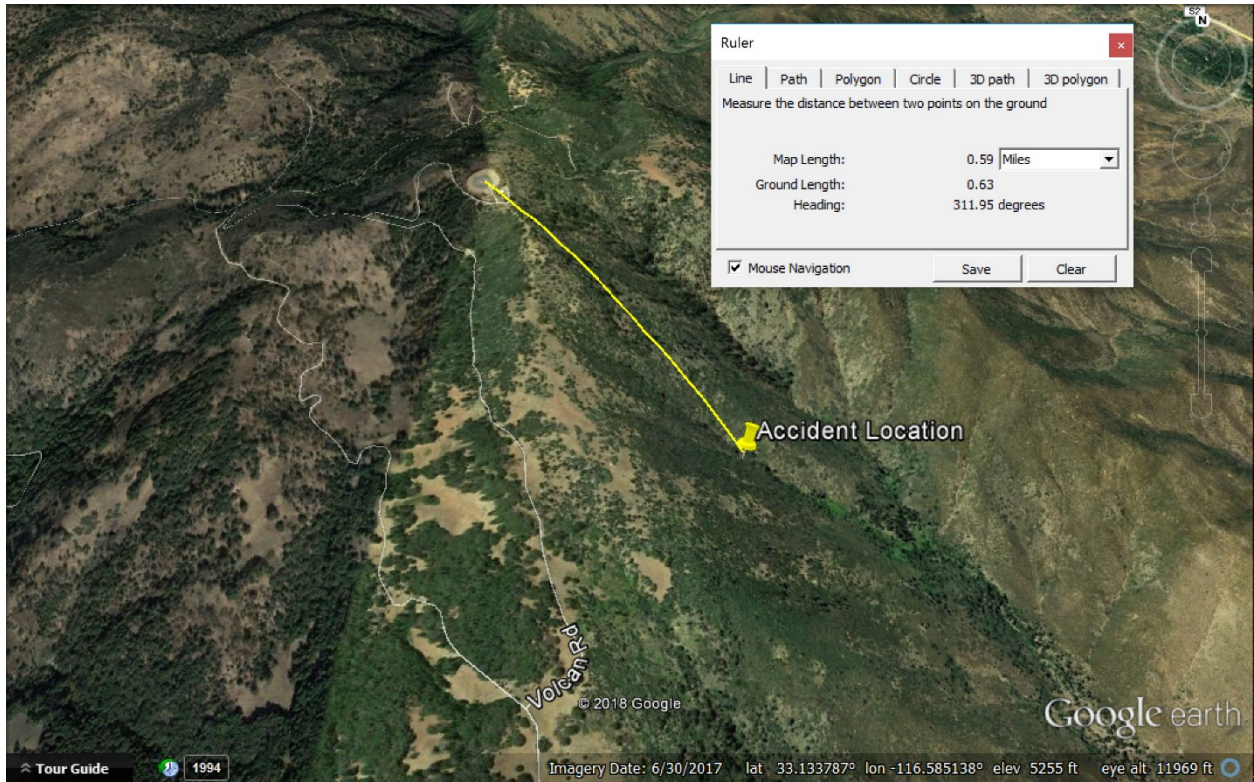
Figure 6: Google Earth – Map of accident location.

The accident site was located less than 1 mile southeast of the Julian VOR (Very-High-Frequency Omnidirectional Range Navigation Equipment) in mountainous terrain near the bottom of a draw at an elevation of about 4,200 ft. The wreckage debris was orientated along an east-west direction and the initial impact direction was on a westerly heading. The wreckage was contained within a 150-foot circumference of the initial impact point. The first piece of identified wreckage near the initial impact point was the fire extinguisher. The farthest portion of wreckage located downslope of the initial impact was the right-side propeller. All structural components were located at the accident site.
