FedEx Flight 1478 Operational Factors

Captain David J. Ivey Group Chairman

Operational Factors

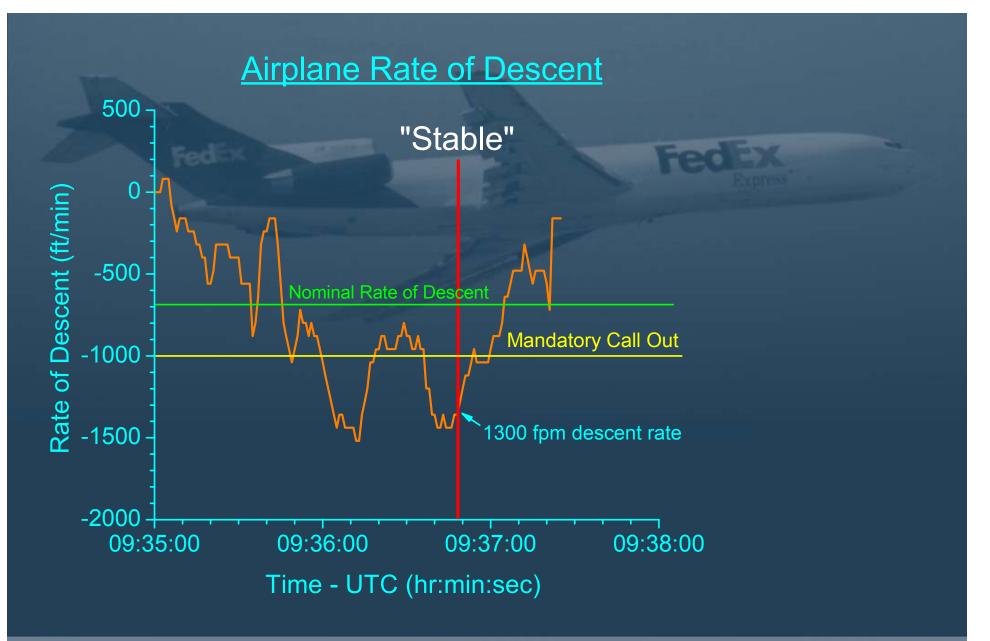
Flight Profile with PAPI Indications

- Early decision to land on runway 27
 - ILS, PAPI, approach lights, TDZ lights, and runway lights
- Late decision to land on runway 9
 - No electronic approach, PAPI, no approach or TDZ lights, only runway lights
- Improperly flown visual approach
