NATIONAL TRANSPORTATION SAFETY BOARD  
OFFICE OF AVIATION SAFETY  
Anchorage, Alaska, 99513

Operations / Witness Group Chairman's Factual Report

Operator: Helicopter Consultants of Maui, Inc.  
Dbas: Blue Hawaiian Helicopters  
Location: Pukoo, Hawaii (Island of Molokai)  
Date: November 10, 2011  
Time: 1214 Hawaiian standard time<sup>1</sup>  
Helicopter: Eurocopter EC130 B4, Registration Number: N11QV, MSN: 4909

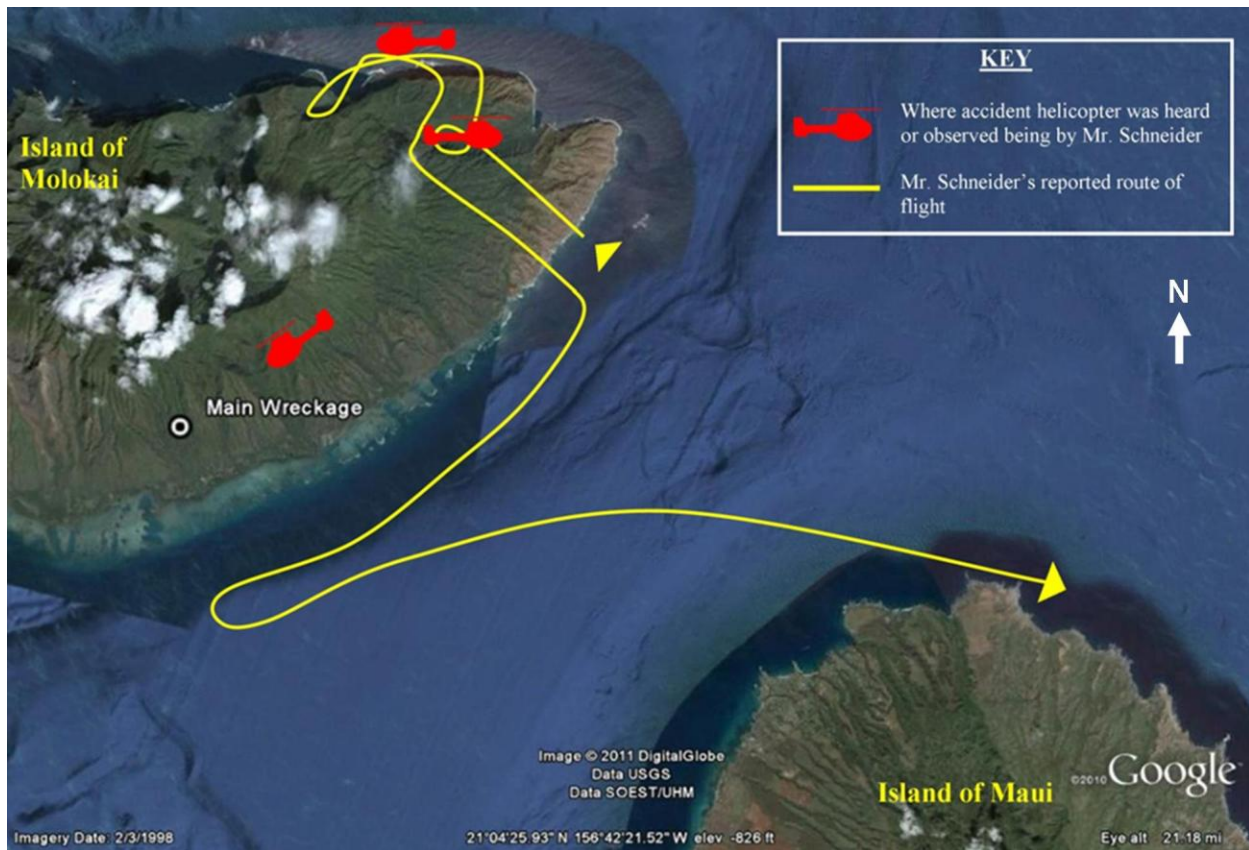
Figure 12: Mr. Schneider's Route of Flight and Sightings/Communication from Accident Helicopter

Mr. Schneider reported that he departed the Island of Maui at 1130-1135 and was conducting a tour flight around the Island of Molokai at the time of the accident. He estimated that during the flight, the clouds around the island were about 2,000 to 2,100 feet high. His flight path started along the northeast side of the island, and continued westbound along the northern shoreline. He then turned back the way he came and proceeded along the eastern part of the island towards the southern shoreline. During this time, he observed the accident helicopter and started to speak to the accident pilot. The conversation was short and strictly casual. Mr. Schneider continued southbound along the eastern side of the island and crossed over to the southern shore where he experienced a “little bit of a bumpy ride.” While flying west across the south side of the island, he briefly observed the accident helicopter flying along the south side of the mountain ridges just below the clouds. Mr. Schneider stated that he could not see the main rotor of the helicopter, just the silhouette. From Mr. Schneider’s perspective, he stated that the

accident helicopter appeared to be straight and level and did not appear to be in any form of distress. Mr. Schneider continued along the southern shore before turning back towards the east and departing for the Island of Maui. It was not until he landed that he learned of the accident. He reported that he did not hear any distress or “mayday” calls from the accident pilot. Mr. Schneider gave the NTSB a cut out picture from a newspaper (source unknown) of the accident scene right after the accident occurred and stated that the clouds looked very similar during the flight as they do in the picture (see below). Also, throughout this interview, Mr. Schneider provided a drawing of his route of flight, indicating when he observed the accident helicopter (also below).

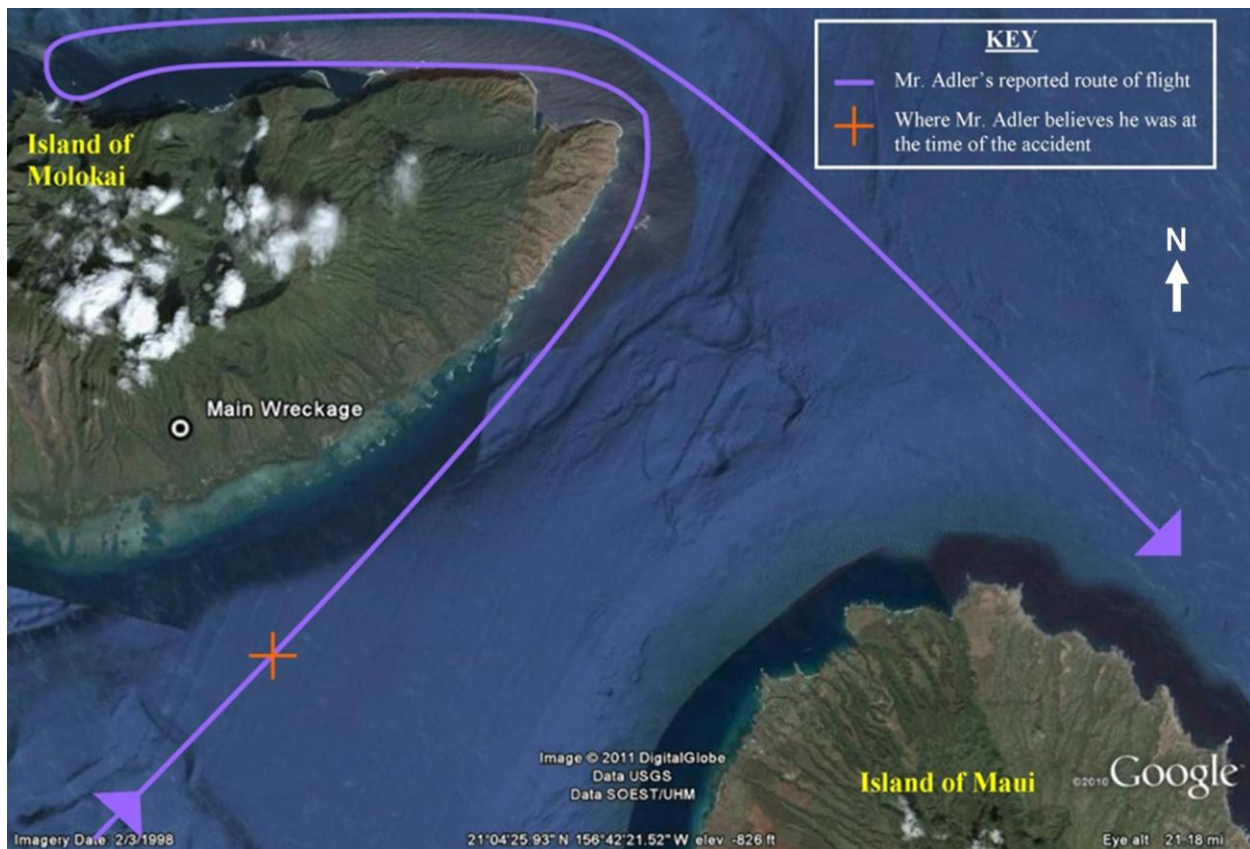
**Figure 13: Mr. Adler’s Route of flight with Approximate Location when Accident Occurred**

Mr. Adler reported that his flight originated from Lanai before proceeding to the Island of Molokai. Mr. Adler approached the Island of Molokai from the east; he proceeded along the southern shore before flying north along the east side of the island. He then wrapped around to the north side of the island before flying across the water to the Island of Maui. Mr. Adler stated that at the time of the accident, he believes his location would have been about 2 miles off the southern shore of the Island of Molokai, just west of the accident site. He stated that he did not hear any radio calls from the accident pilot, just air traffic control asking if he had heard any word from the accident pilot. Mr. Adler reported that he observed large moderate/heavy rain showers along the shoreline at the time of the accident. Mr. Adler did not provide a picture of his route of flight, however, he pointed out his route on a map to NTSB investigators. His route is shown below.

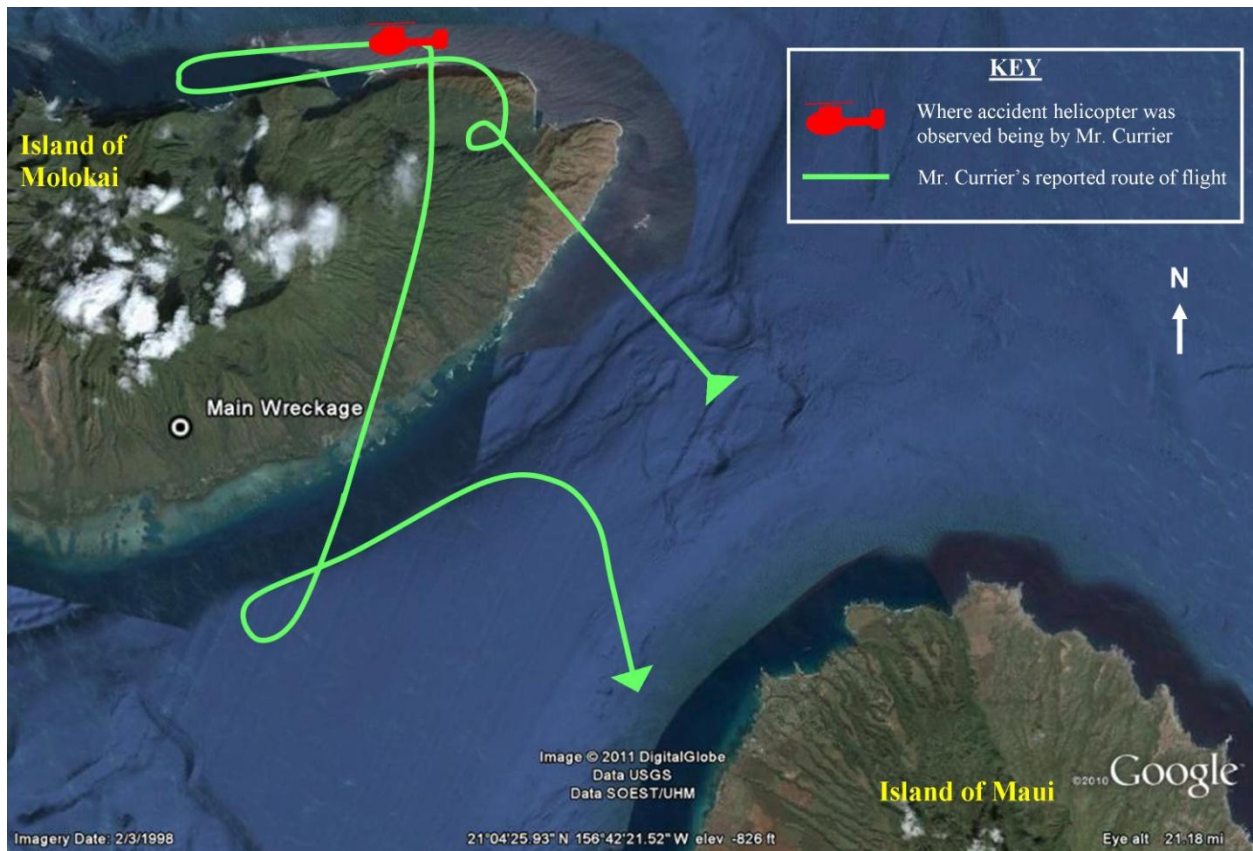
Figure 14: Mr. Currier's Reported Route of Flight and Sightings/Communication from Accident Helicopter

When asked what the weather conditions were like on the southern mountain ridge, Mr. Currier stated that the clouds were at about 1,500 feet with descending ceilings. He further stated that when he says descending, he is referring to the fact that the ceilings were descending parallel along the mountain ridge. As a whole, the weather was VFR with rain showers coming from the northeast. The wind was about 20-25 knots.

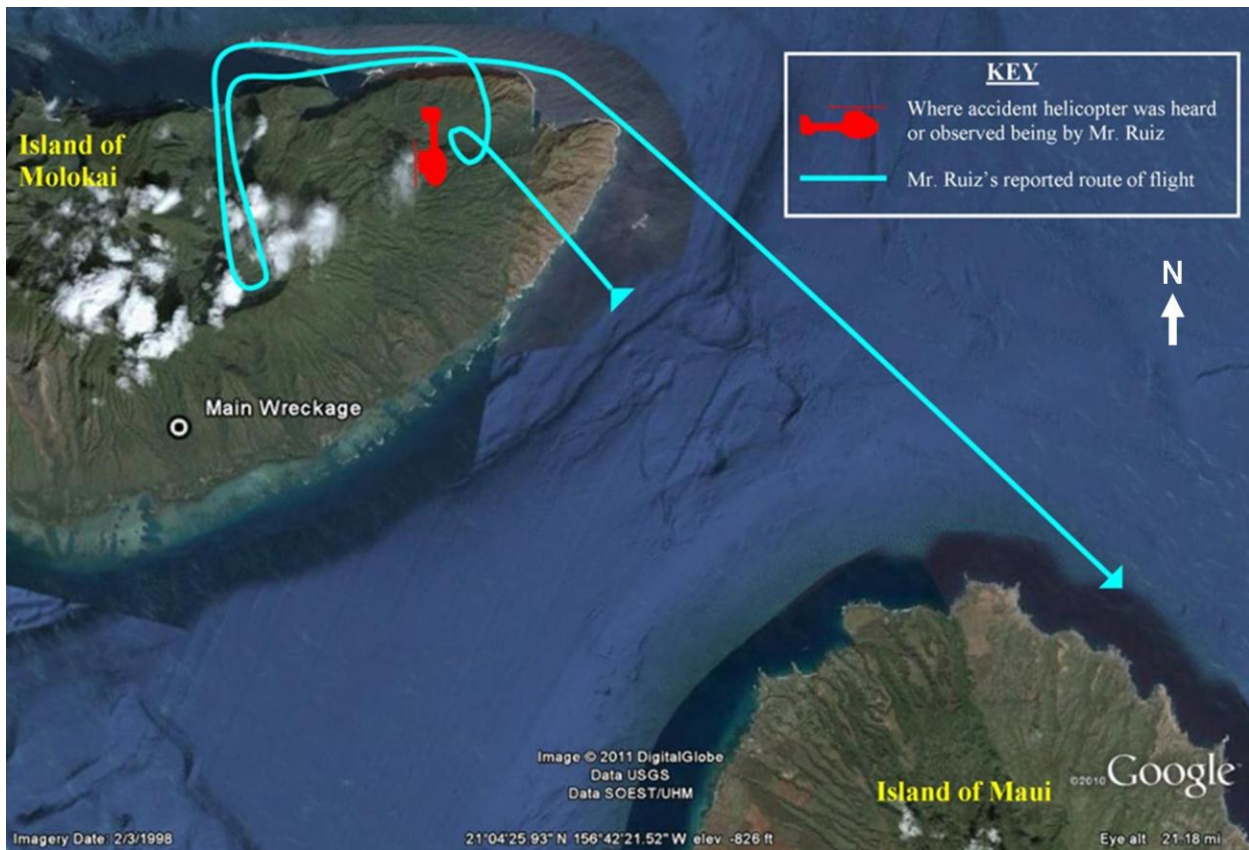
**Figure 15: Mr. Ruiz's Route of Flight and Sightings/Communication from Accident Helicopter**

Mr. Ruiz reported that he was flying around the Island of Molokai at the same time as the accident pilot. He reported that, at the time, the clouds were about 2,000 feet high with light rain; the wind over the water was believed to be about 10-15 knots. Mr. Ruiz mentioned that there were a lot of little cells moving through the area constantly, which is nothing out of the ordinary. Mr. Ruiz flew along the east side of the island and hovered around the Halawa Valley Waterfall. At this time, he had observed the accident helicopter flying over the Halawa Valley Waterfall towards the southwestern part of the island. He then proceeded north and continued westbound along the northern shoreline, he entered the Wailau Valley, and since he could not climb over the Wailau Valley wall, he turned around and exited the valley the same way he

When asked about common areas of turbulence on the island, Mr. Ruiz stated that with a southeast wind, the Wailau Valley can be very turbulent. With a northeast wind, the southern side of the island, where the accident occurred, can also have some turbulence.
