Addendum 1
To Operations/Human Performance Group Factual Report
Attachment 6

DCA11IA040

Meeting Notes – Airbus

**Meeting summary for United Airlines flight 497 Incident, A320 Runway Excursion,
April 4, 2011 (NTSB # DCA11IA040)**

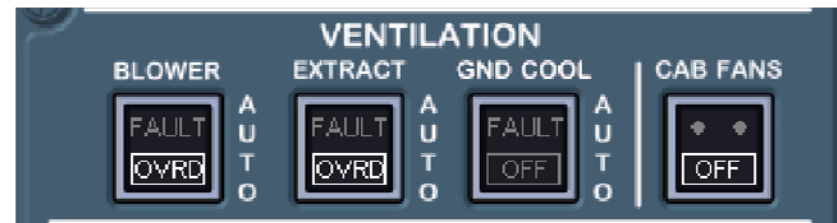
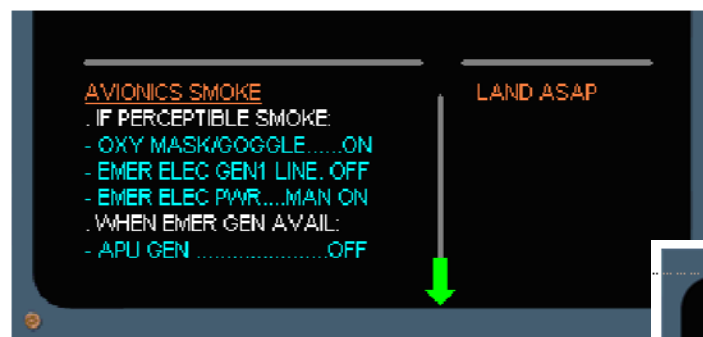
ECAM checklist after 5 minutes

- The timer will count down from 5 minutes as a conditional statement on the ECAM. If the timer reaches zero and smoke is still detected, the conditional statement will disappear. This occurs even if the event was initiated on the ground before the crew arrived at the aircraft.
