# Attachment 8

DCA12IA096

Airbus Safety First article “A320 Dual  
Hydraulic Failure”

# A320 - Dual hydraulic loss

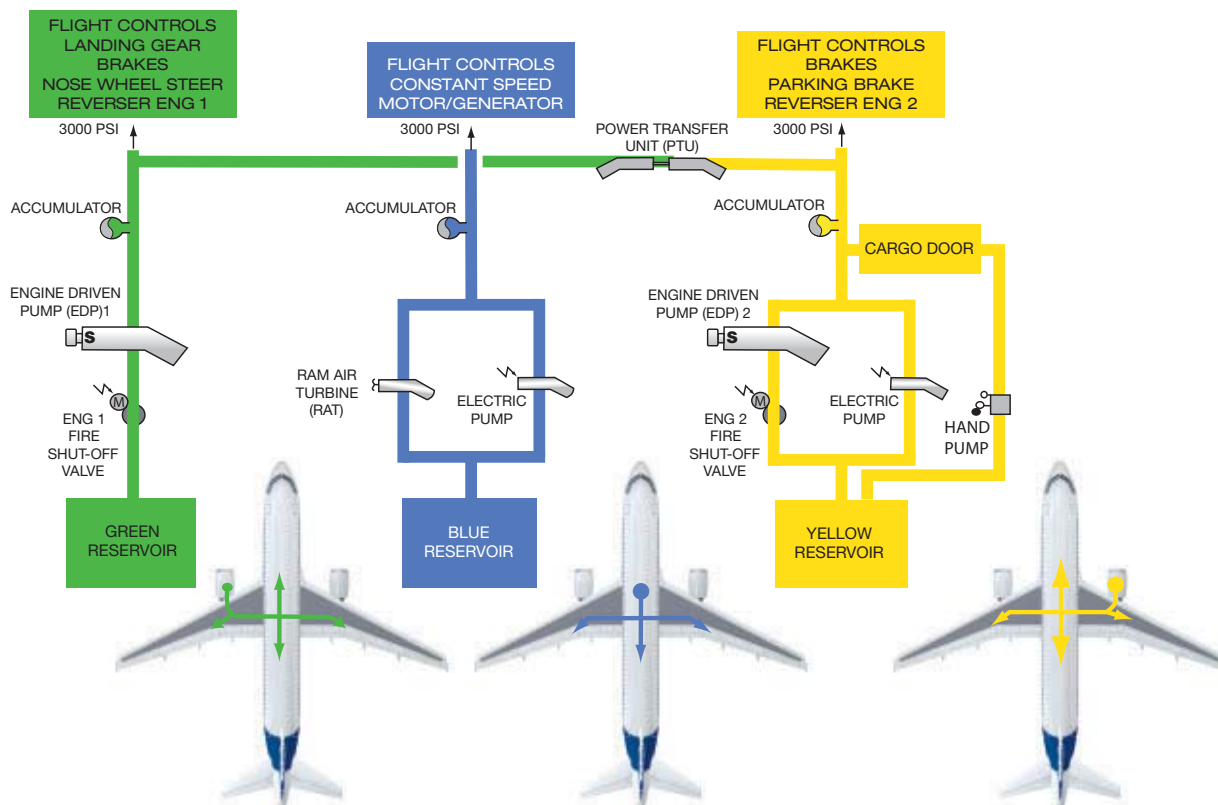
The figure below shows all the systems, which are interconnected to the hydraulic systems:

SYSTEM OVERVIEW / RAT  
Example of architecture.  
Aircraft pre modification 26925.
