**NATIONAL TRANSPORTATION SAFETY BOARD
Office of Aviation Safety
Gardena, CA 90248**

GROUP CHAIRMAN'S FACTUAL REPORT

OPERATIONS GROUP

WPR10FA371

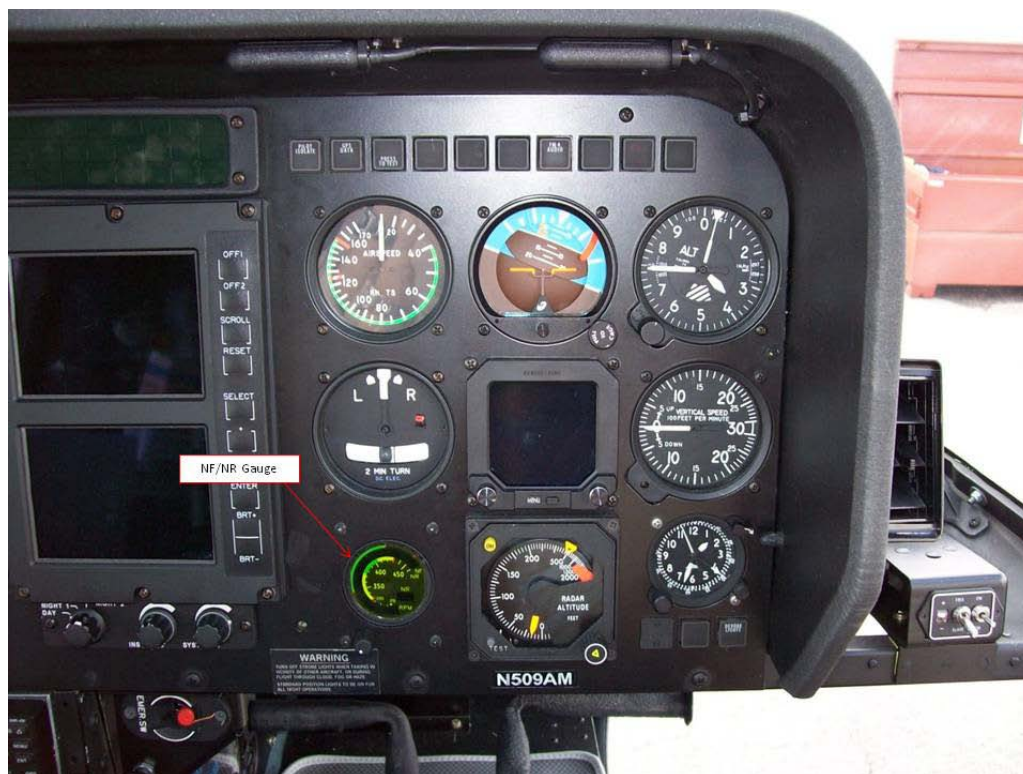
Step 1 of the engine flame-out procedure refers to maintaining the NR (rotor rpm) in the green arc. The rotor rpm gauge is a dual gauge representing engine free turbine speed (NF) and rotor rpm (NR) displayed using LED bars along the arc of the gauge. The gauge itself is approximately 2 inches in diameter and resides in the lowest left portion of the pilot's instrument panel. See figure 3.

Fig 3 - N509AM pilot instrument panel. Location of the NF/NR gauge indicated by the red arrow.
