NATIONAL TRANSPORTATION SAFETY BOARD

Operations Group Chairman's Factual Report

Aircraft: Eurocopter AS350-B2, N37SH

NTSB Accident Number: DCA12MA020

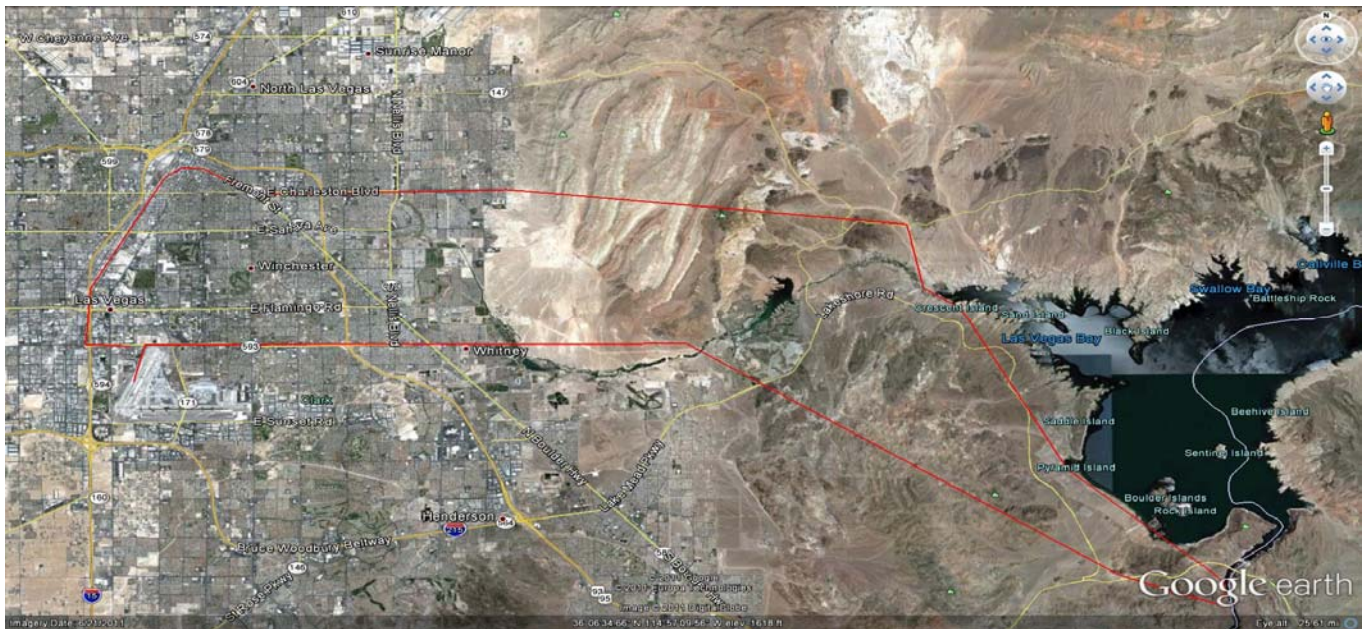
The Tropicana Departure and the Callville Arrival are standardized helicopter routes established by the Las Vegas area Air Traffic Control (ATC) and the local helicopter operators. The routes are published in the "Las Vegas Terminal Radar Approach Control (L30), Las Vegas Airport Traffic Control Tower (LAS), North Las Vegas Airport Traffic Control Tower (VGT), and Signatories Letter of Agreement," dated 11/2/2011. The Twilight Tour route is depicted in 'red' on the chart below.

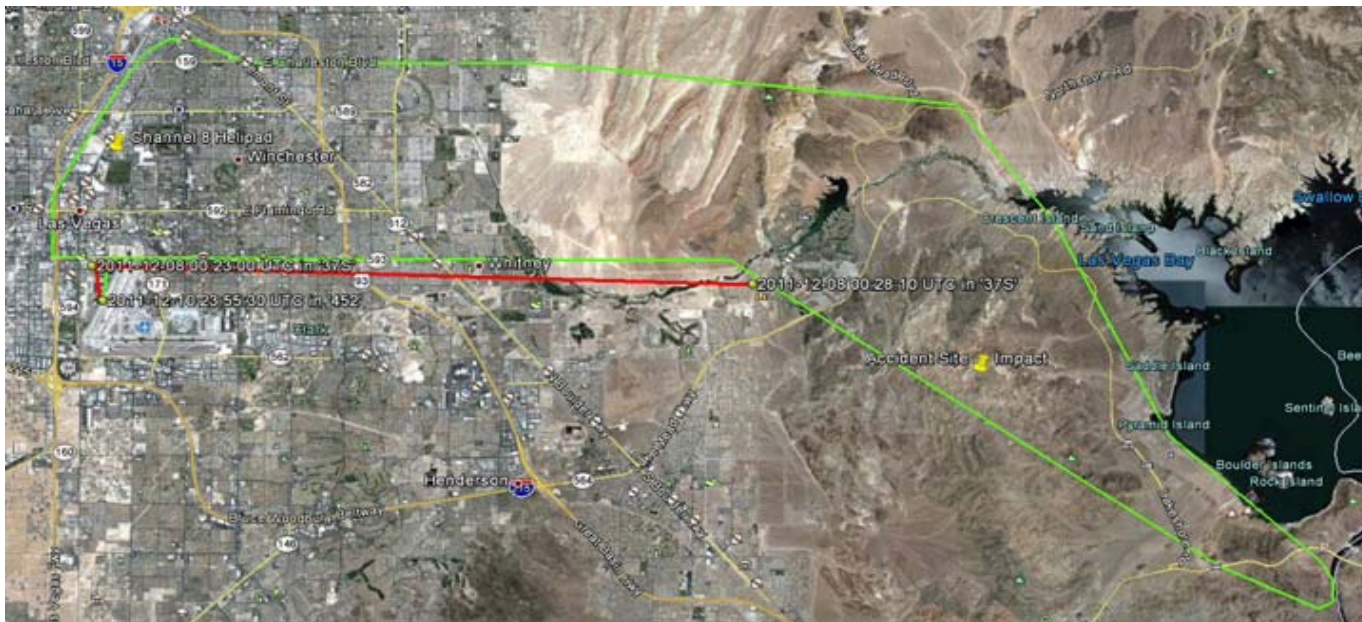
1.2 Accident Flight Track

site, Spidertracks.com, by personnel authorized by Sundance². The tracks are utilized by Sundance management and safety personnel to ensure the consistency and quality of tour flights flown. The reporting rates are set by Sundance based on operational needs. The rates reported represent either 8 minutes or 20 km., whichever comes first. The Spider track for the accident flight was provided to the NTSB and is depicted in 'red' with an overlay of the prescribed Twilight Tour route is depicted in 'green' on the chart below.

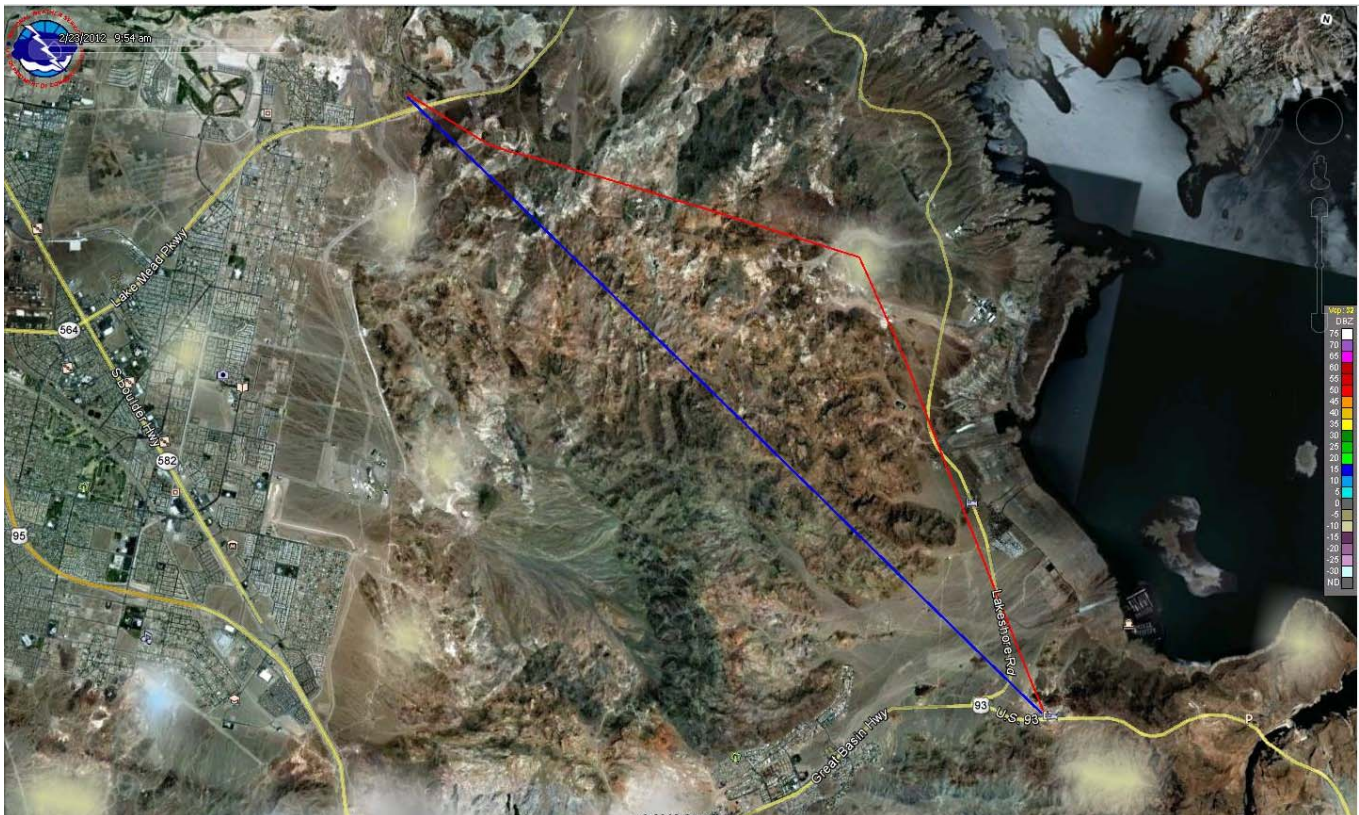
Modified Tour Route (new route is in 'red')

- Conduct a more thorough post-flight inspection following any MOC or FCF flight.
- Specifically, re-inspect (visually) any replaced components.
- Document all post-flight inspections in the maintenance log.
- Slightly alter air tour flight routing in the vicinity of the River Mountains to the north. This will provide quicker access to relatively flat terrain in the event of an unscheduled landing. The new route was also adopted by the other 2 helicopter tour operators on the Las Vegas strip.
