NATIONAL TRANSPORTATION SAFETY BOARD

Group Chairman's Factual Report

OPERATIONAL FACTORS

DCA13MA133

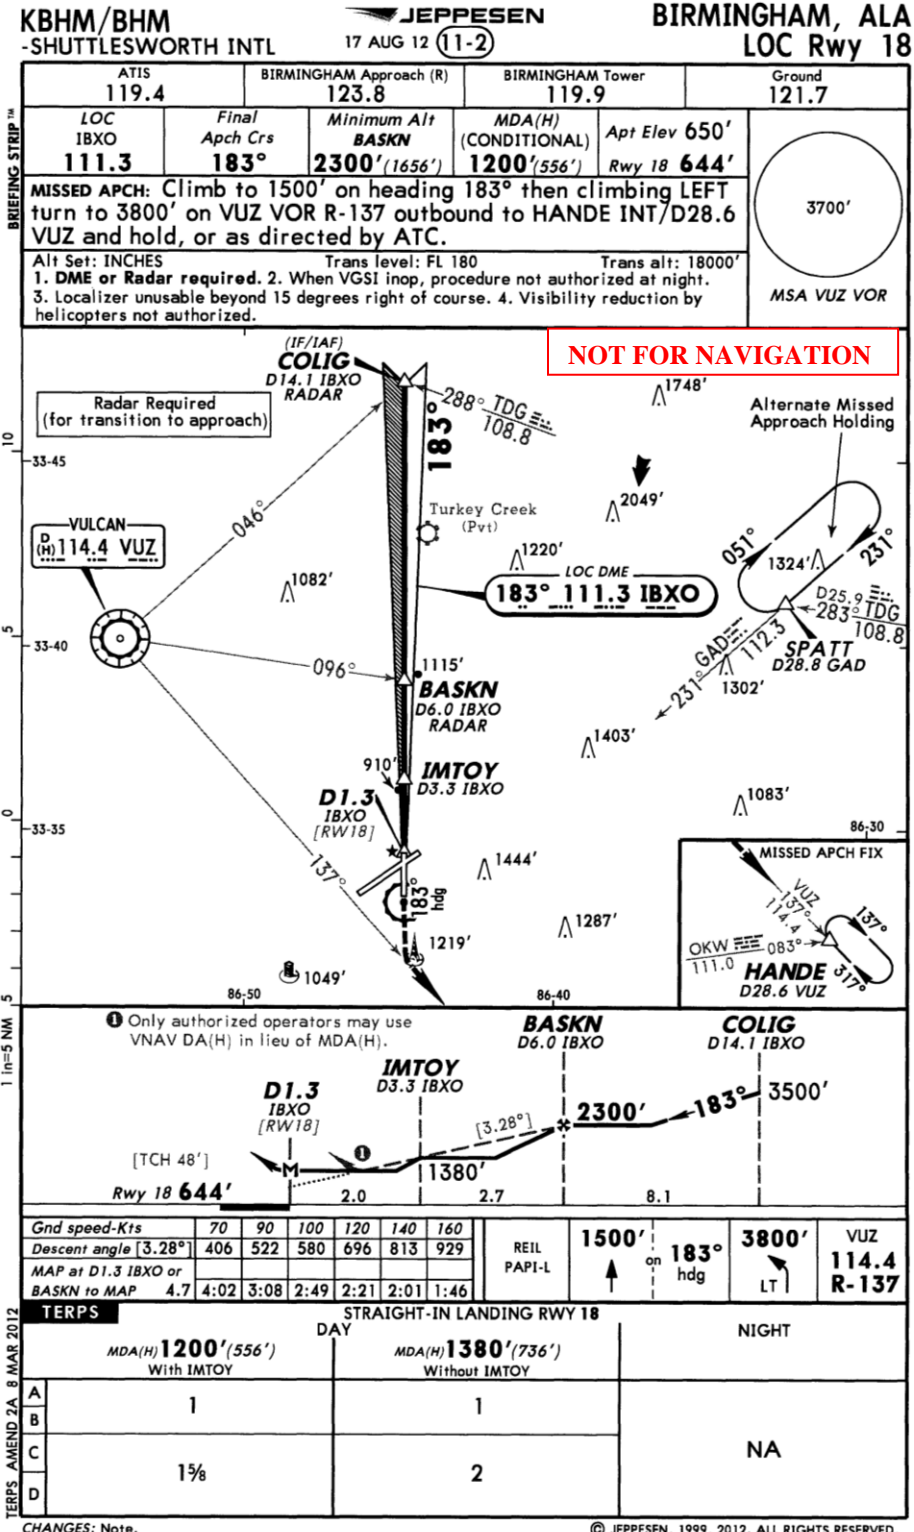
11.2.2 Jeppesen KBHM LOC18 Approach Chart (pre-accident)

⁹² According to an email sent to the Operations Group Chairman from the Senior Manager Aviation & Marine Safety at Jeppesen on January 29, 2014, Jeppesen completed an internal review of the circumstances surrounding the discrepancy in the KBHM LOC18 chart, and said “the root cause was human error in not catching the removal of “NA” from the minimums section of the Jeppesen 11-2 LOC RWY 18 for KBHM.” The email further stated that Jeppesen was “providing additional training to employees involved in chart analysis, production and verification, and also emphasizing attention to detail as part of upcoming safety awareness campaigns” to “help to mitigate the chance of further errors.”

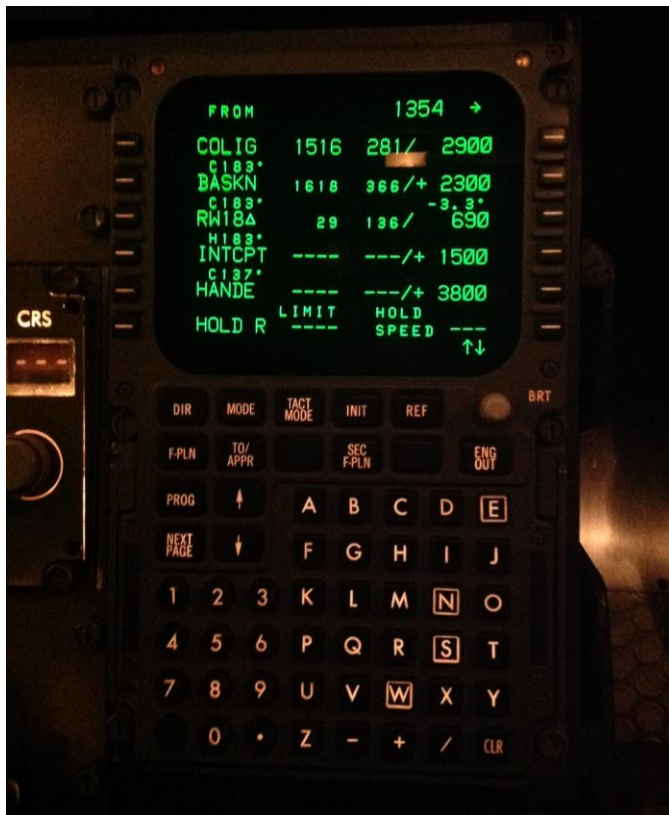
Photo 8: CDU with re-sequenced flight plan for KBHM LOC18.¹³⁷

During the December 4, 2013 simulator testing in KSDF, representatives of the Operations Group inserted the KBHM LOC 18 approach into the FMC, and applied the “H.O.V.E.” check to re-sequence the LOC 18 approach in the FMC. Following the re-sequencing of the approach, the F-PLN DISCONTINUITY was no longer viewed in the active flight plan on the CDU (see photo 8), and the previous navigation path that showed a direct routing to KBHM on the ND was removed (see photo 9).

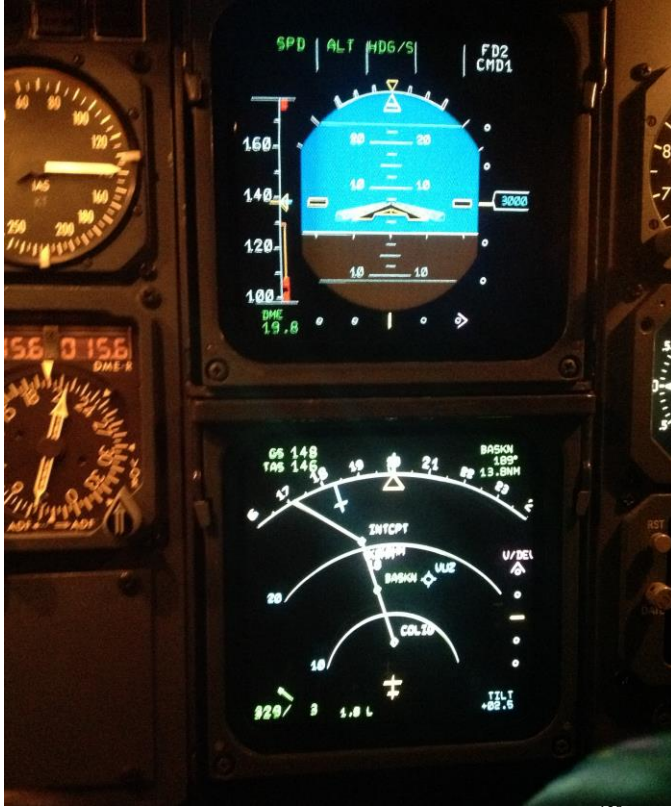
Photo 9: PFD and ND with re-sequenced flight plan.¹³⁸

According to downloaded FMC data from the accident airplane, the flight plan for UPS1354 was not re-sequenced prior to executing the KBHM LOC18 approach, and the flight plan discontinuity remained in the flight plan (see photos 10 through 12, taken during the December 4, 2013 simulator testing in KSDF of the PFD/ND and CDU when the KBHM LOC18 approach was not sequenced).¹³⁹
