National Transportation Safety Board

OPERATIONS CHAIRMAN FACTUAL REPORT ADDENDUM

A. Accident

Accident Number: DCA10MP008
Type of System: Natural Gas Transmission Pipeline
Accident Type: Pipeline Rupture
Location: San Bruno, California
Date: September 9, 2010
Time: about 6:11 pm
Owner/Operator: Pacific Gas and Electric Company
Material Released: Natural Gas
Pipeline Pressure: 386 - 396 psi at time of rupture
Component Affected: 30 inch diameter pipeline.

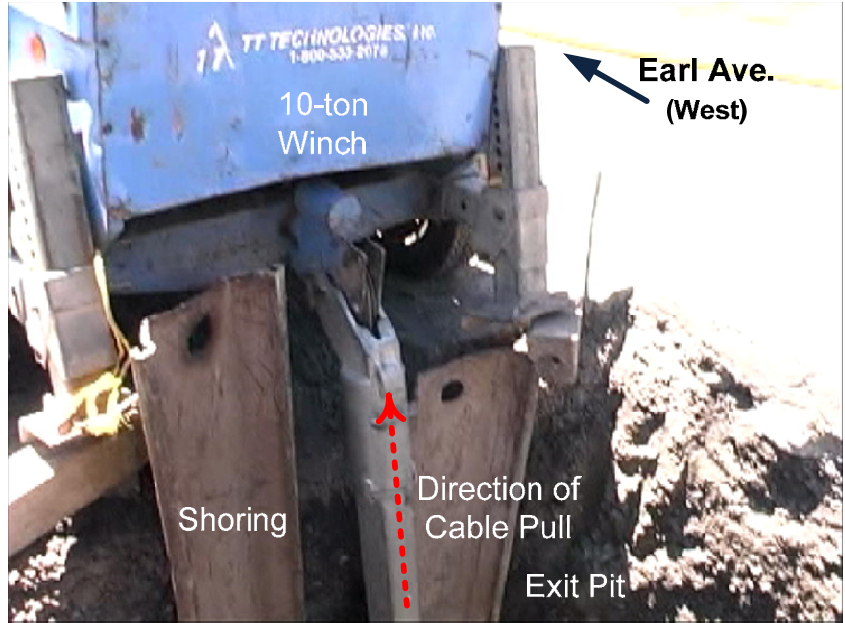
Images from the video appear in Figures 6 and 7 showing the winch relative to the riser bar and pulley. The still images show that the winch was located on the west side of the exit pit with 3 pieces of shoring used as bracing to resist the forces imposed at the pulley. A portion of the winch is set on a steel plate that is laid over the east side of the excavation above the gas main. The video includes shots of the 30 inch gas main as it crosses the potholing or excavation trench dug by the contractor.

Figure 6: Still image from the 2008 Sewer Work Video showing the winch and riser bar in the exit pit

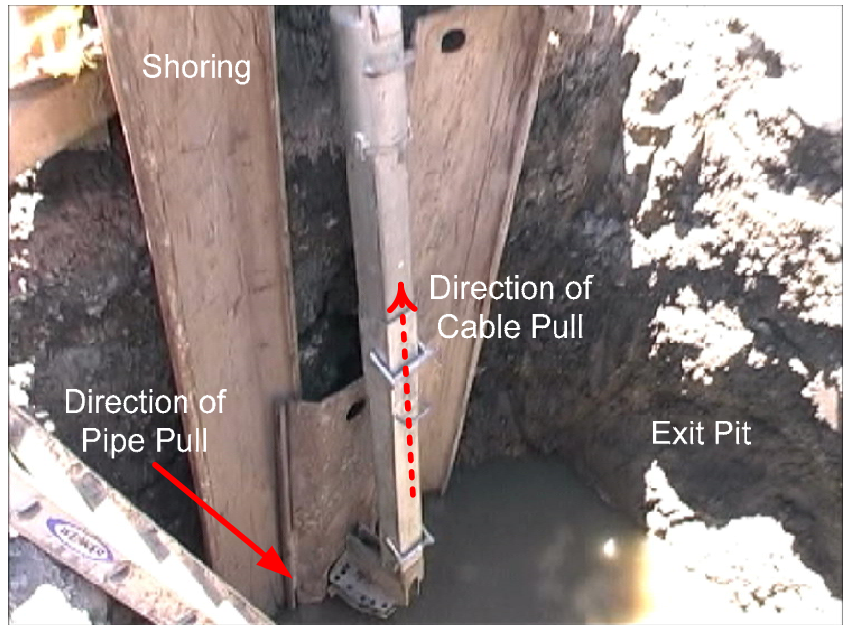
Figure 7: Still image from the 2008 video of the Sewer line replacement project showing the bracing assembly utilized by the contractor in the exit pit during pneumatic pipe bursting.

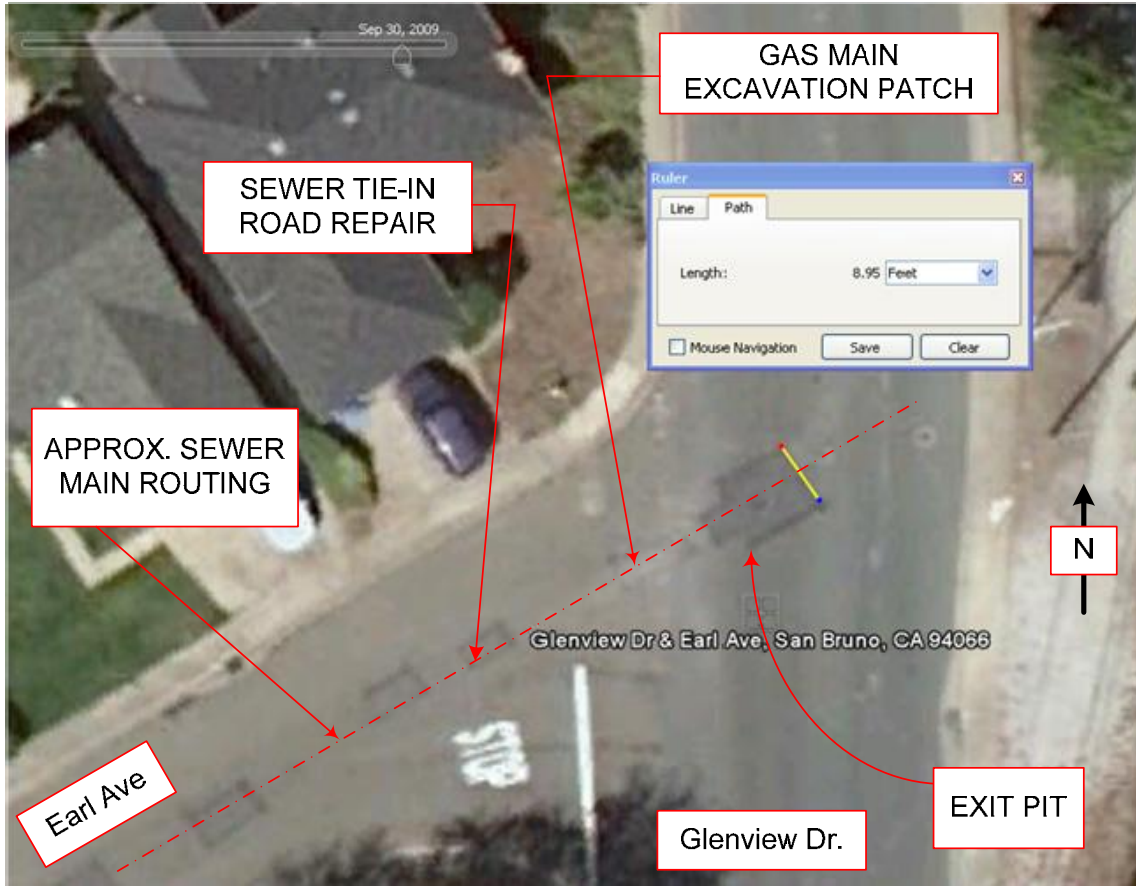
Figure 8: Google Maps and Paving Patches Post 2008 Sewer Repair
