NATIONAL TRANSPORTATION SAFETY BOARD

Group Chairman's Factual Report

OPERATIONAL FACTORS

DCA17FA109

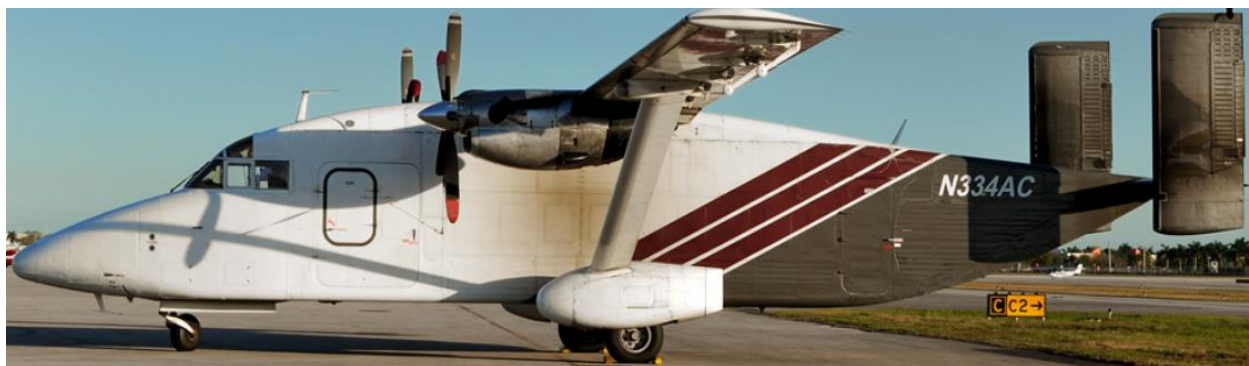
Photo 1. Photograph of accident airplane N334AC³⁴

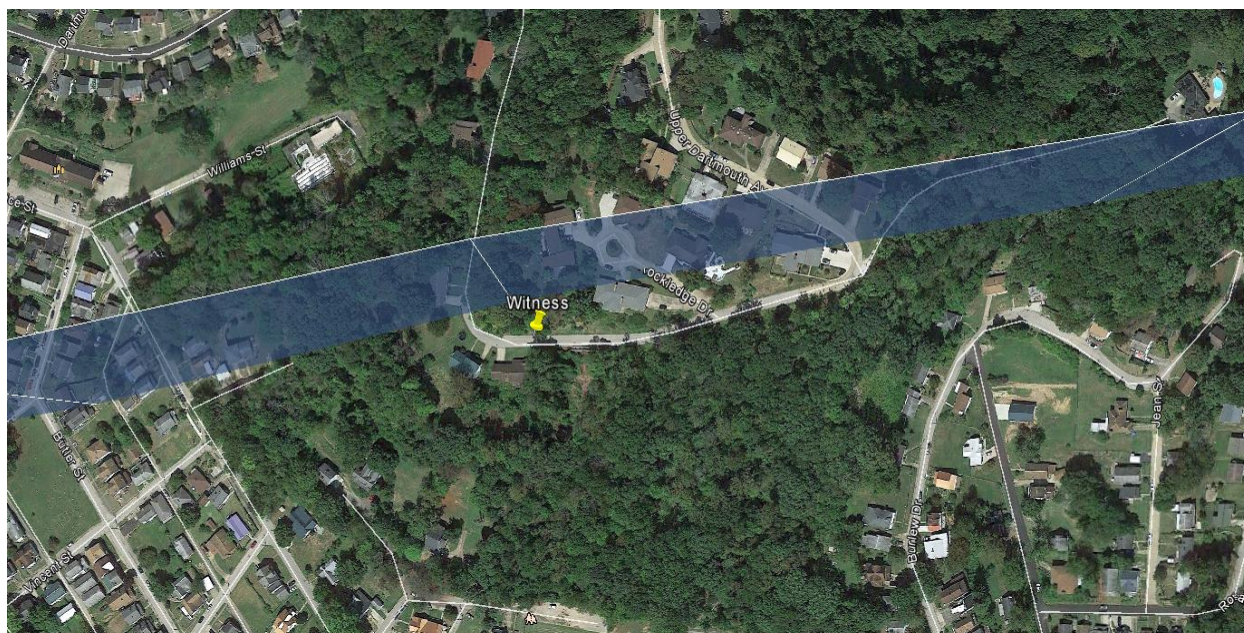
During the course of the investigation, a local attorney and pilot, was departing [driving] out of his neighborhood about 2 miles east of the approach end of runway 5 on a magnetic heading of approximately 265 degrees. As he was driving down the hill, he saw the accident airplane flying towards him on an easterly heading. He stated, "it was a beautiful sight" the airplane was "hugging" the bottom of the clouds, "just grazing the bottom of the cloud or fog deck." He stated he saw the landing lights and the shadow of the airplane perfectly as it headed towards him, then it passed directly overhead. He thought the airplane was on the VOR-Alpha approach. He stated, he realized when he got to the office that it was the accident airplane.

Photo 10. Witness location and flight track of airplane.

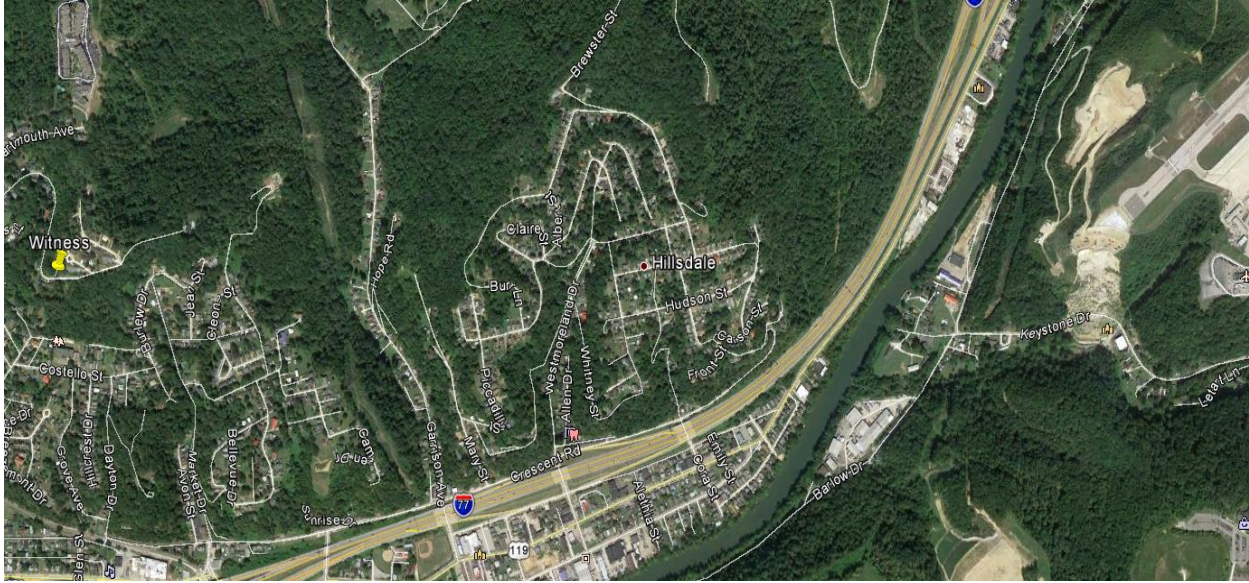
Photo 11. Witness location in relation to airport.

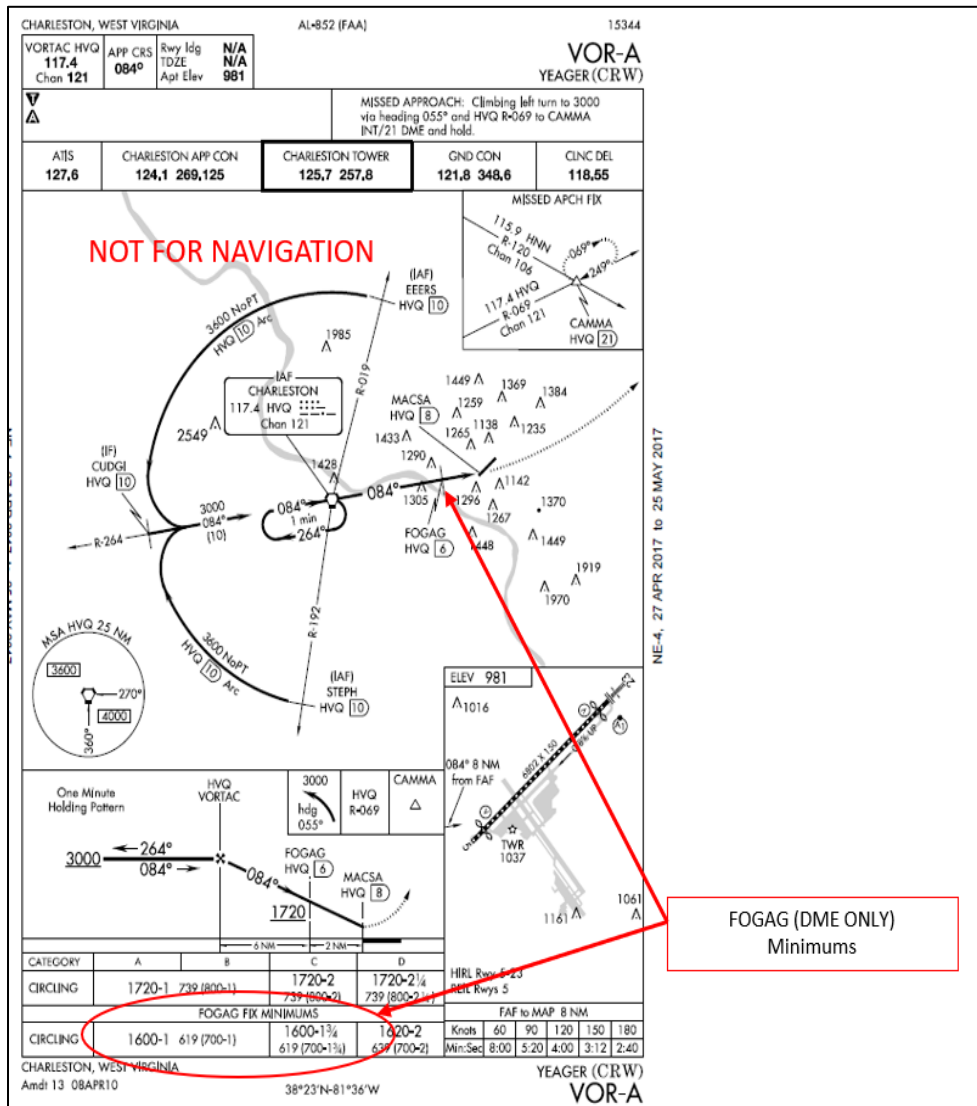
CRW was advertising the localizer runway 5 approach. ACC Flight SNC1260, herein referred to as SNC1260 requested the VOR-A approach to runway 5. The accident flight was executing the VOR-A runway 5 non-precision approach at CRW. The localizer was tuned by setting the CRW VORTAC (HVQ) channel frequency to 117.4 and setting the approach course, utilizing the HSI course selector knob to 084°

Figure 2. VOR-A approach chart and notations (red lines and circles showing FOGAG Fix and Minimums)
