NATIONAL TRANSPORTATION SAFETY BOARD

Group Chairman's Factual Report

OPERATIONAL FACTORS

DCA13MA081

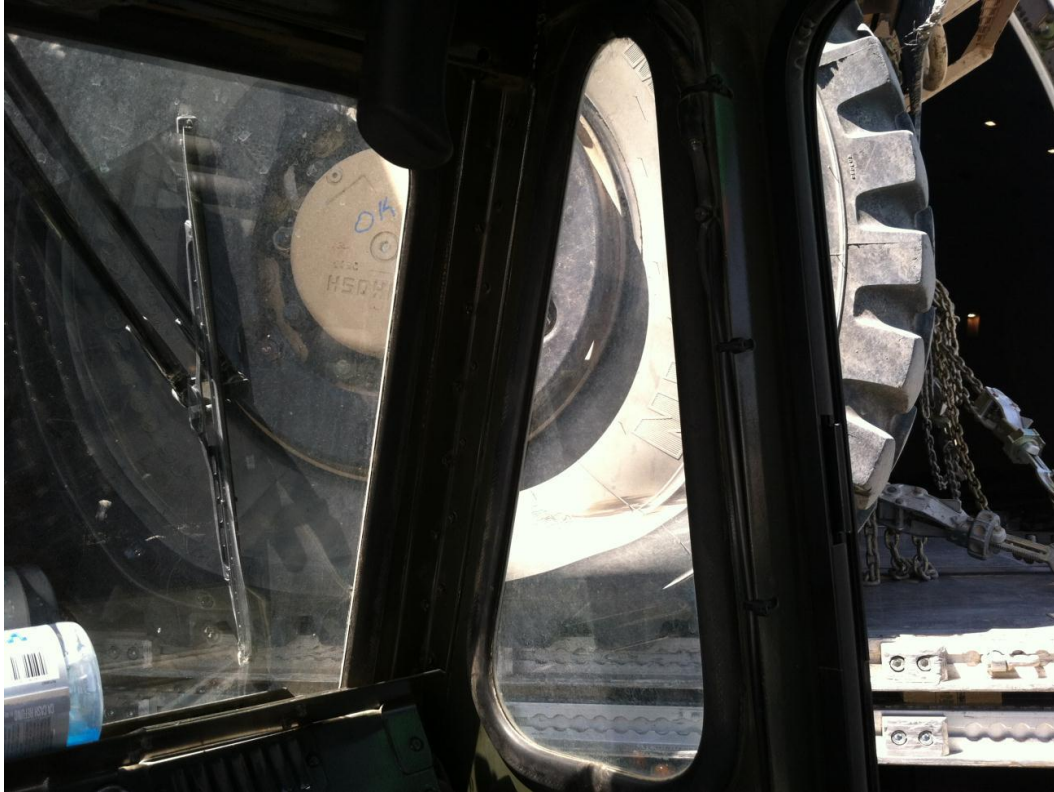
Photo 10: Photo of Camp Bastion loading provided to the NTSB by A1C Sarah Lipfird, USAF, taken April 29, 2013.

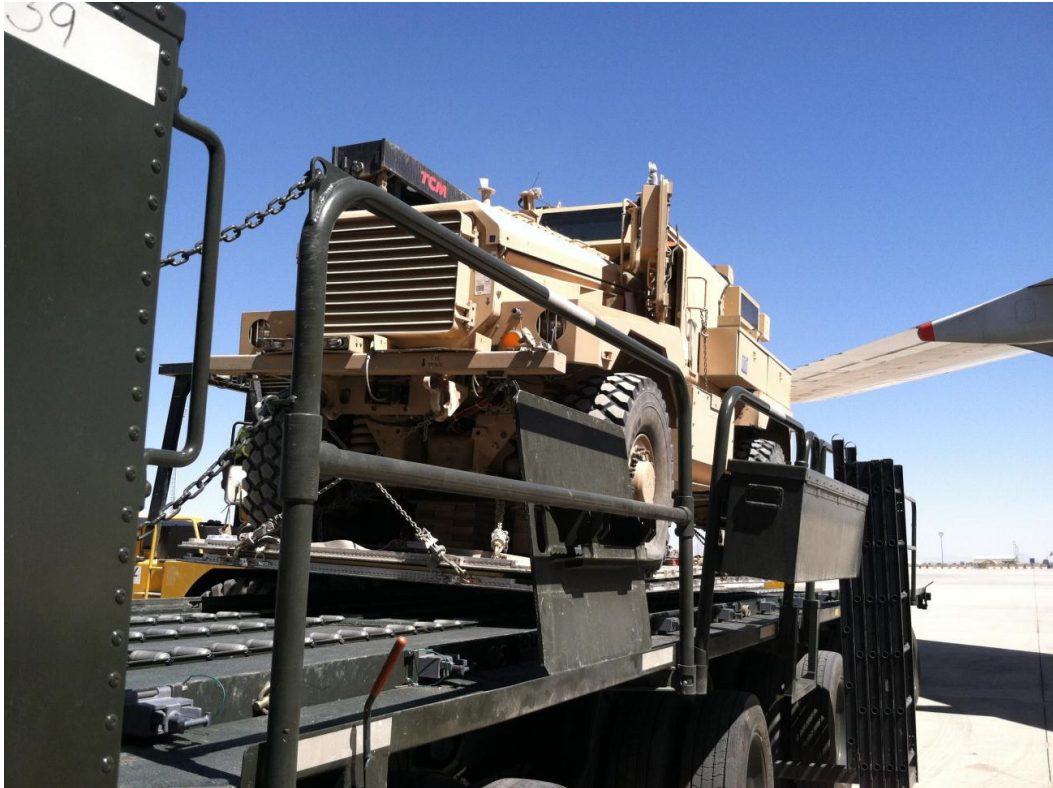
Photo 11: Photo of Camp Bastion loading provided to the NTSB by A1C Sarah Lipfird, USAF, taken April 29, 2013.

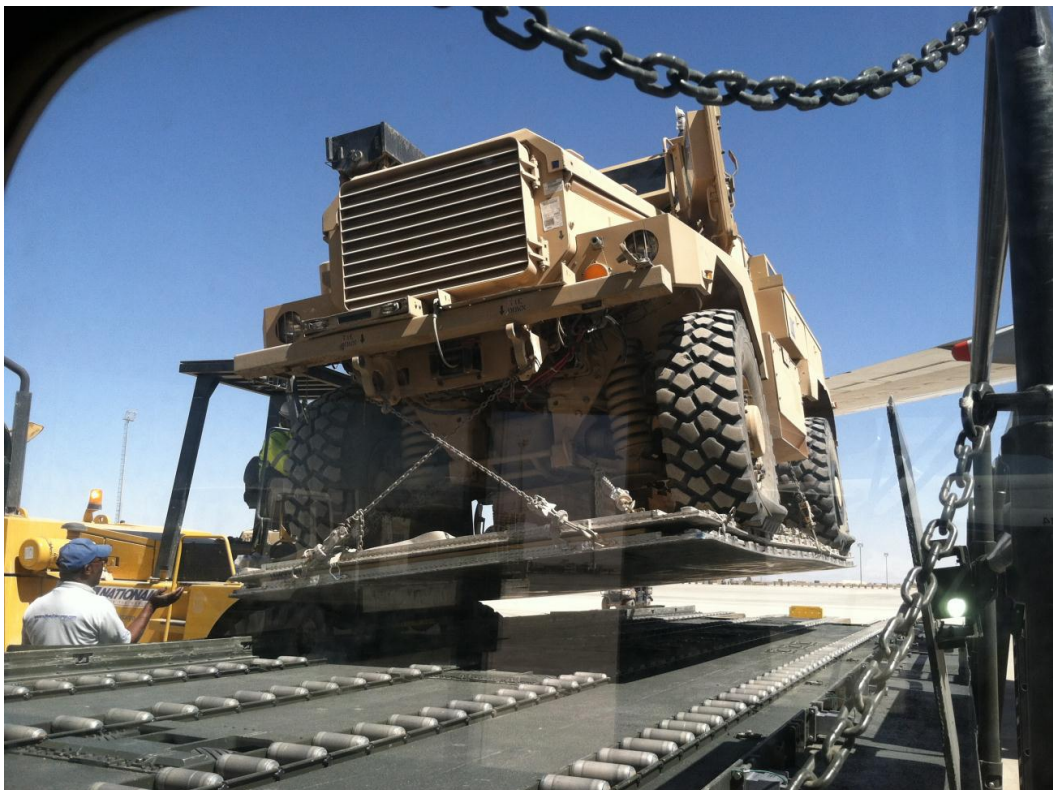
Photo 12: Photo of Camp Bastion loading provided to the NTSB by A1C Sarah Lipfird, USAF, taken April 29, 2013.

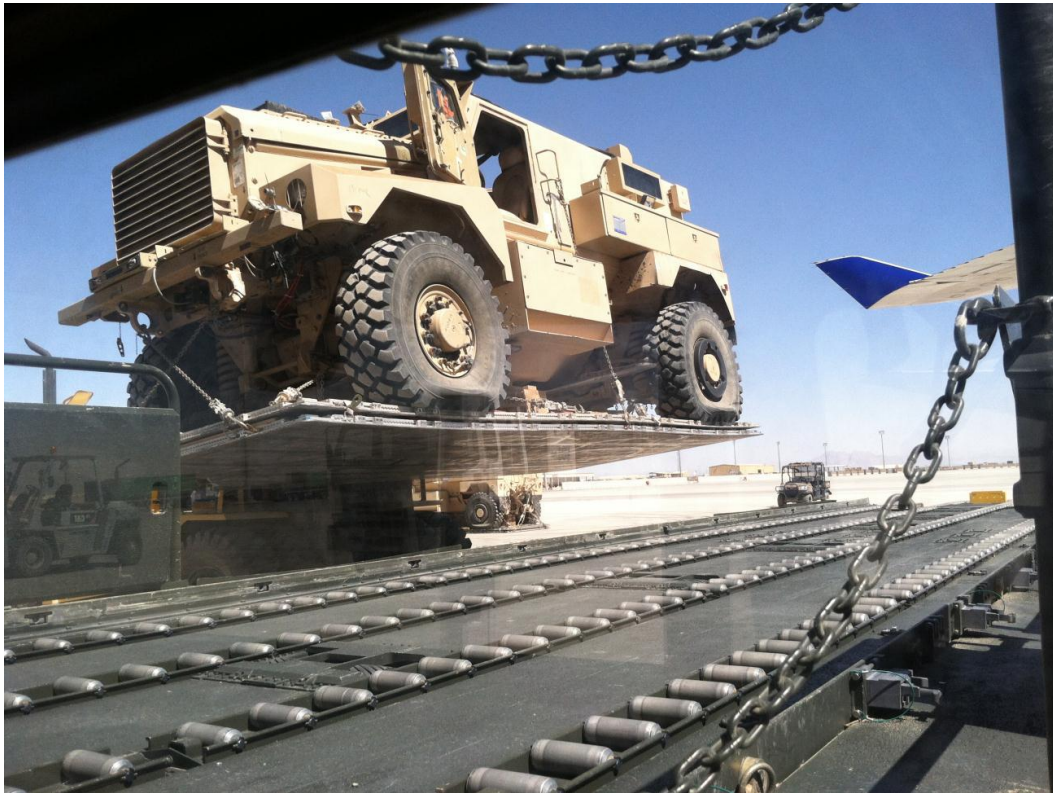
Photo 13: Photo of Camp Bastion loading provided to the NTSB by A1C Sarah Lipfird, USAF, taken April 29, 2013.

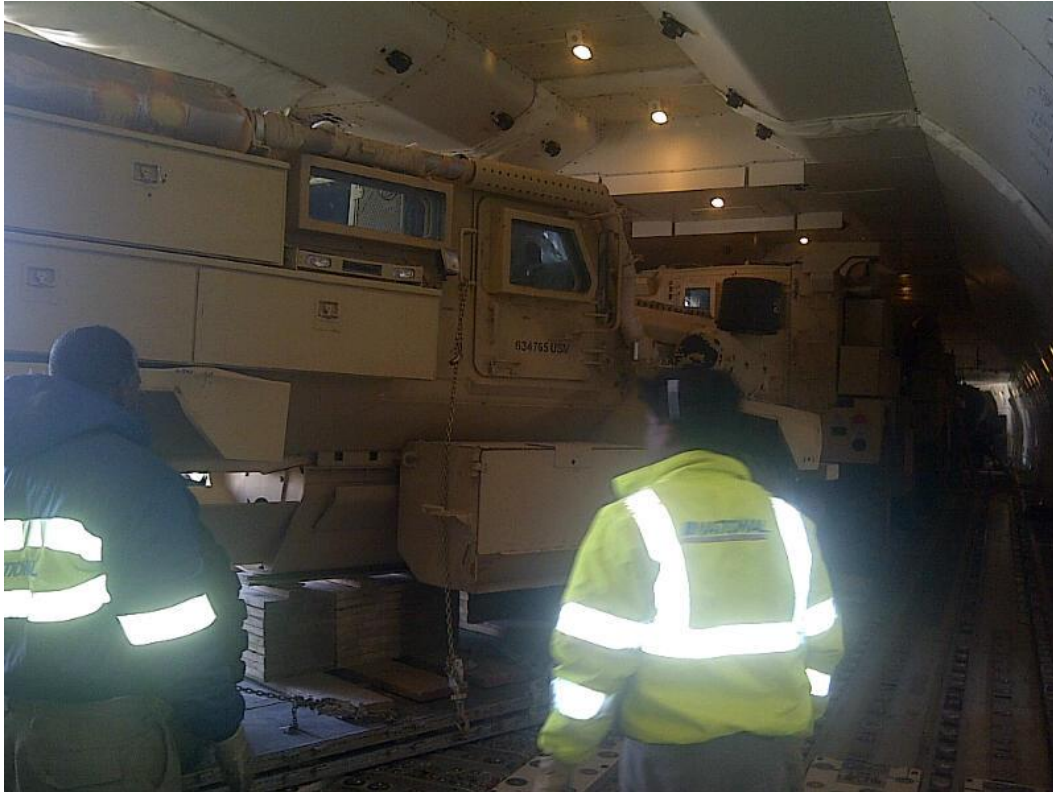
Photo 14: Photo provided to the NTSB by National Air Cargo, depicting the accident load in Camp Bastion on April 29, 2013.

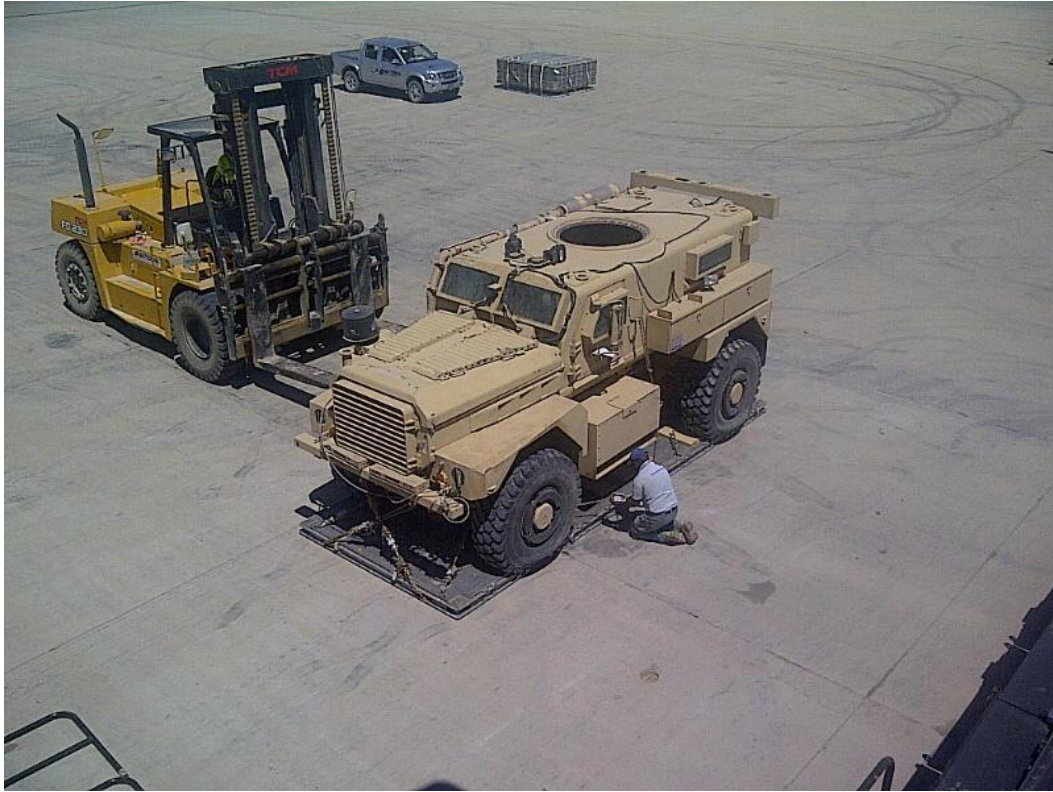
Photo 15: Photo provided to the NTSB by National Air Cargo, depicting the accident load in Camp Bastion on April 29, 2013.

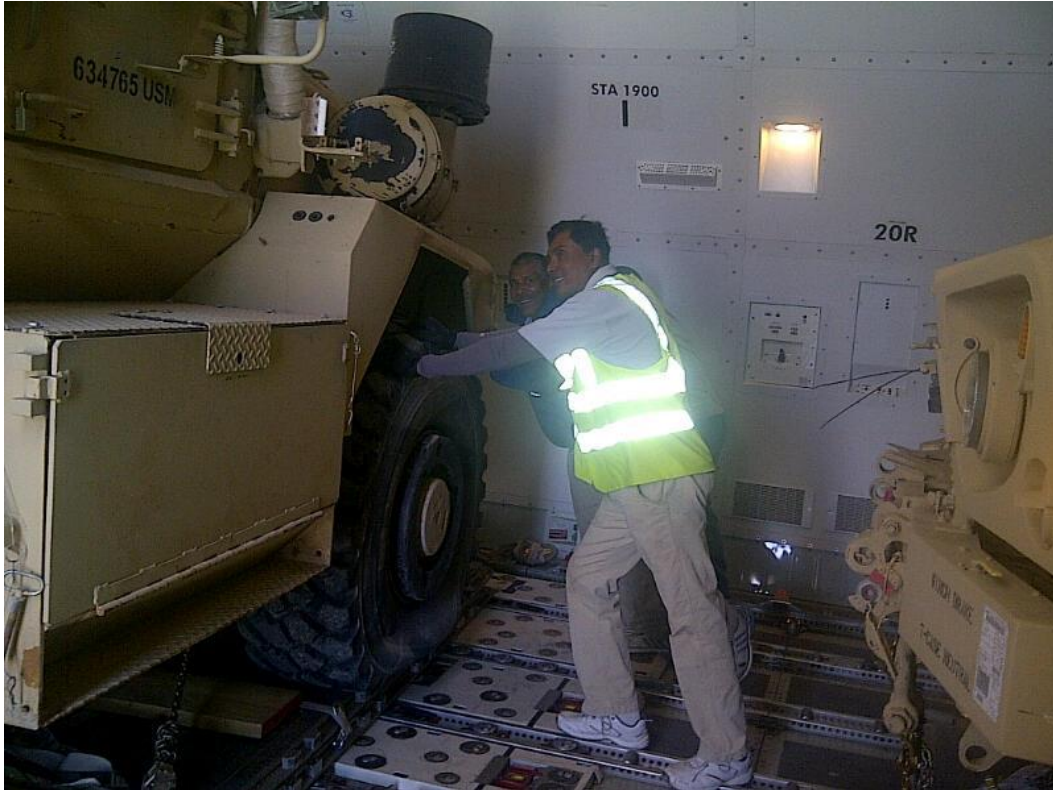
Photo 16: Photo provided to the NTSB by National Air Cargo, depicting the accident load in Camp Bastion on April 29, 2013.

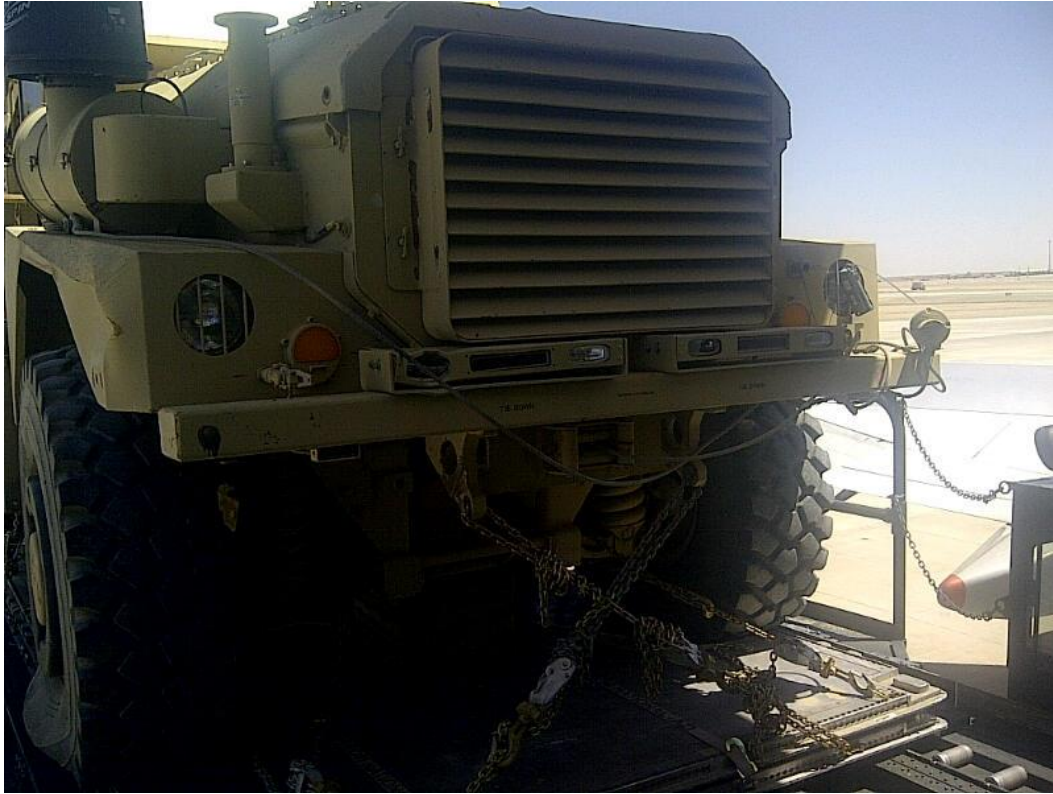
Photo 17: Photo provided to the NTSB by National Air Cargo, depicting the accident load in Camp Bastion on April 29, 2013.

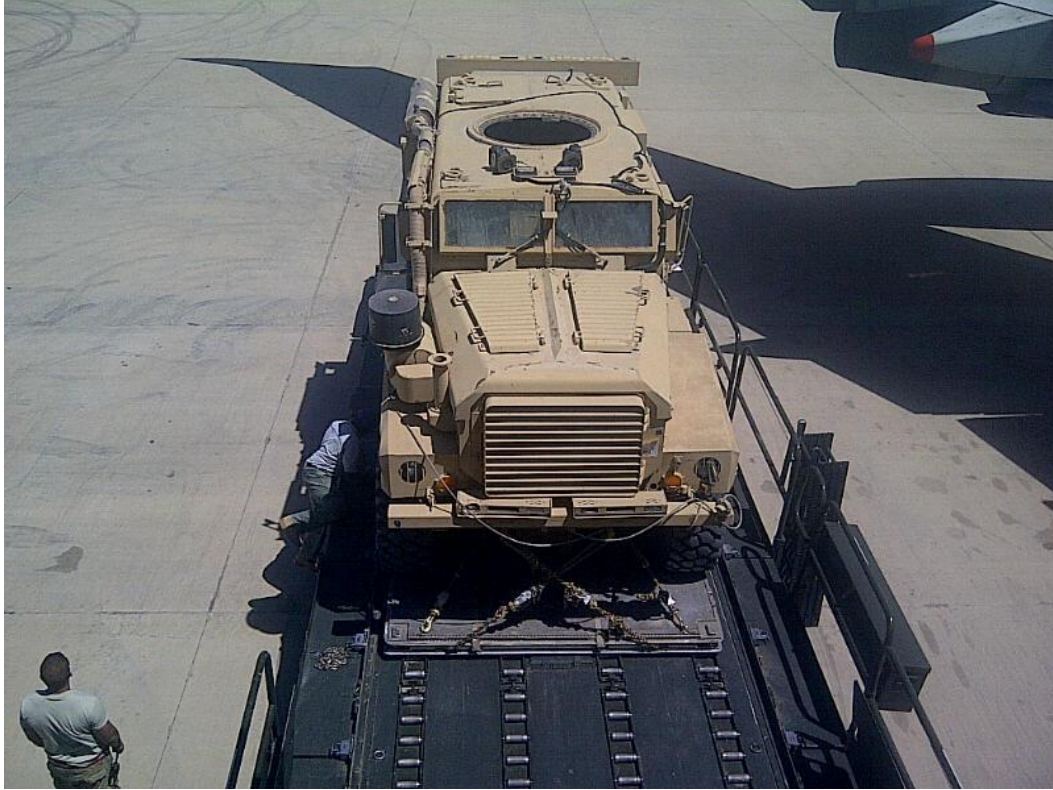
Photo 18: Photo provided to the NTSB by National Air Cargo, depicting the accident load in Camp Bastion on April 29, 2013.

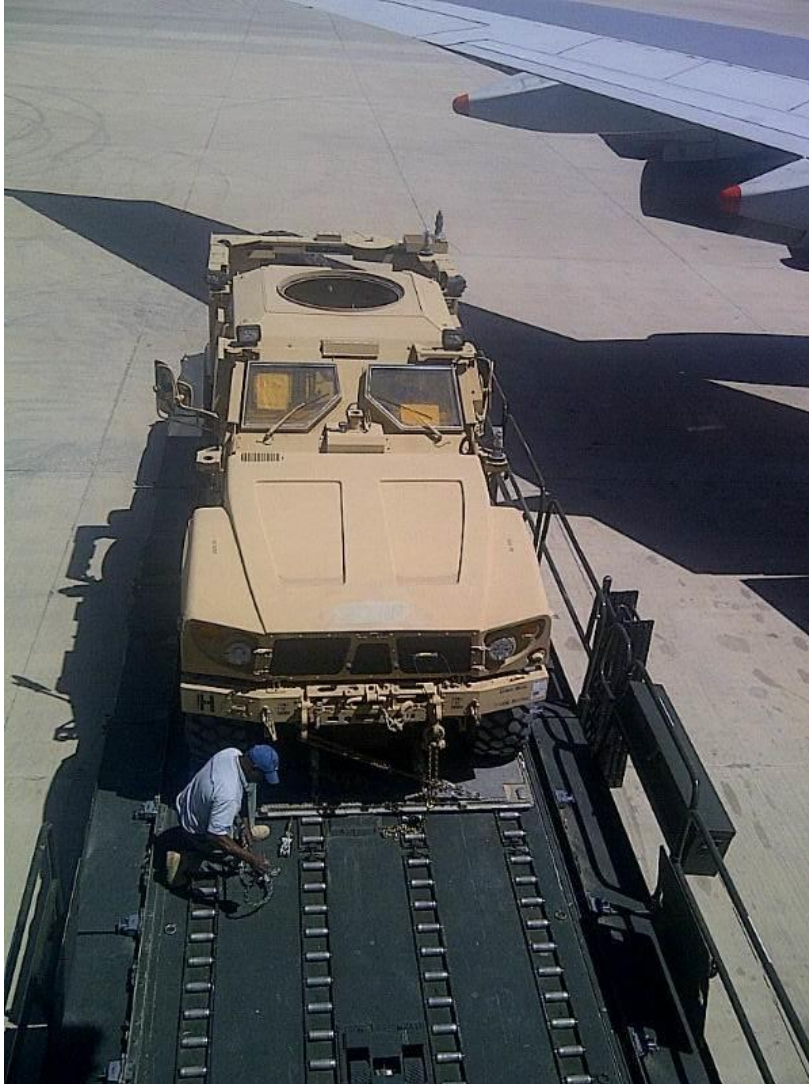
Photo 19: Photo provided to the NTSB by National Air Cargo, depicting the accident load in Camp Bastion on April 29, 2013.
