NATIONAL TRANSPORTATION SAFETY BOARD

Group Chairman's Factual Report

OPERATIONAL FACTORS

DCA14MA081

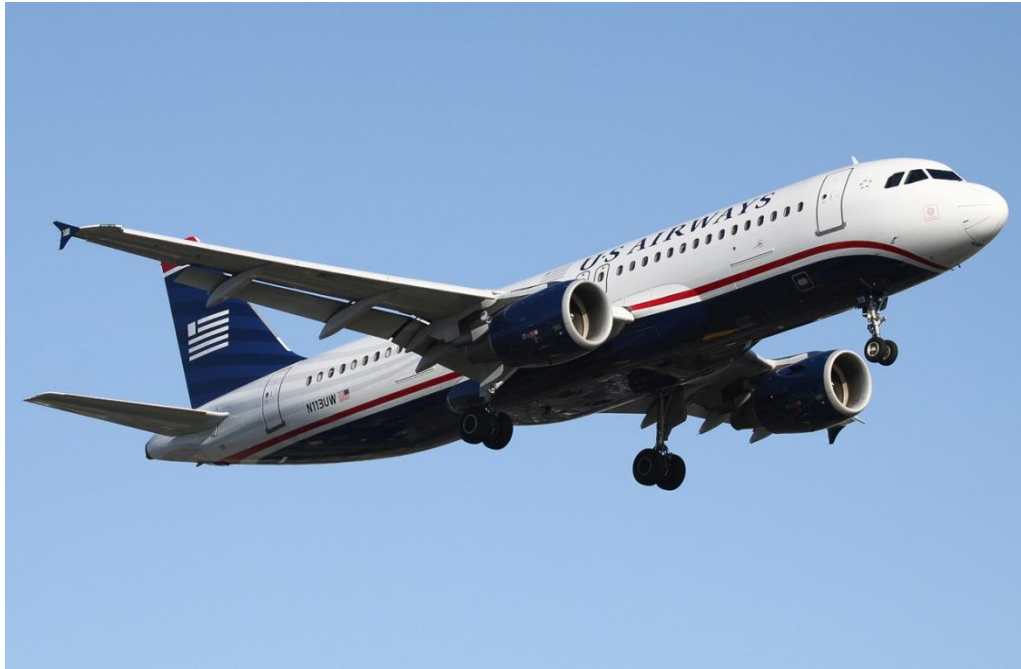
Photo 1: Accident Aircraft N113UW.

The accident airplane was an Airbus A320-214 (Registration N113UW), Serial number 1141, and was manufactured in 1999. The registered owner was USAirways, Inc., and it held a transport category airworthiness certificate dated February 4, 2000. The airplane had a maximum ramp weight of 170,635 pounds, and had a total passenger seating capacity of 150, plus 4 flight crew seats, 5 cabin crew seats, and 150 passenger seats. At the time of the accident, it had a total of 44,230 airframe hours, and the last recorded inspection occurred on March 3, 2014. A review of NTSB and FAA records found that the accident airplane had not been involved in any previous serious incidents that merited a formal investigation or accidents.³³

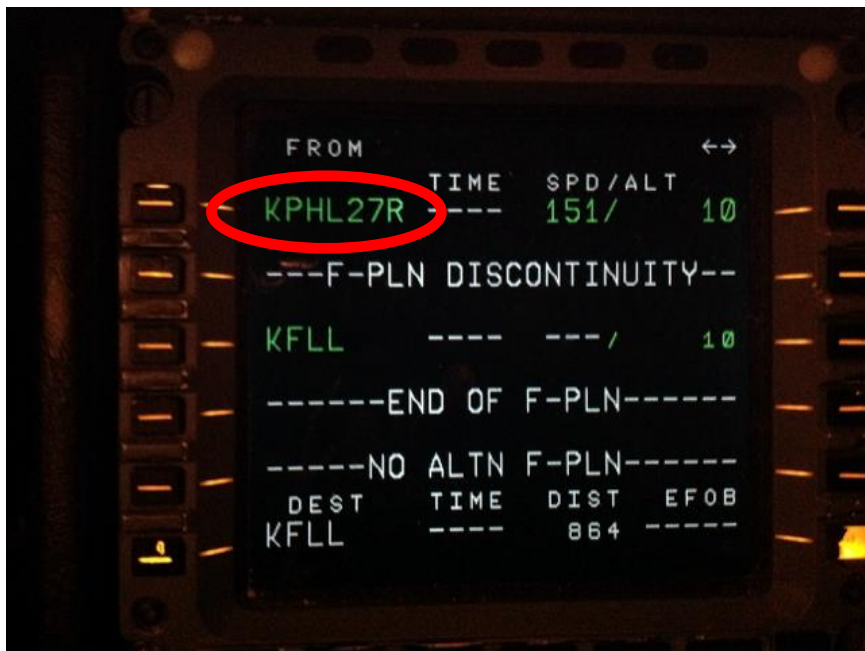
On March 26, 2014, the Operations Group conducted simulator testing in an A320 simulator at the USAirways training facility in Charlotte, NC.⁹⁵ Investigators entered 27R at PHL into the flight plan to document the visual cues available to the pilots during the route verification.⁹⁶ Upon entry of 27R into the flight plan, the MCDU flight plan page showed 27R at the 1L (first left) position (see Photo 2).

Photo 2: MCDU with PHL runway 27R (indicated) inserted in the flight plan page.⁹⁷

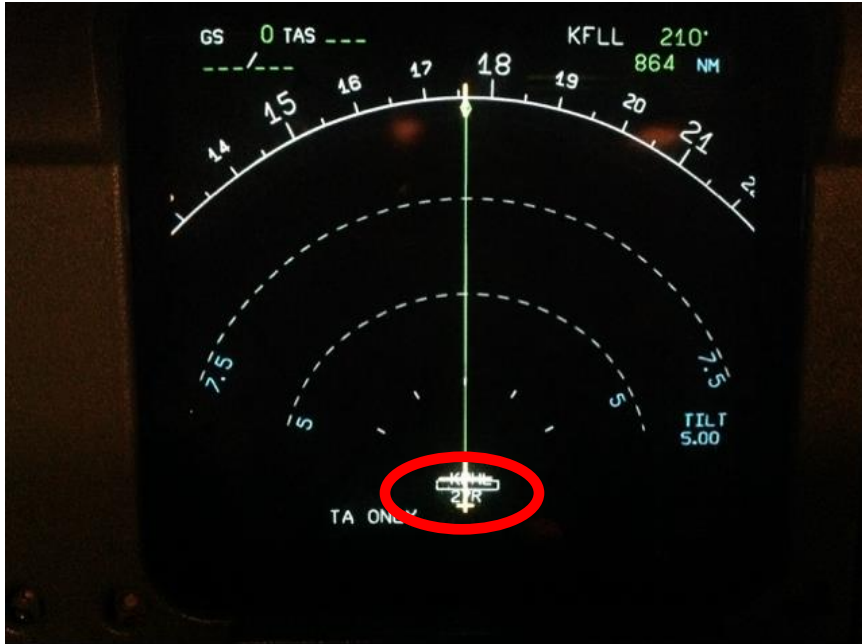
In addition, runway 27R was visible on the ND (see photo 3).

Photo 3: A320 ND Display with runway 27R (indicated) in flight plan indicated.⁹⁸

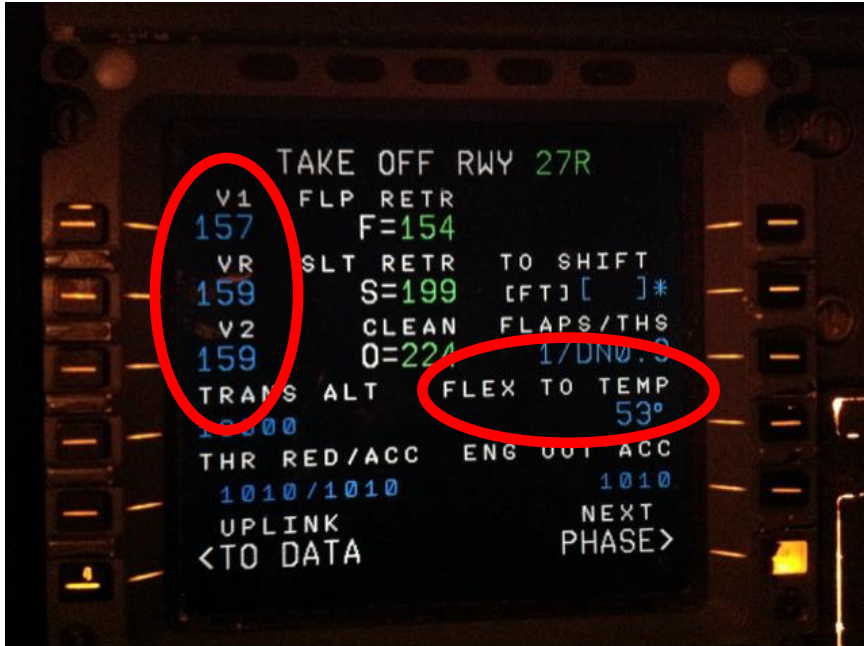
During the March 26, 2014 simulator testing in an A320 simulator at the USAirways training facility in Charlotte, North Carolina, NTSB staff entered the takeoff data and FLEX temperature (53°C) into the FMS with runway 27R inserted in the flight plan, as indicated from crew interviews, and the speeds and FLEX temperature were visible on the MCDU Takeoff page (see Photo 4).

Photo 4: MCDU Takeoff page with V-speeds (indicated) and FLEX temperature (indicated) inserted for PHL runway 27R.¹¹¹
