NATIONAL TRANSPORTATION SAFETY BOARD

Group Chairmen's Factual Report

OPERATIONAL FACTORS/HUMAN PERFORMANCE

ANC15MA041

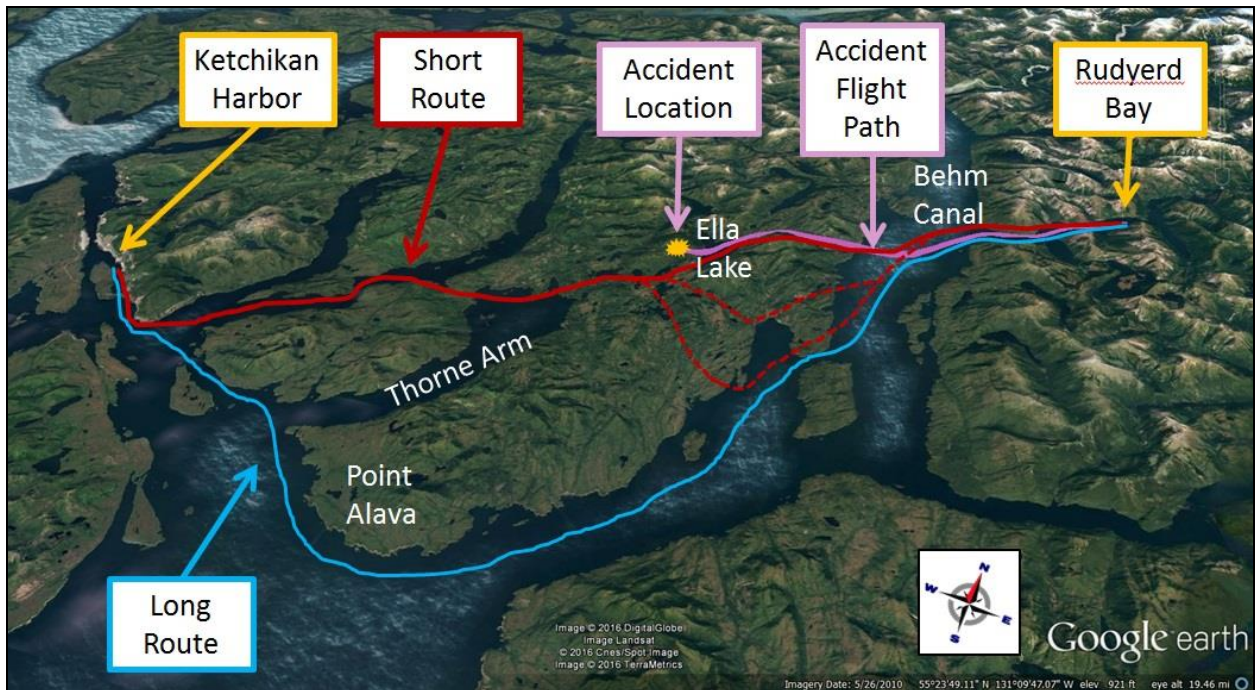
Promech pilots normally used two major routes to fly between Rudyerd Bay and Ketchikan (See Figure 2). Pilots flying the "short route" normally exited Rudyerd Bay at Point Louise, crossed Behm Canal, proceeded overland through Ella Narrows, then flew southwest across Ella Lake, transited Gokachin Lakes, crossed Thorne Arm and Carrol Inlet, rounded Mountain Point, and proceeded up Tongass Narrows to Ketchikan. Common variations on this route involved flying through one of two other areas of low terrain south of Ella Lake. One of these areas was known as "Muskeg" and the other was known as "Sea Level." Another route, known as the "long route," also exited Rudyerd Bay at Point Louise but continued south down Behm Canal around

Figure 2. Promech’s two major routes between Ketchikan and Misty Fjords: The “short route” (in red) and the “long route” (in blue).

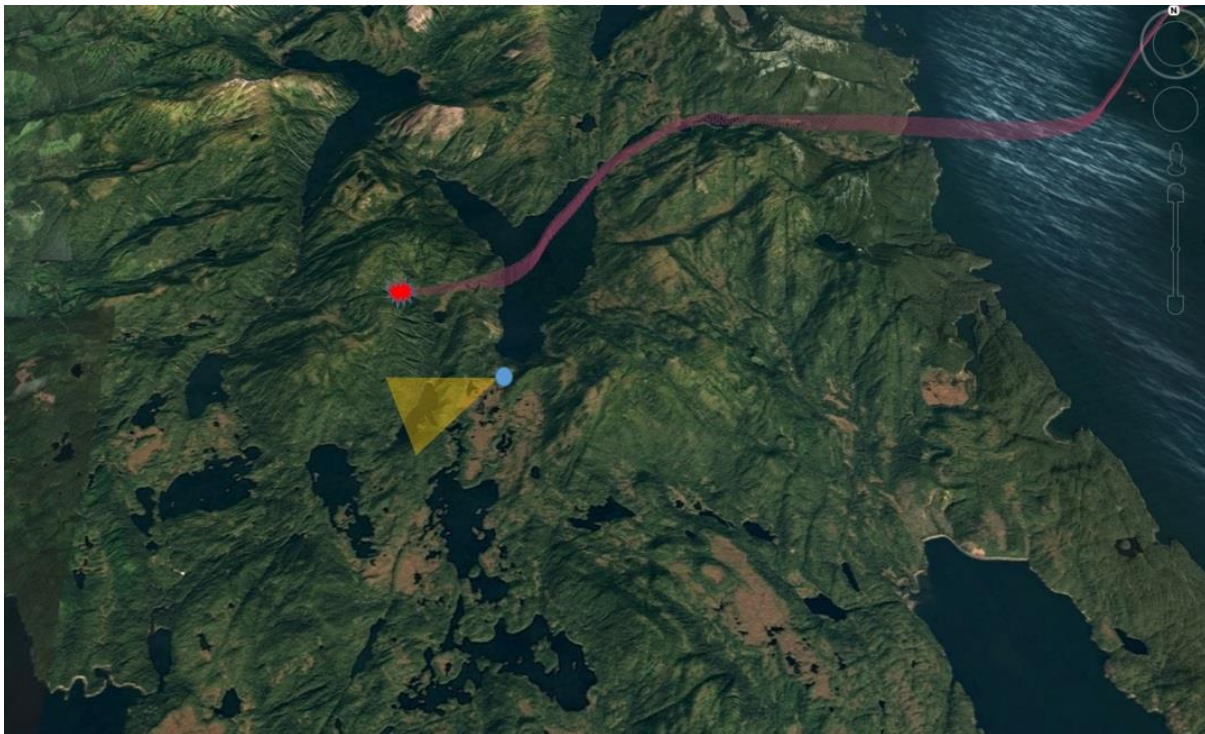
Conditions encountered by the first Promech pilot about ½ nautical mile south of Ella Lake were documented in two passenger photos obtained by investigators (one of which is shown in figure 6). These photos show a southwesterly view (see figure 7). The most distant visible landmarks are about 1.5 nautical miles away. These photos indicate that the first Promech airplane transited the area south of Ella Lake about 900 to 1,000 feet msl over terrain that is at least 600 feet in elevation. The southeastern face of a large mountain is visible in the photo. It is completely obscured by clouds above about 1,000 feet msl, with scattered clouds hanging down the mountainsides to lower elevations. This is the same mountain that was subsequently impacted by the accident airplane about 1.3 nautical miles north of the area shown in this photo. The Seawind Aviation DCH-2 referenced in the previous section of this report is visible in the upper right-hand corner of this photo.

Figure 7. Approximate vantage point (blue circle) and field of view (yellow triangle) of the photos shown in Figures 5 and 6, relative to the accident flight path (pink) and accident location (red).
