INVESTIGATION OF SWIVEL ASSEMBLY FAILURE, P/N 7438-4, S/N 0748

ATS JOB # D166449 Rev. 1*

Investigation of Swivel Assembly Failure, P/N 7438-4, S/N 0748 removed from A/C 5305

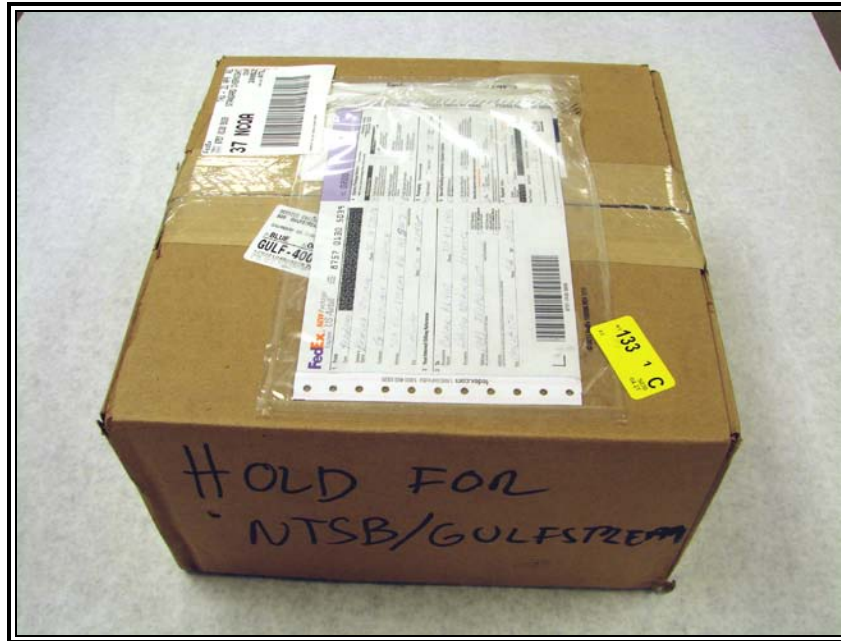
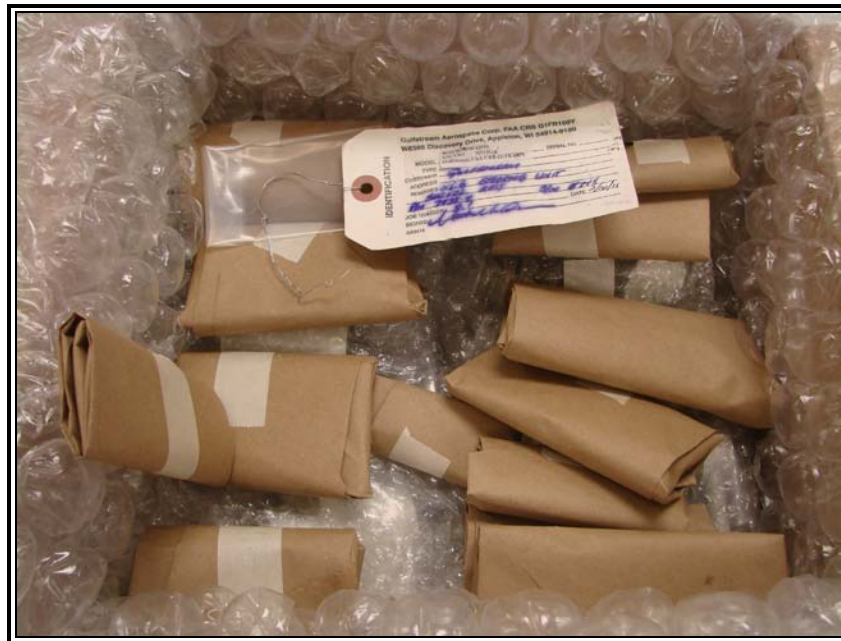
A sealed box (Figure 1) containing the sample was opened under supervision of the attendees. The samples were documented in the as-received condition (Figures 2 and 3). The spool and housing samples, the t-seals and backing rings that were removed from the center spool, and the vials containing the residue that was removed during the disassembly of the components were submitted for analysis.

Figure 1: Photographs of the box that contained the samples

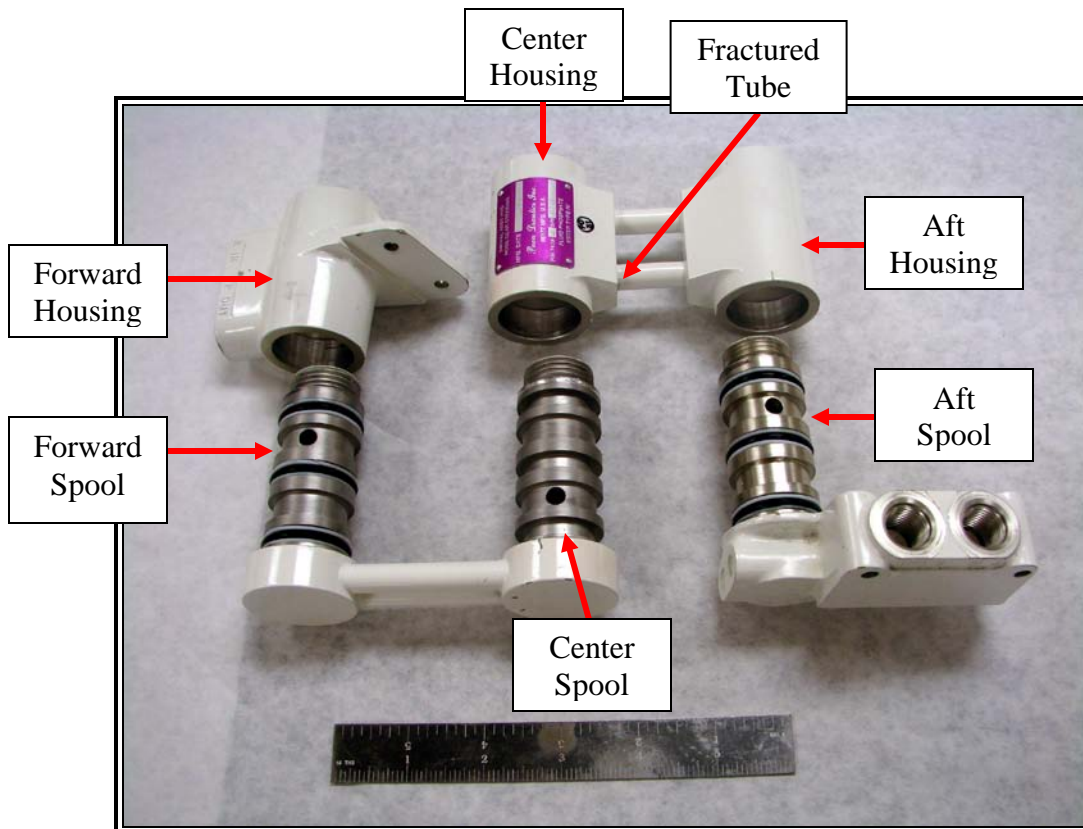
Figure 2: Photograph of the as-received components

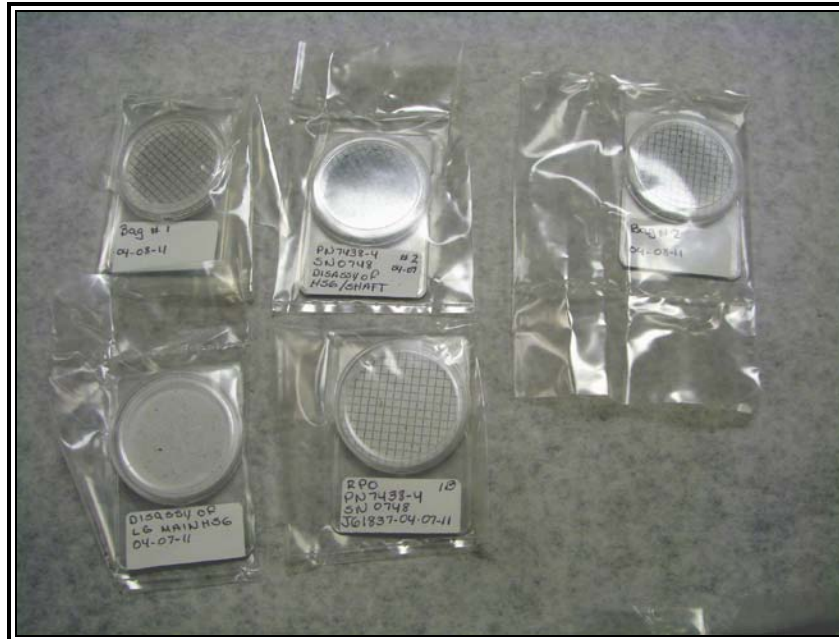
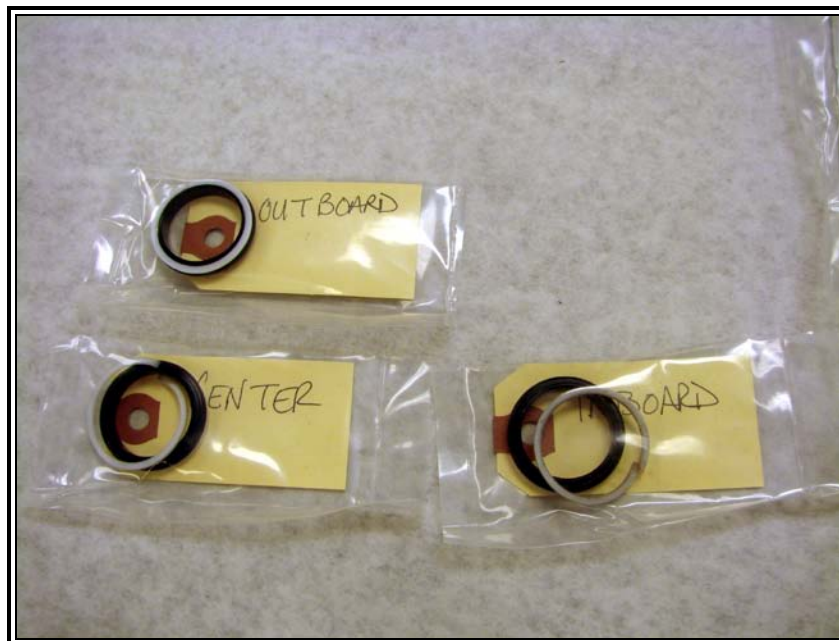
Figure 3: Photographs of the as received residue (top) and seal (bottom) samples

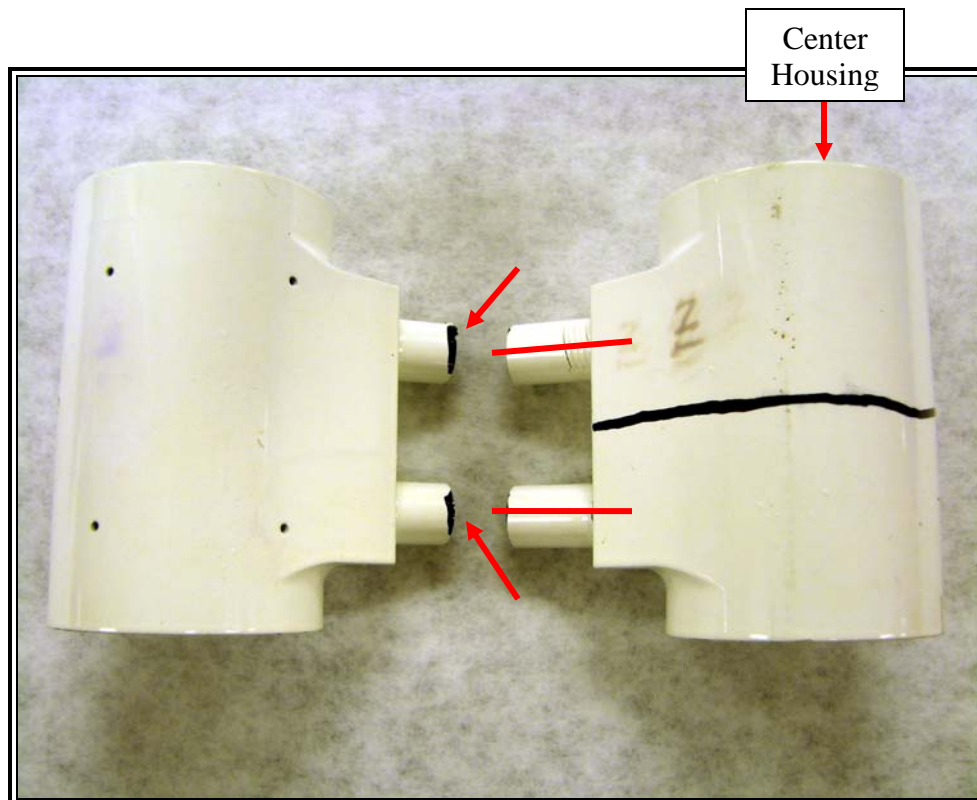
The crack on the connecting tube was opened to expose the fracture surface. In order to open the fracture surface, the center-to-aft housing assembly was sectioned as shown in Figure 8. See Figures 9 and 10 for the overall views of the fracture surface. The fracture surface exhibited a thin area of flat, shiny faceted appearance near the outer diameter around the circumference including the lab induced overload area, consistent with brittle fracture. The rest of the fracture surface was angled and exhibited a dull appearance.

Figure 8: Photograph showing sectioned locations to open the fracture surface (arrows)

Red lines indicate the sectioning locations for microstructural exam.

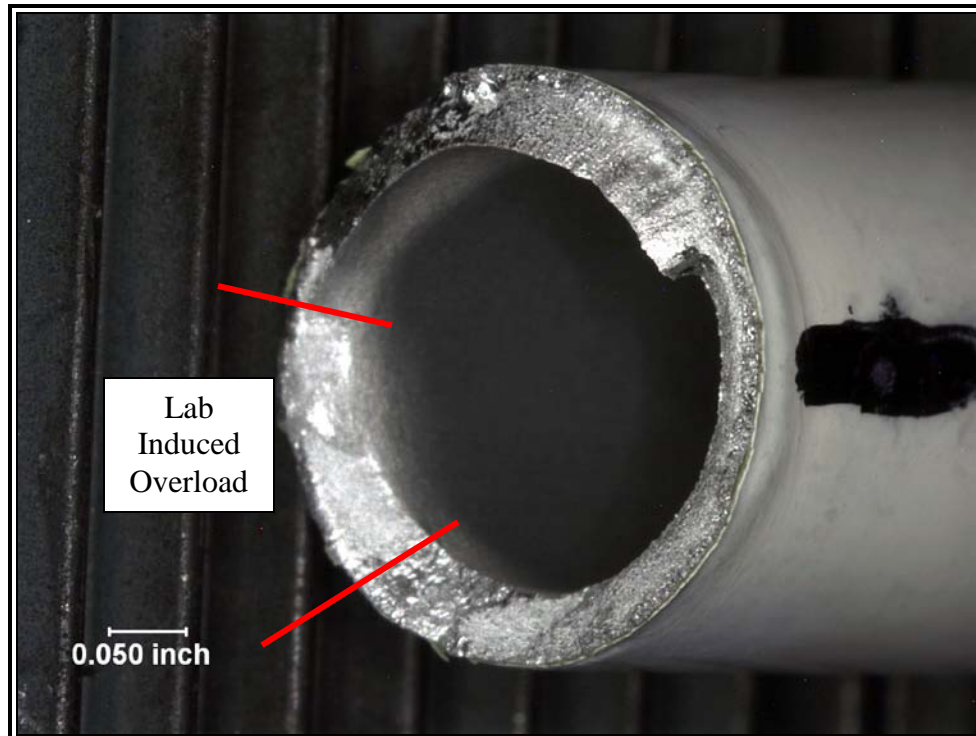
Figure 10: Photomicrograph of the tube fracture surface

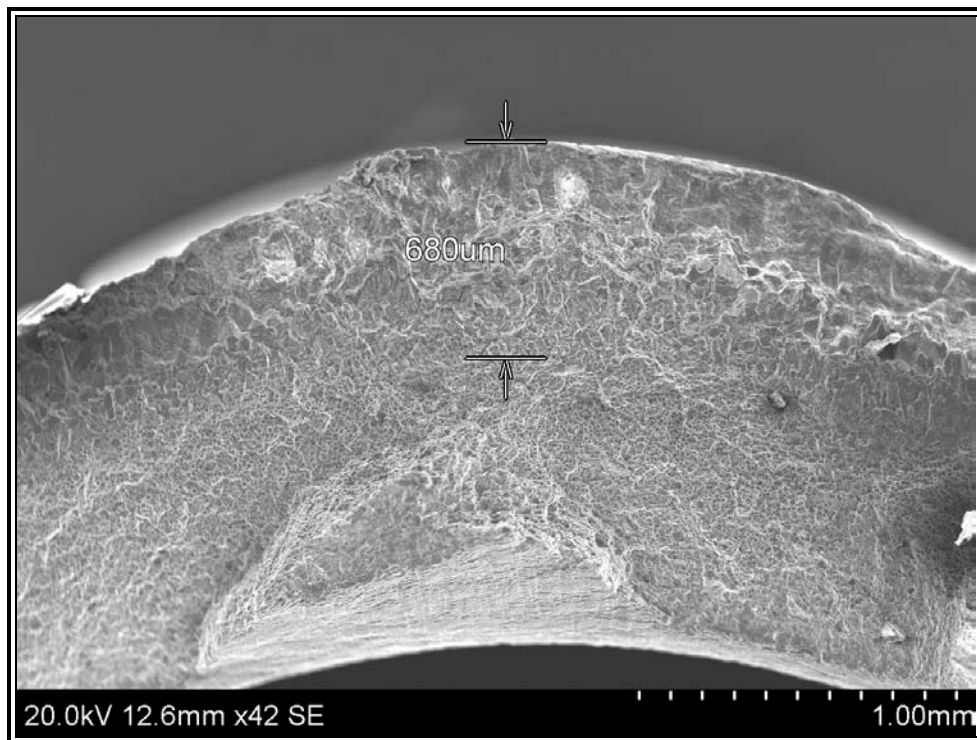
Figure 15: SEM image of the lab induced overload fracture surface showing similar features to the service fracture surface

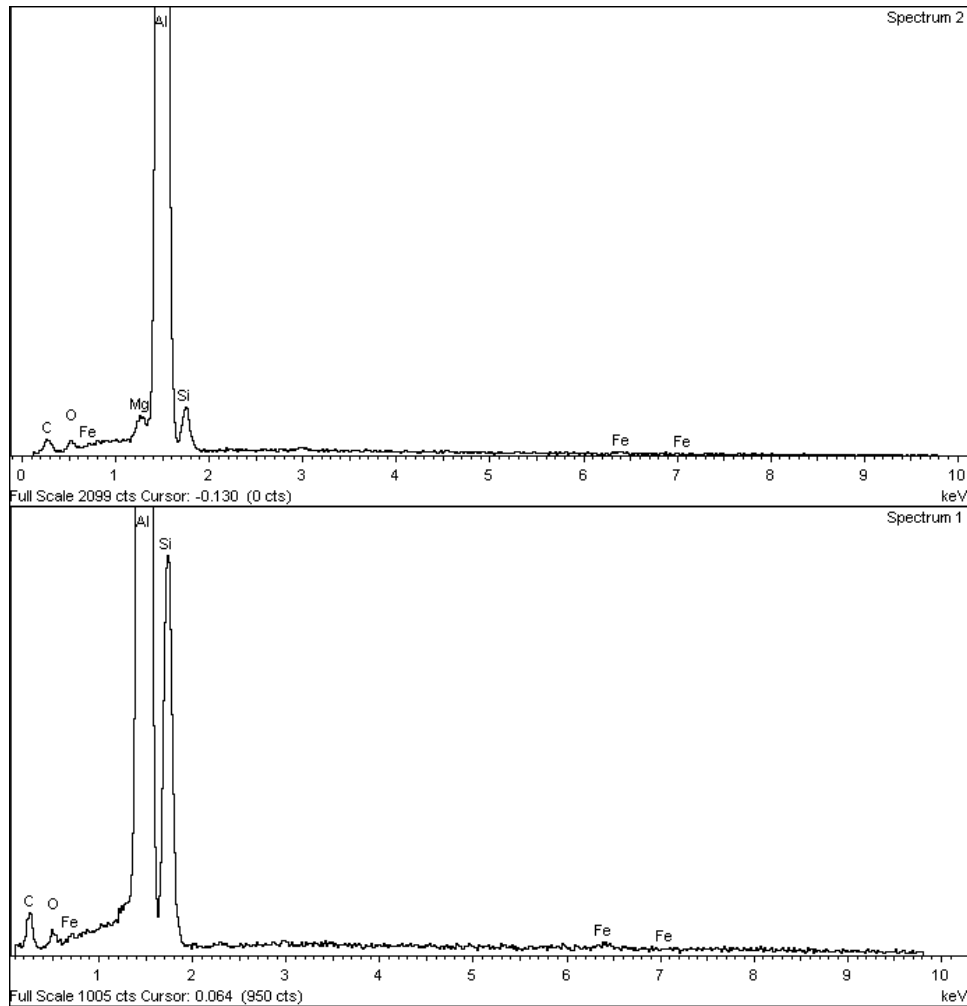
The fracture surface was chemically analyzed by energy-dispersive spectroscopy (EDS) per ASTM E1508-98 (2008), *Standard Guide for Quantitative Analysis by Energy-Dispersive Spectroscopy*. See Figure 16 for the EDS spectra. The ductile area of the fracture surface was consistent with reported 6061 aluminum alloy. The interdendritic areas near the OD surface exhibited higher concentrations of silicon, which is consistent with braze material per AMS 4185 as reported in the supplied certification.

Figure 16: EDS spectra of the ductile (top) and the interdendritic (bottom) areas of the fracture surface

The spectra indicate carbon (C), oxygen (O), iron (Fe), magnesium (Mg), aluminum (Al), and silicon (Si).

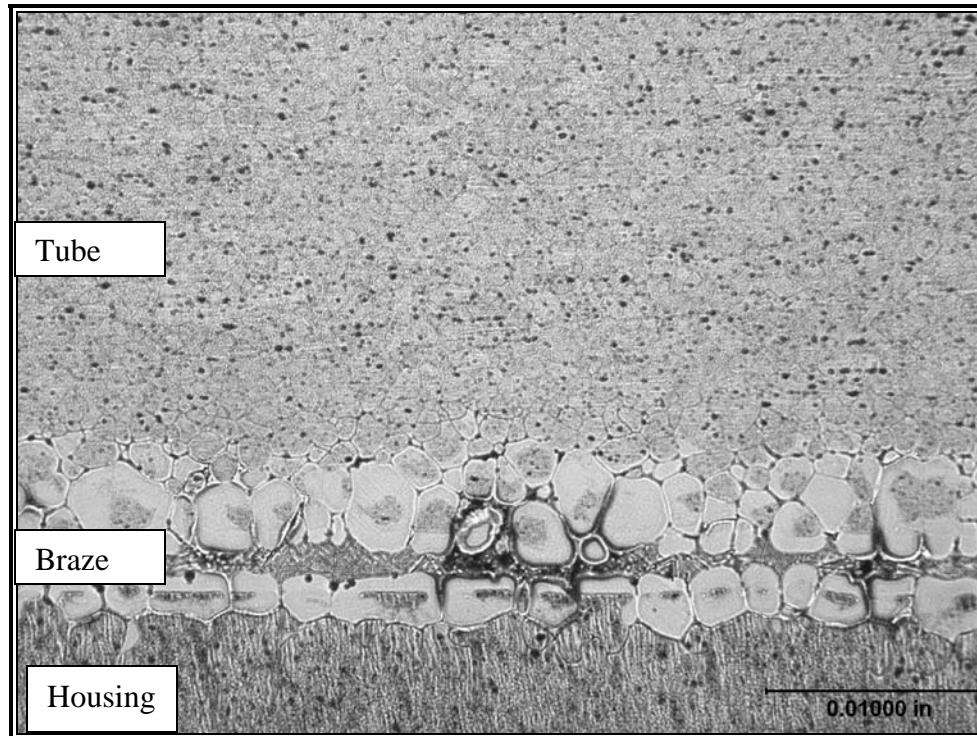
Figure 18: Photomicrograph of the failed tube sample's section showing microstructure

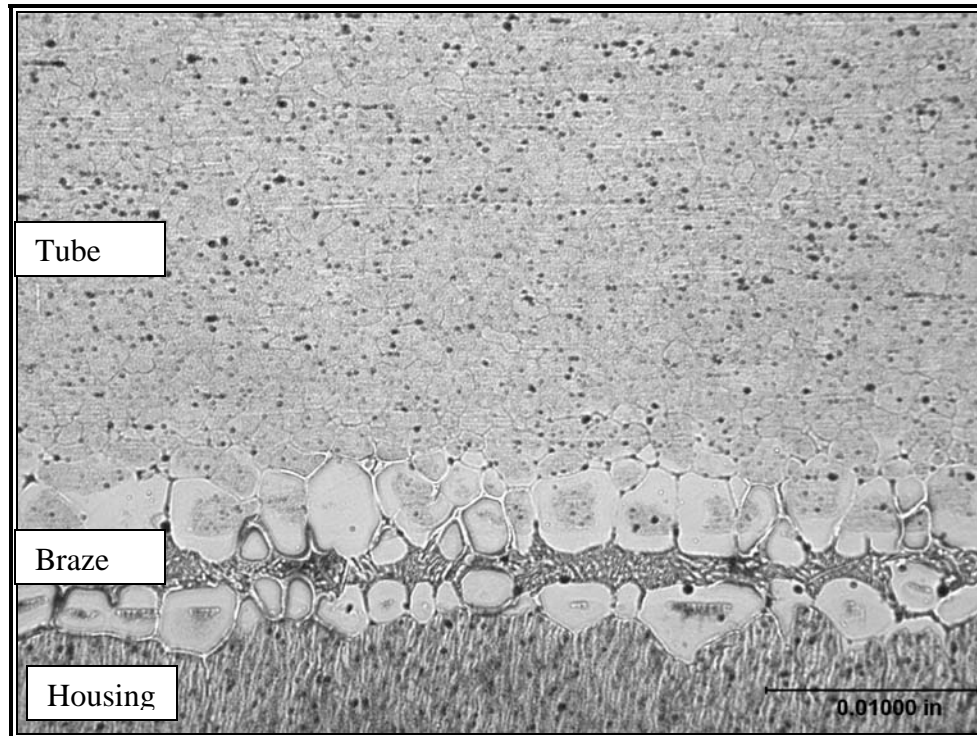
Figure 19: Photomicrograph of the intact tube sample's section showing microstructure

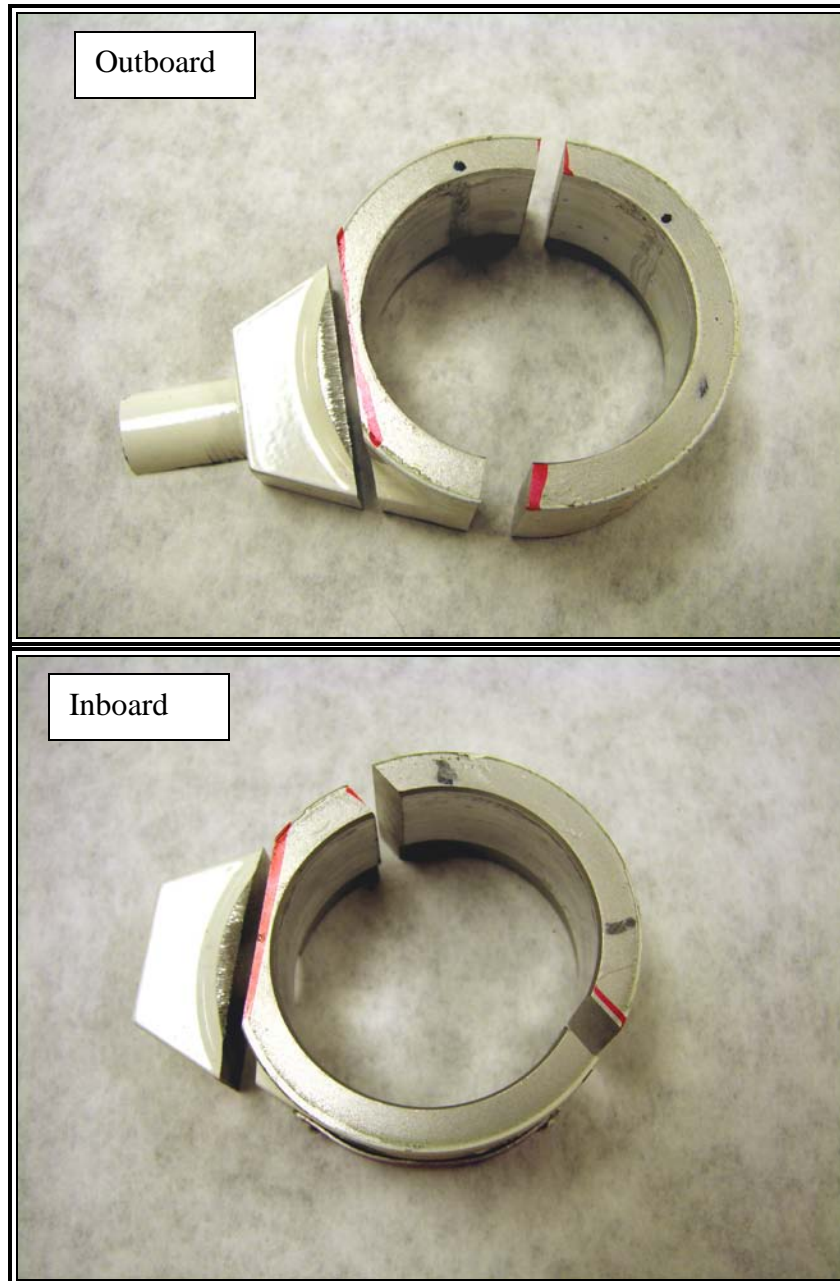
Figure 26: Photographs of the center housing sectioned for analyses

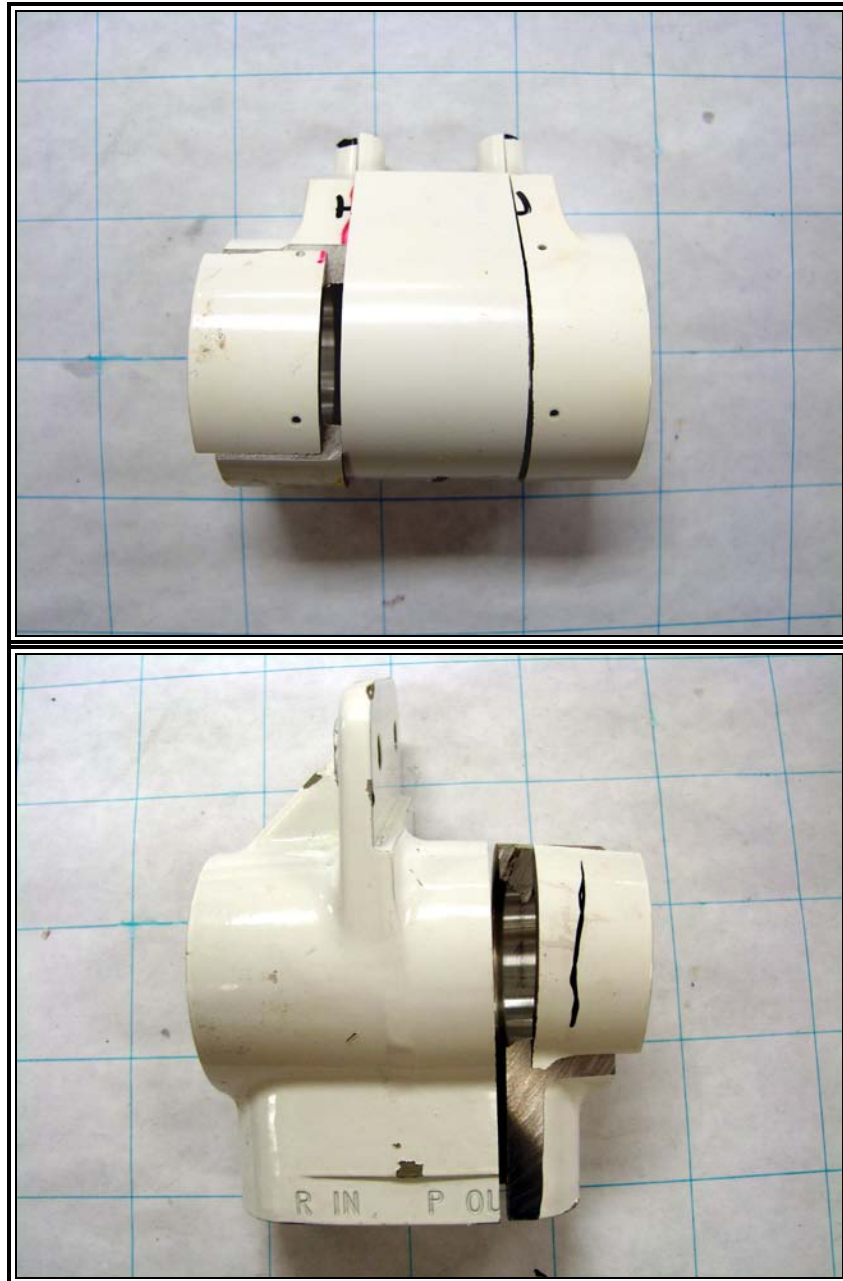
Figure 27: Photographs of the aft (top) and forward (bottom) housings sectioned for analyses

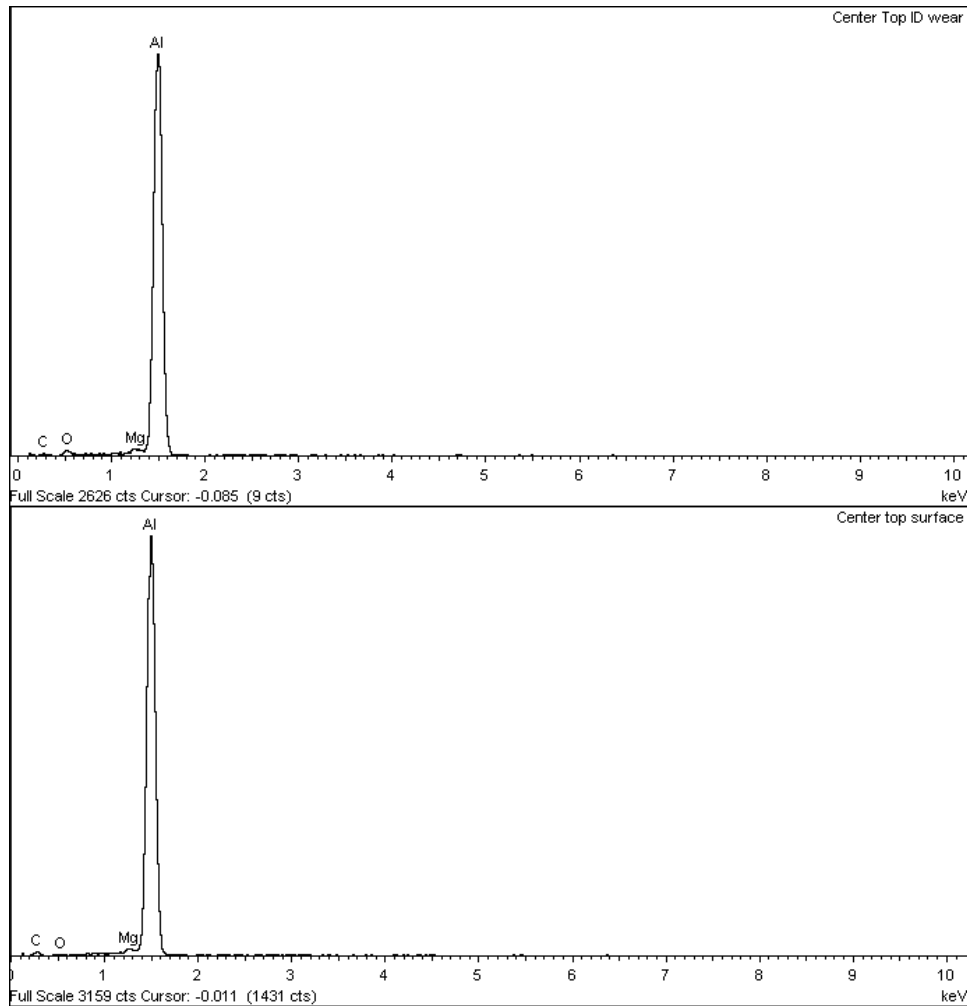
The worn and unaffected surfaces of the housing and the spool samples were chemically analyzed by EDS). See Figures 33 through 39 for the EDS spectra. No evidence of a foreign object that may have caused the damage was detected on worn areas. All samples exhibited elements that were consistent with the reported aluminum alloys. The spool samples exhibited significant levels of oxygen and sulfur, consistent with the reported anodizing process. The housing samples did not exhibit any evidence of anodizing on the undamaged surfaces adjacent to the worn areas. Only worn areas exhibited some concentrations of oxygen and sulfur, consistent with transfer of the anodizing from the spool samples at the contact points. Recessed areas of the housing samples exhibited anodizing (Figure 40).

Figure 33: EDS spectra of the center housing worn (top) and the undamaged (bottom) areas

The spectra indicate carbon (C), oxygen (O), magnesium (Mg), and aluminum (Al).

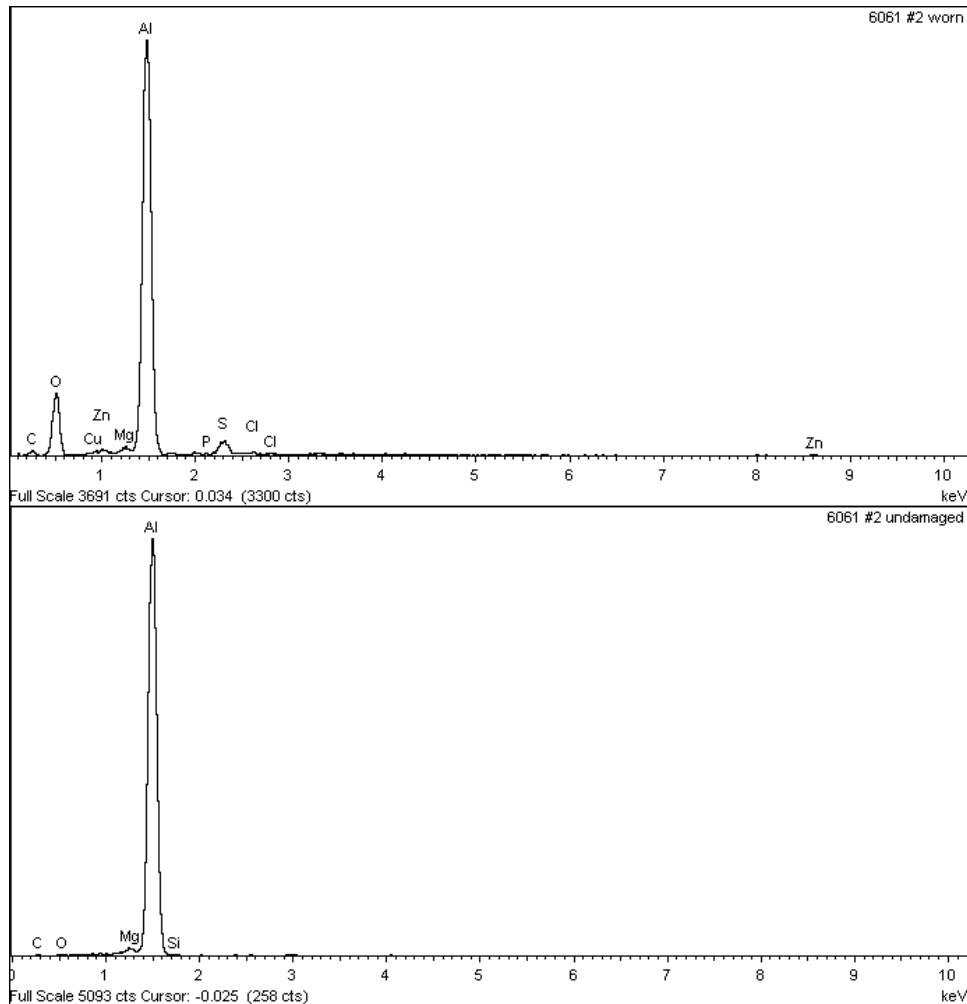
Figure 34: EDS spectra of the aft housing worn (top) and the undamaged (bottom) areas

The spectra indicate carbon (C), oxygen (O), copper (Cu), zinc (Zn), phosphorus (P), sulfur (S), chlorine (Cl), magnesium (Mg), and aluminum (Al).

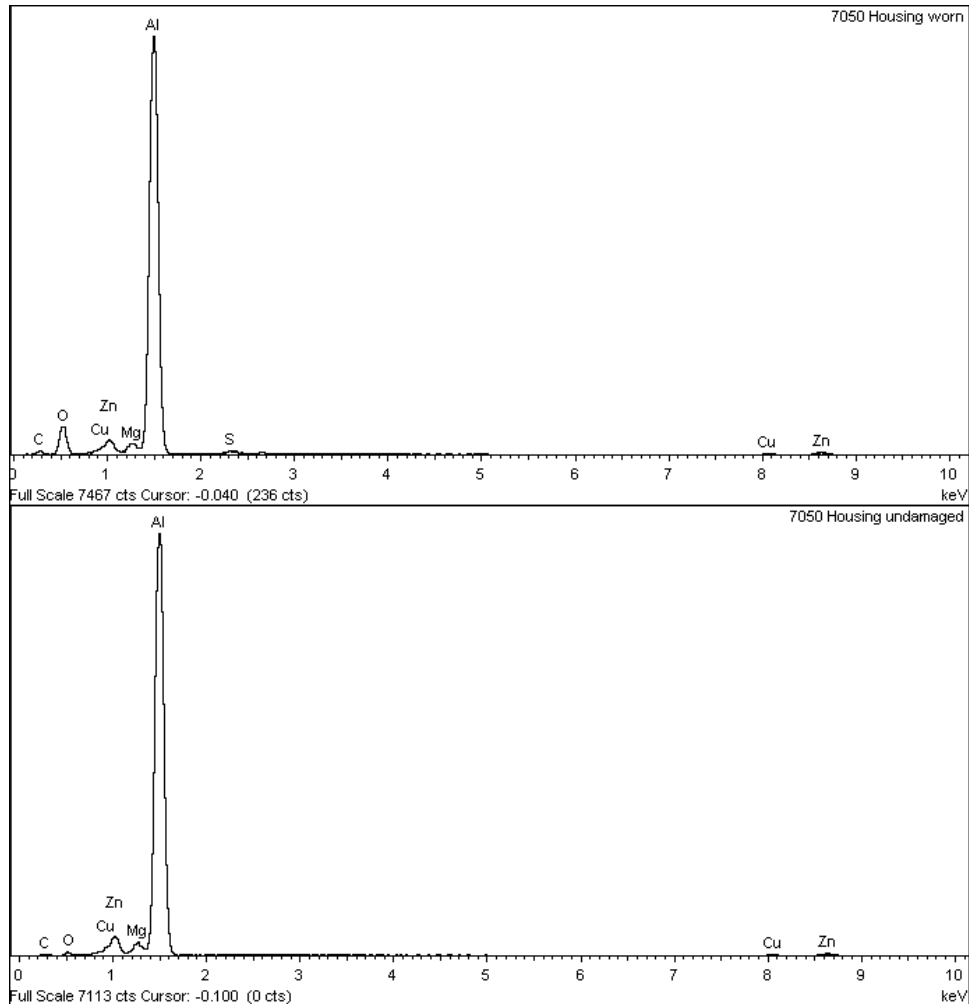
Figure 35: EDS spectra of the forward housing worn (top) and the undamaged (bottom) areas

The spectra indicate carbon (C), oxygen (O), copper (Cu), zinc (Zn), sulfur (S), magnesium (Mg), and aluminum (Al).

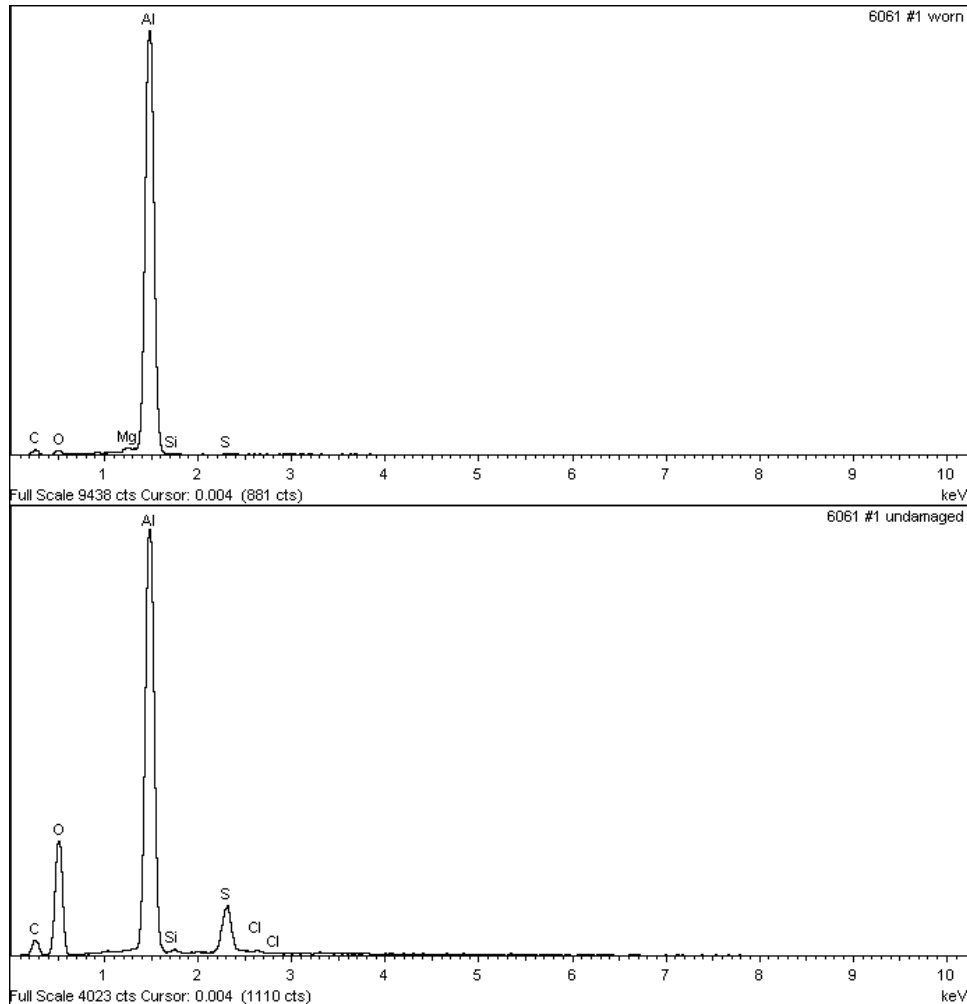
Figure 36: EDS spectra of the center spool worn (top) and the undamaged (bottom) areas

The spectra indicate carbon (C), oxygen (O), silicon (Si), sulfur (S), chlorine (Cl), magnesium (Mg), and aluminum (Al).

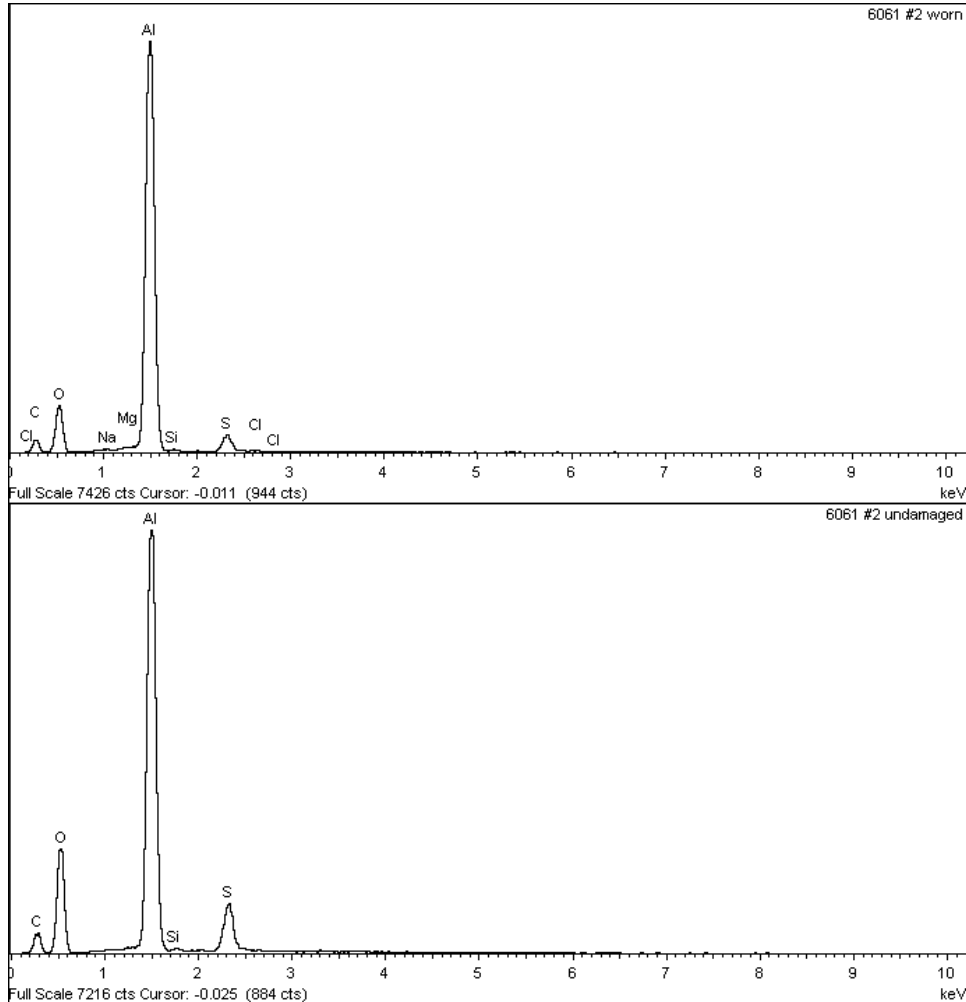
Figure 37: EDS spectra of the forward spool worn (top) and the undamaged (bottom) areas

The spectra indicate carbon (C), oxygen (O), silicon (Si), sulfur (S), chlorine (Cl), sodium (Na), magnesium (Mg), and aluminum (Al).

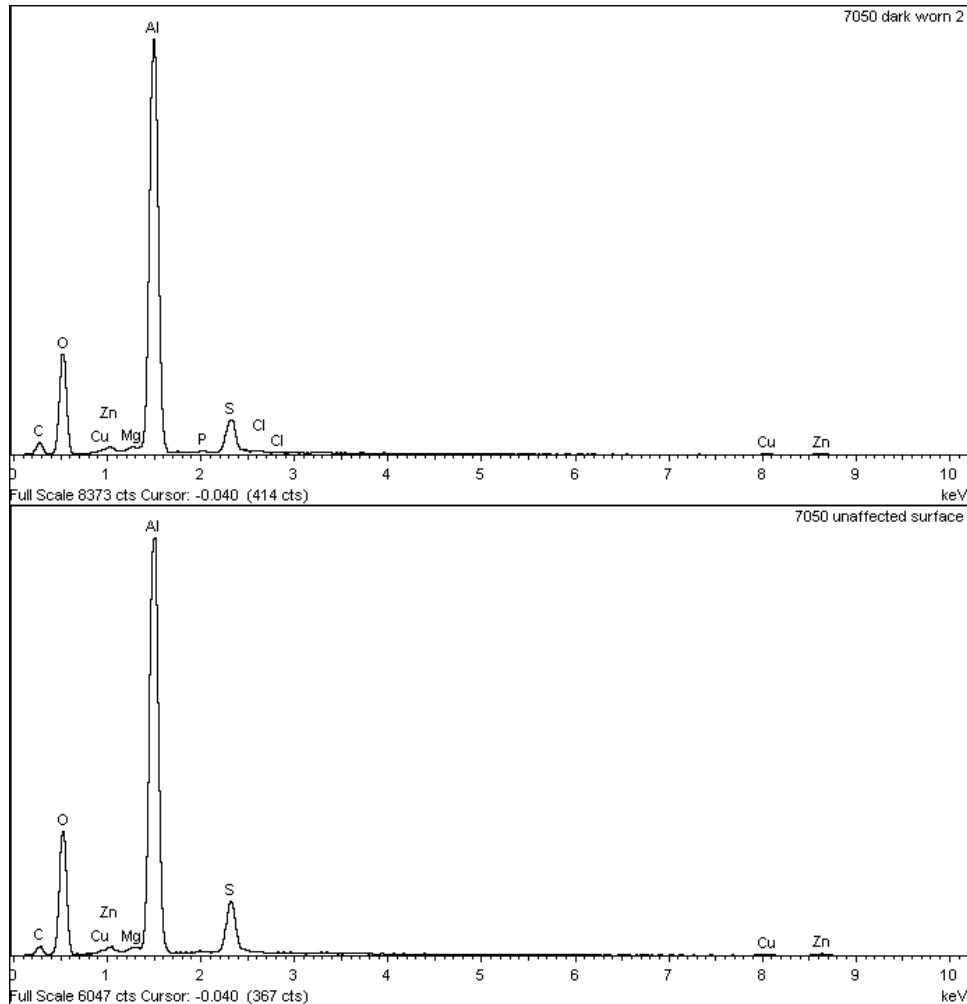
Figure 38: EDS spectra of the aft spool worn (top) and the undamaged (bottom) areas

The spectra indicate carbon (C), oxygen (O), zinc (Zn), copper (Cu), sulfur (S), chlorine (Cl), phosphorus (P), magnesium (Mg), and aluminum (Al).

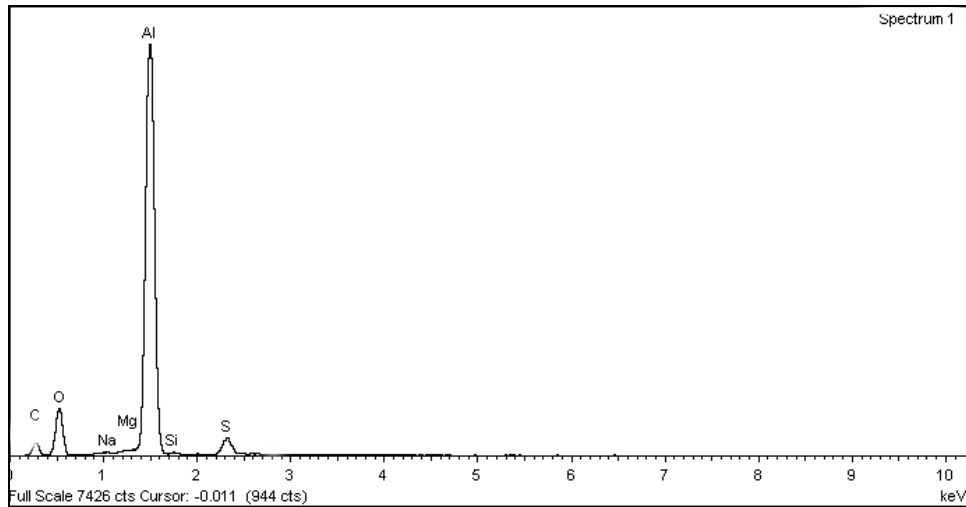
Figure 39: Representative EDS spectrum of a housing recessed area

The spectra indicate carbon (C), oxygen (O), sodium (Na), sulfur (S), magnesium (Mg), silicon (Si), and aluminum (Al).

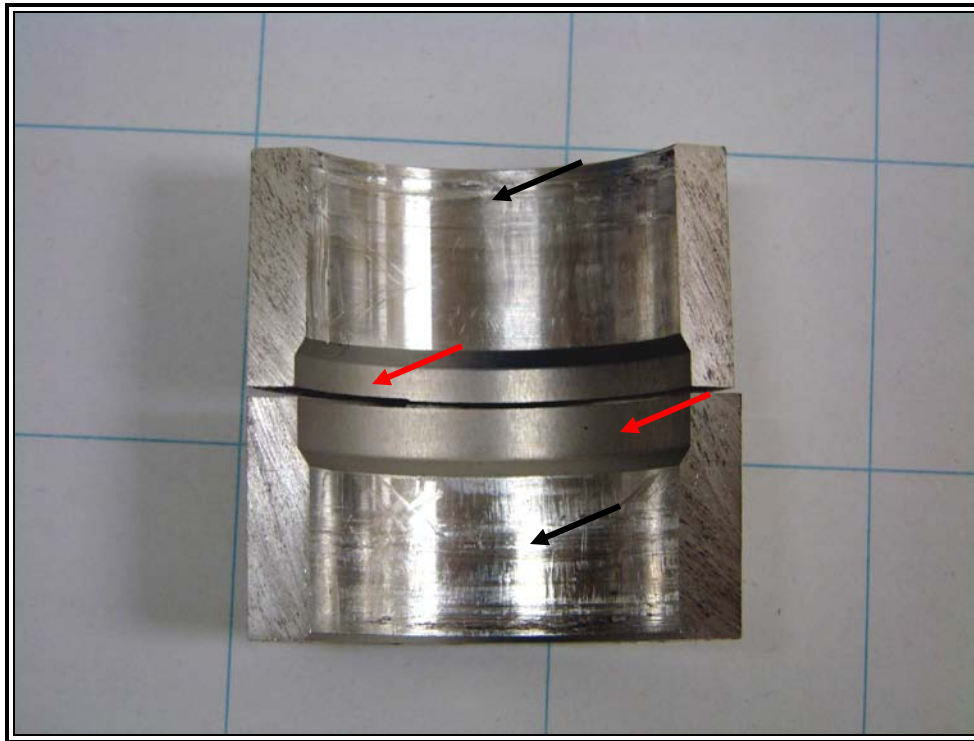
Figure 40: Photograph of a representative sectioned housing sample section showing the areas with anodizing (red arrows) and with no anodizing (black arrows) areas

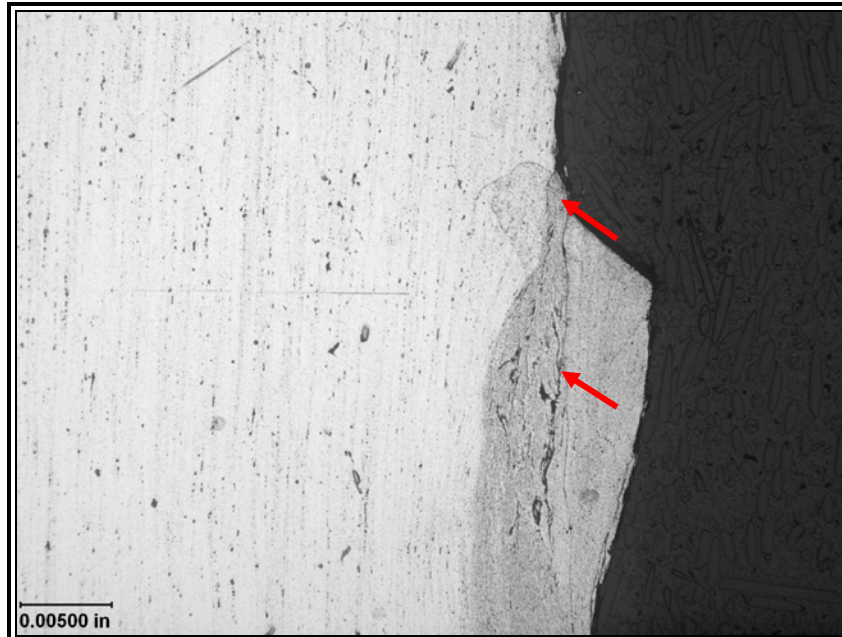
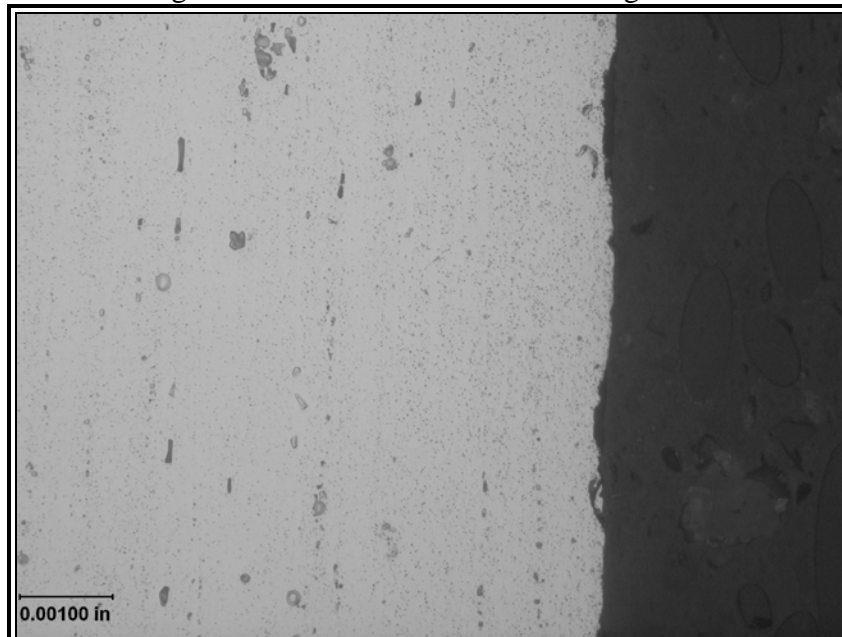
Figure 41: Photomicrographs of the center housing sample's section showing the damaged (top, arrows) and unaffected (bottom) areas

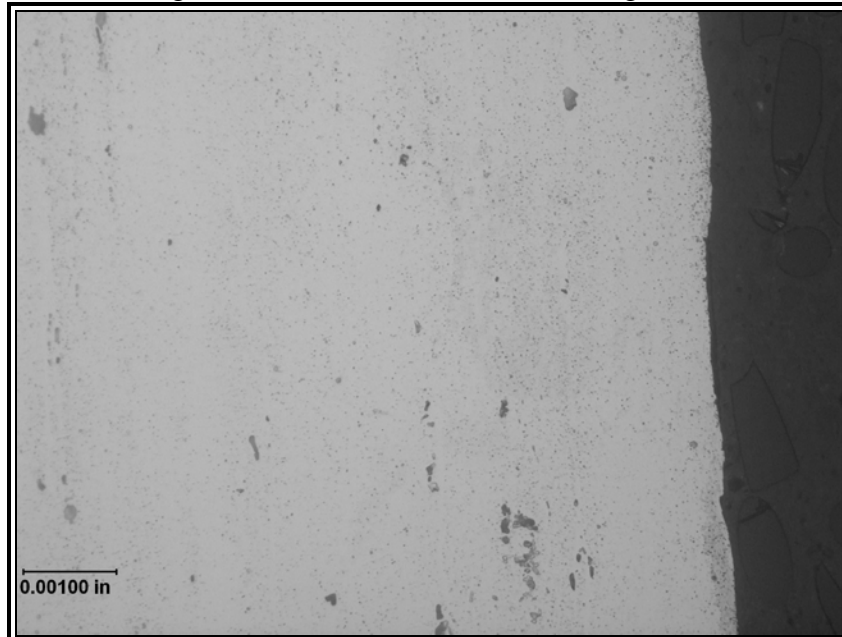
Figure 42: Photomicrographs of the aft housing sample's section showing the damaged (top, arrows) and unaffected (bottom) areas

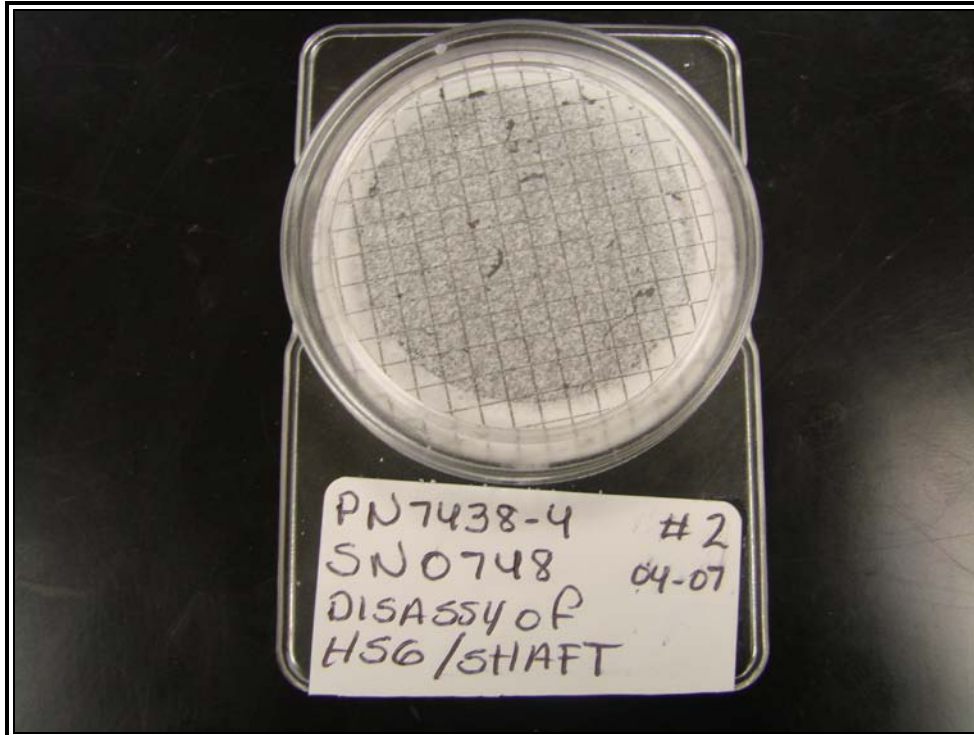
Debris on one of the submitted vials (Figure 47) were chemically analyzed by EDS. See Figures 48 through 50 for representative EDS spectra and SEM images. The debris samples were collected by the customer during disassembly of the swivel. No evidence of foreign metallic materials was found. All particles were consistent with aluminum, paint, and Teflon.

Figure 47: Photograph of the container with the analyzed particles

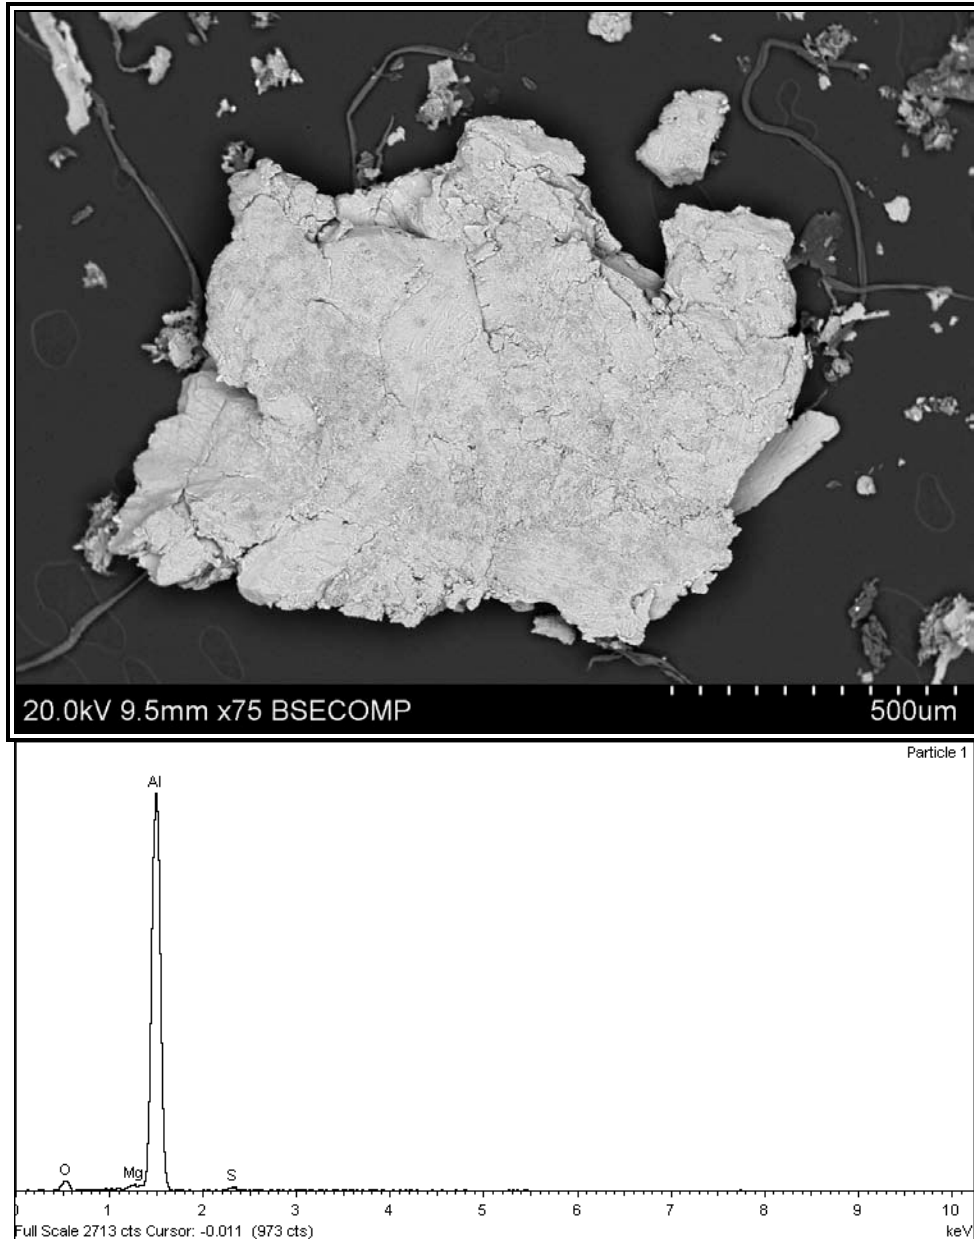
Figure 48: Back-scattered electron image (top) and EDS spectrum (bottom) of a particle

The spectra indicate oxygen (O), sulfur (S), magnesium (Mg), and aluminum (Al).
