INVESTIGATION OF SWIVEL ASSEMBLY FAILURE, P/N 7438-4, S/N 0748

ATS JOB # D166449 Rev. 1*

Investigation of Swivel Assembly Failure, P/N 7438-4, S/N 0748 removed from A/C 5305

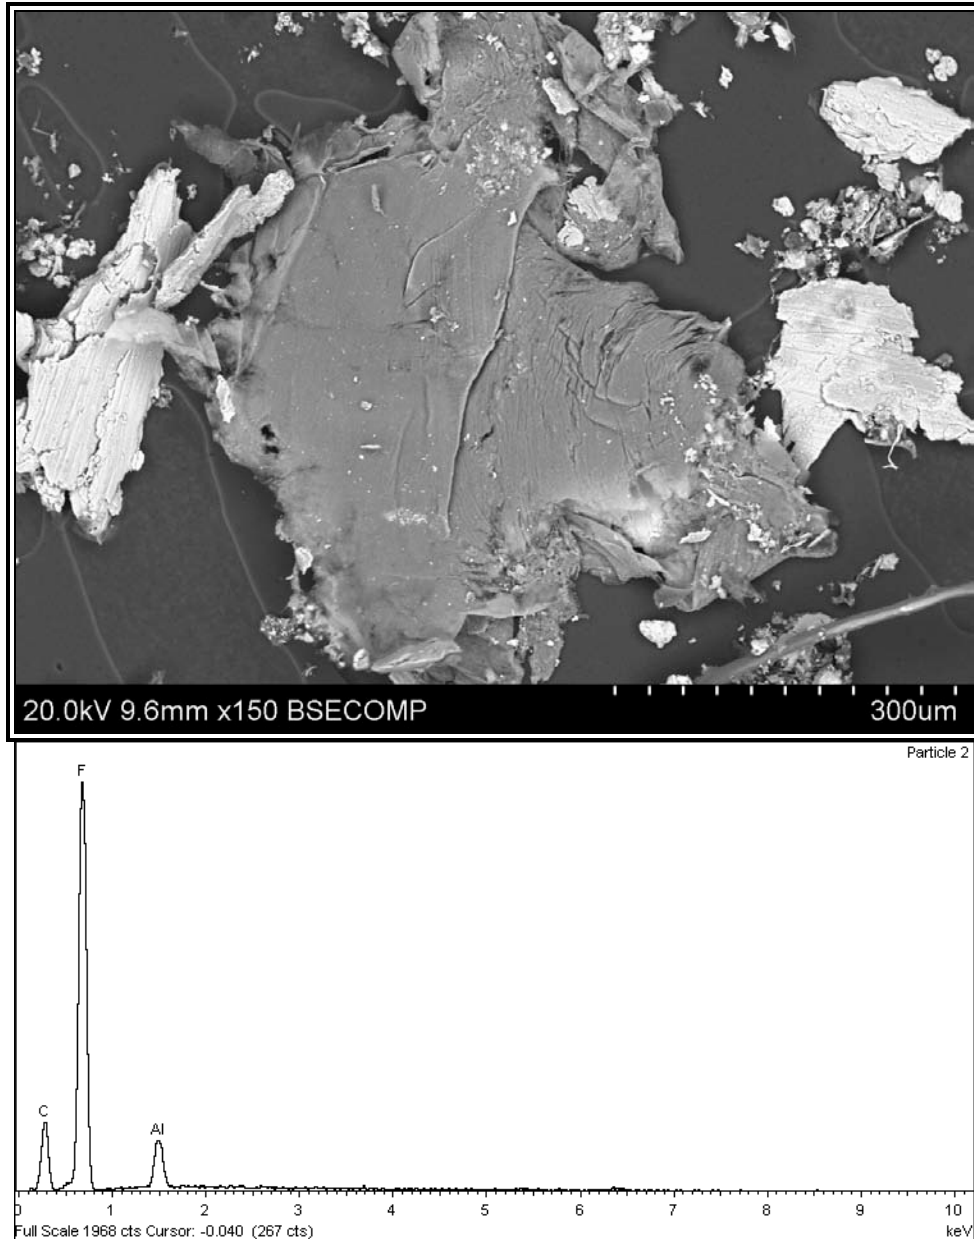
Debris on one of the submitted vials (Figure 47) were chemically analyzed by EDS. See Figures 48 through 50 for representative EDS spectra and SEM images. The debris samples were collected by the customer during disassembly of the swivel. No evidence of foreign metallic materials was found. All particles were consistent with aluminum, paint, and Teflon.

Figure 49: Back-scattered electron image (top) and EDS spectrum (bottom) of a particle

The spectra indicate carbon (C), fluorine (F), and aluminum (Al), consistent with Teflon.

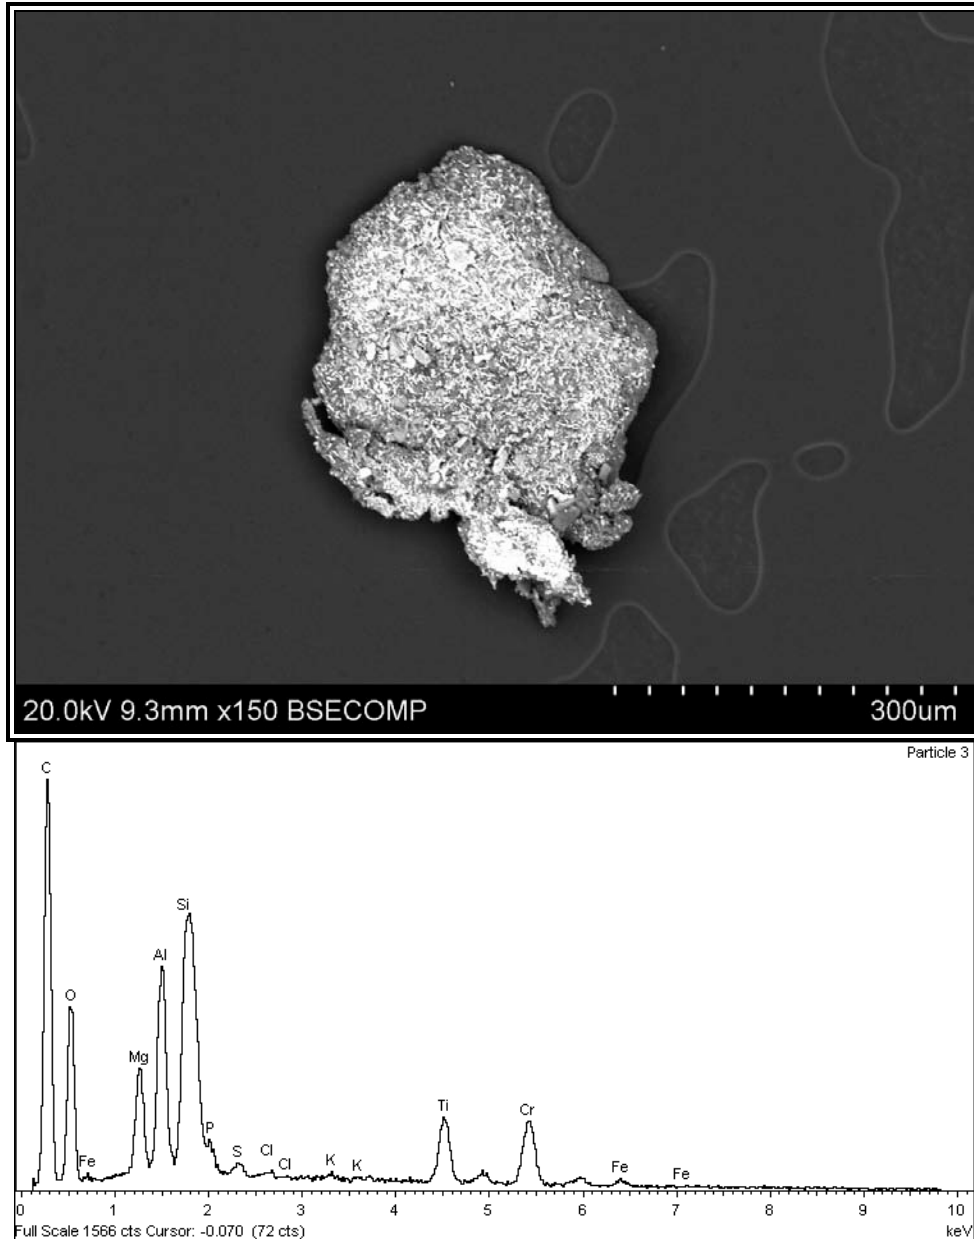
Figure 50: Back-scattered electron image (top) and EDS spectrum (bottom) of a particle

The spectra indicate carbon (C), oxygen (O), iron (Fe), sulfur (S), silicon (Si), phosphorus (P), chlorine (Cl), potassium (K), titanium (Ti), chromium (Cr), magnesium (Mg), and aluminum (Al), consistent with paint and base material.

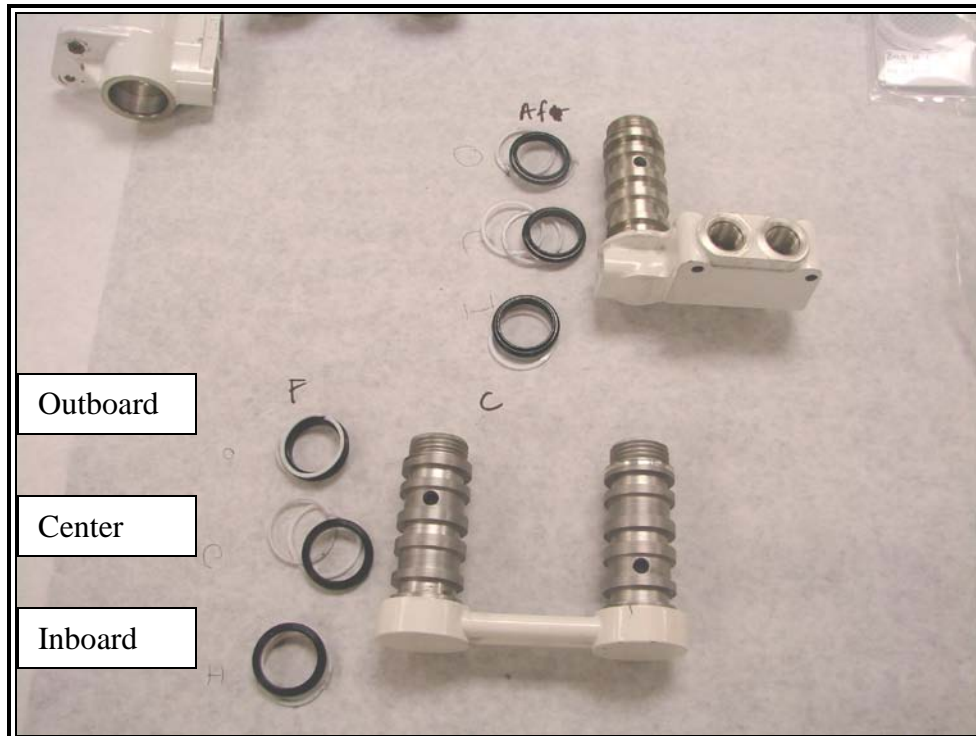
Hardness of the t-seal and backing rings that were removed from the spool samples (Figure 51) were measured using ASTM D 2240 - 05(2010), *Standard Test Method for Rubber Property—Durometer Hardness*, as a guide. See Tables VI and VII for the results. All t-seal samples met the minimum customer supplied requirement of 75 Shore A. No requirements were supplied for the backing ring samples.

Figure 51: Photograph showing the removed t-seals (black) and backing rings (white)

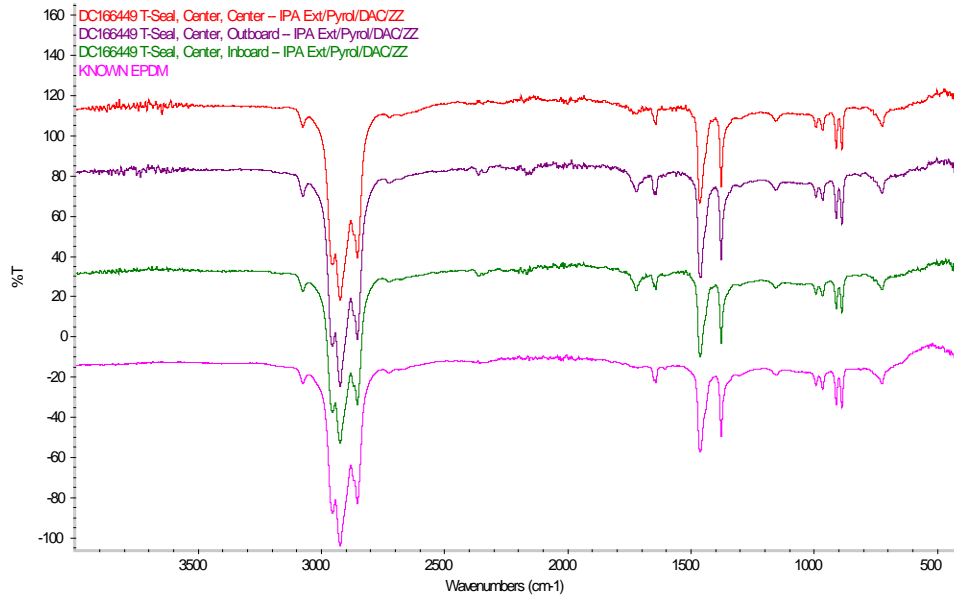
Materials of the t-seal and the backing ring samples from the center spool were verified using FT-IR techniques. The materials of the t-seals were consistent with known ethylene propylene rubber (EPR), such as EPDM (Figure 52). The materials of backing rings were consistent with known PTFE (Figure 53).

Figure 52: FT-IR spectra of t-seals of the center spool

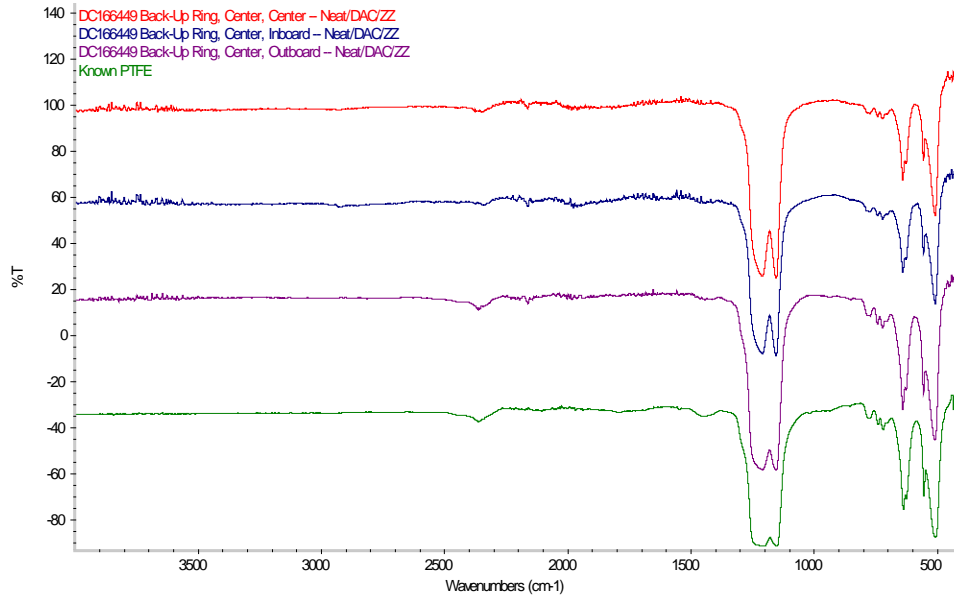
Figure 53: FT-IR spectra of backing rings of the center spool
