TRAINING RECORD FOR LETTER OF AUTHORIZATION						
AIRCRAFT TYPE: Aero L-39	INITIAL RECUR	RENT				
NAME Michael Akbar C	howdry					
		:				
ADDRESS	STATE CO	ZTP 80401				
CITYGOIden	SIAIE					
PHONE NUMBER		<u>, , , , , , , , , , , , , , , , , , , </u>				
	TRAINING					
, T I	RAINER APPLICANT	DATE				
GROUND: SYSTEMS COCKPIT TAXI EMERGENCY FLIGHT PLANNING	Deltres Del	<u>3-21-98</u> <u>3-22-98/4-11-48</u> <u>3-22-98/4-11-48</u> <u>3-22-98/4-11-48</u> <u>4-11-98</u>				
TOTAL GROUND:	JI BHrs	4-11-98				
FLIGHT: INSTRUMENT INSTRUMENT INSTRUMENT AEROBATIC INSTRUMENT FORMATION INSTRUMENT SFO INSTRUMENT GO/AROUND INSTRUMENT	I.S.Hrs.	10-12-97 				
FLIGHT TIMEDATE 1.5 Hrs $10.10.97$ 1.5 Hrs $3.01-98$ 1.5 Hrs $4.1.98$ 1.5 Hrs $4.10.98$ 1.5 Hrs $1.0.0$ LIMITATIONS:For maticFAA FORM 8710-1 ATTACHEDMINIMUM HOURS REQUIRED AFGROUND INSTRUCTION-FLIGHT INSTRUCTION-	AIRCRAFT # N3977 Orie Nb00mc Junt Nb00mc Ail Nb00mc Ail Nb00mc Ail Nb00mc V Nb00mc V Nb0	REMARKS Listron glight - 20 menuars isl Training infront cox kp. + Monners. Ride

AERO VODOCHODY LTD. CZECH REPUBLIC L-39 ADVANCED FANJET TRAINER AIRCRAFT

- 3. How was the real condition of the airplane when the weight and balance was done in 1996

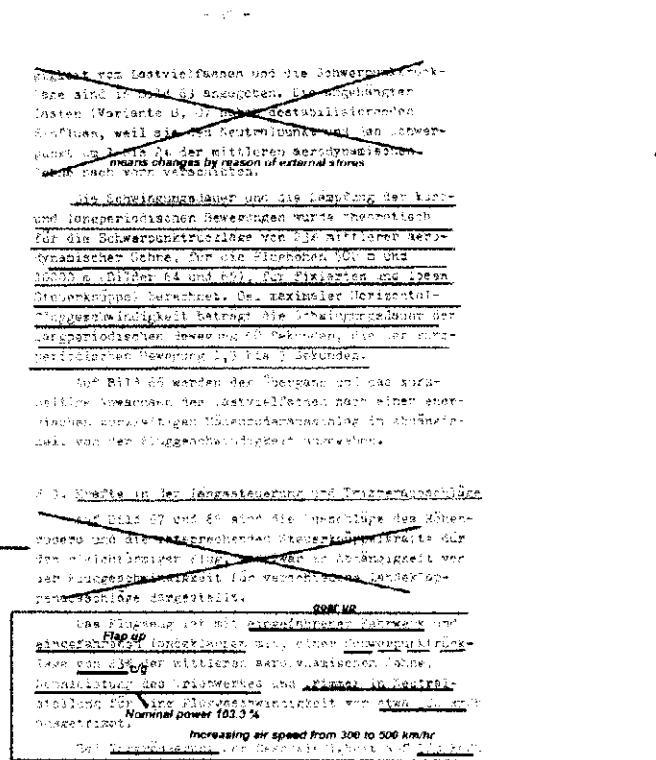
But this will work as self damping effect only if the plane is with his c/g within the limits and at the calculated case exactly at c/g of 23 % !!!! (green marked) In the case of N 602MC the c/g was far aft and the self damping effect doesn't exist and turned in an increasing oscillating longitudinal movement with increasing stick forces. For our case the graph of the 500 meters should apply. Since the airplane is more light weight and got an aft C/G, the mentioned effects could happen much earlier and at a lower speed, and therefore with increasing of the speed from 159 knots (dive as per radar chart) to 200 kts lead to the 30 $^{\circ}$ pitch up - with increasing elevator stick force as well, where M.Ch. was unable to push the stick forward to damp the oscillations.

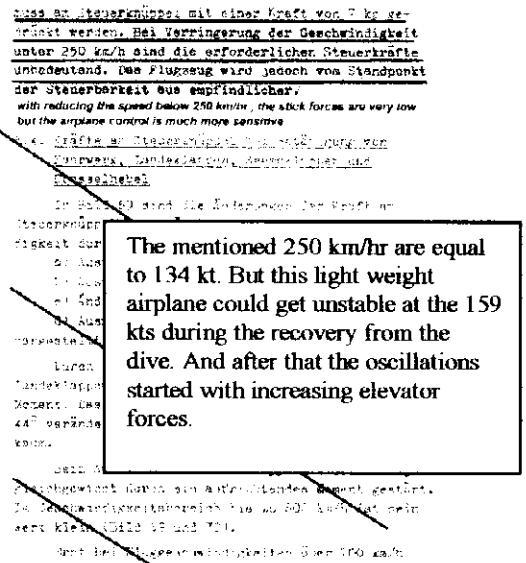
Only explanation for different stick forces with Flaps down at 25 and 44 ⁺ (not our case)

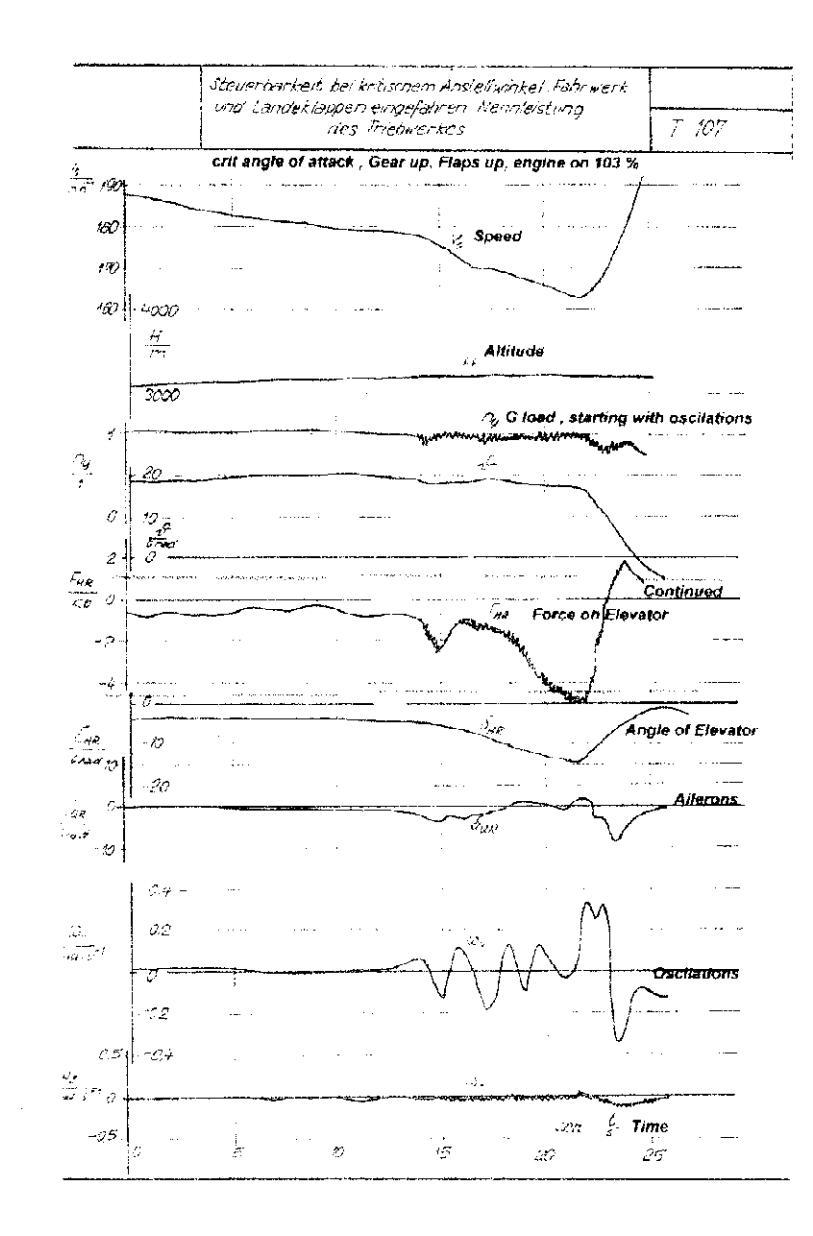
Sin Ethören den unetzenliss riebwerkes vom lent'Auf in mar benesstärbit new nich missistattersom brastit fo zums zit nöstetett dier "Adväst" versen. Picture T-107 shows the increasing forces on the elevator after he reached a critical angle of attack to bring the airplane back on level.....
 I think that does not need a further explanation....
