Accident / Incident Report

Report No.: 19-122

**JRM Air LLC
Textron Aviation 680A, N8JR
Elizabethton, Tennessee
August 15th 2019
PW306D1
Left Hand Engine S/N CN0015
Right Hand Engine S/N CN0016**

**Written By: Jeff Davis
Service Investigation Department**

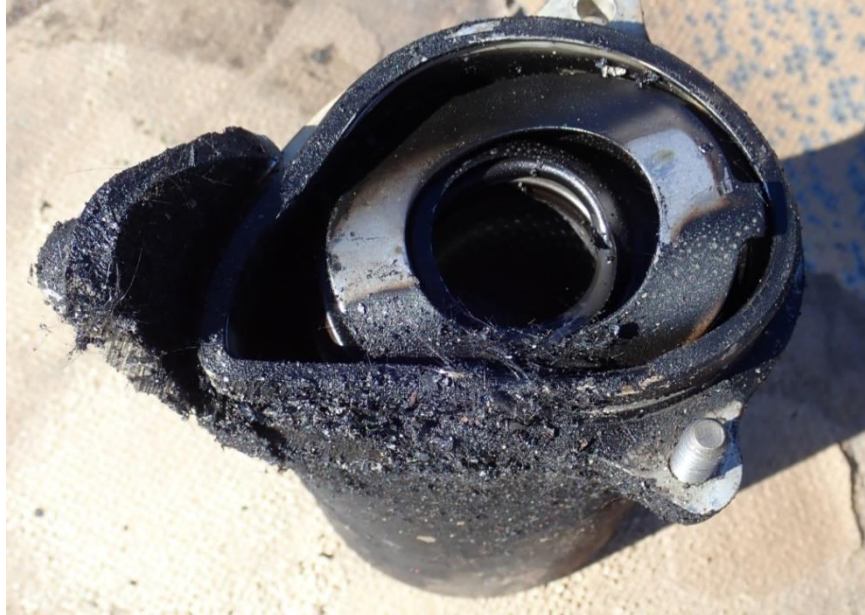
Photo No. 16

Oil Filter: The oil filter cover was distorted from impact damage (Ref. Photo No. 15, red arrow). The damage to the cover prevented removal of the filter element (Ref. Photo No. 16). The filter was stained with soot from the post impact fire but the visible regions of the element did not display contamination that was related to engine operation (Ref. Photo No. 16).

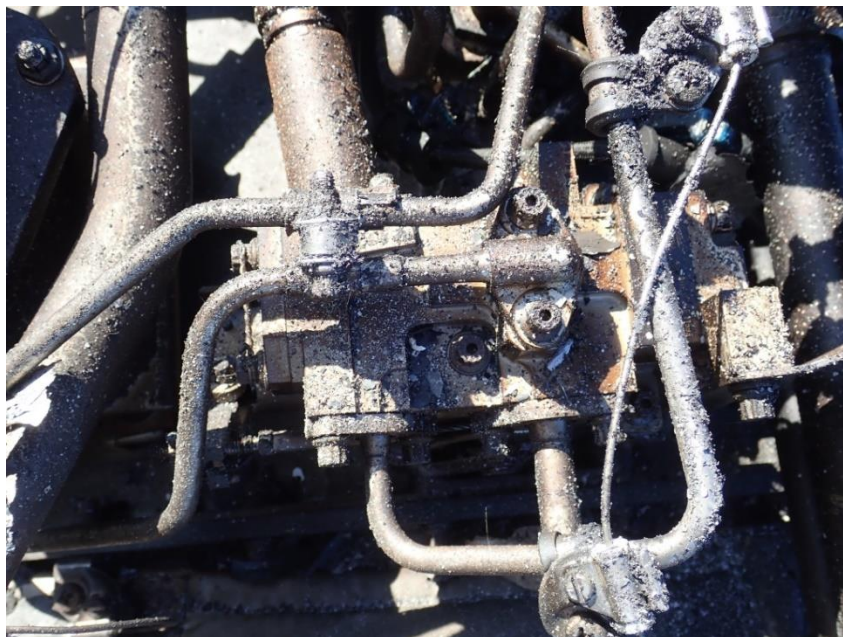
Photo No. 34

Start and Dump Valve: The valve was in place and the exterior was discoloured from exposure to heat and soot from the post impact fire (Ref. Photo No. 34).

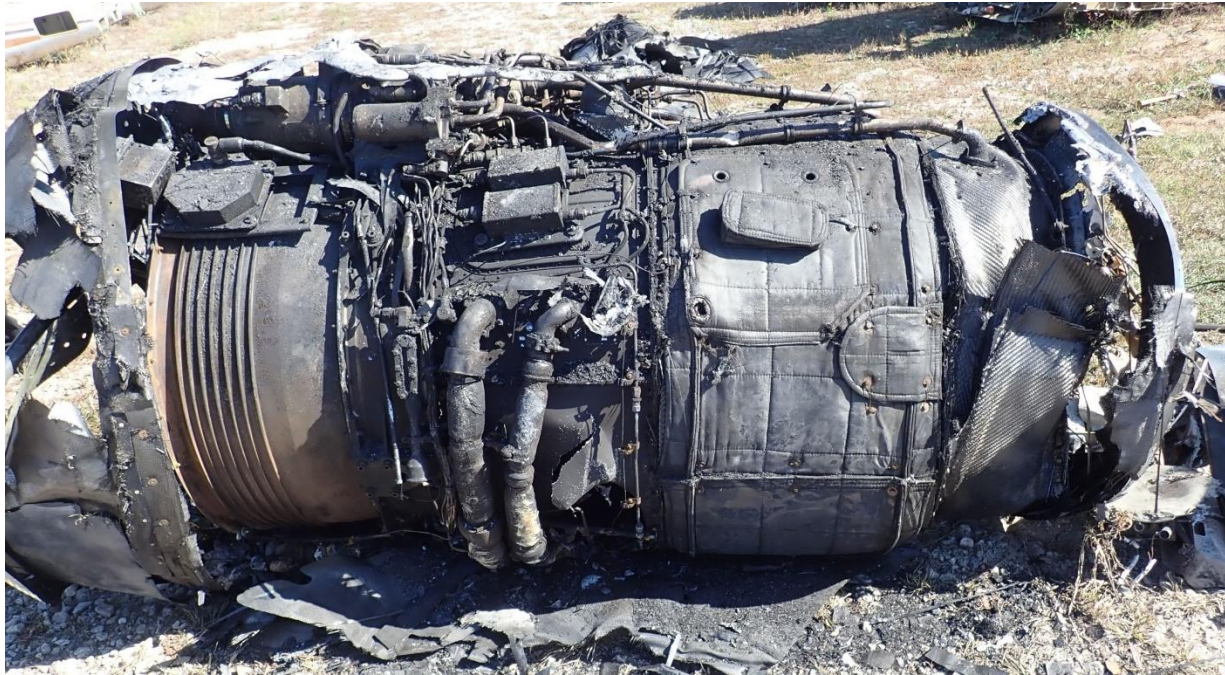
Photo No. 40

- 5.1 **External Condition:** The right hand engine was lying on its right hand side of the heat distressed airframe cowling (Ref. Photos No. 38 & 39). The engine was moved to the inverted position to access the bottom of the aircraft cowling. The external engine components and the bypass ducts were coated in soot and exhibited heat distress from exposure to the post flight fire (Ref. Photo No. 40). The engine data plate showed the engine serial number was PCE-CN0016 (Ref. Photo No. 41).

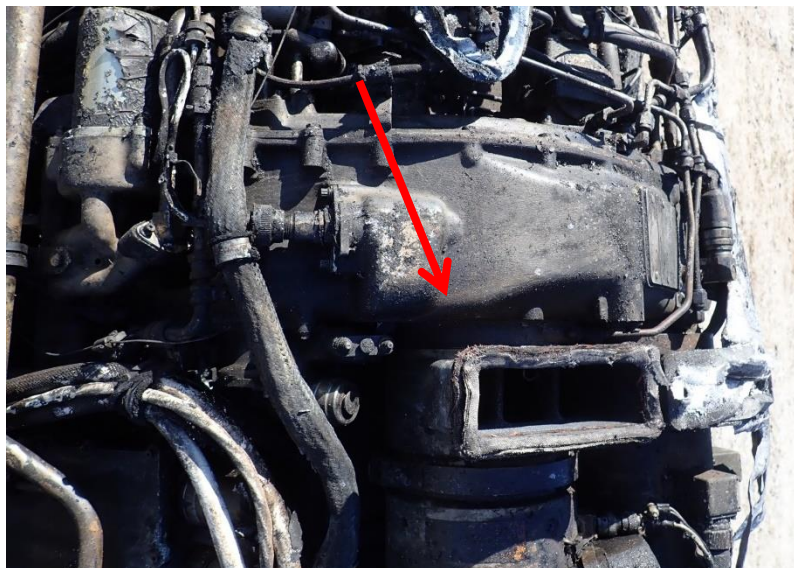
Photo No. 46

Accessory Gearbox: The gearbox was coated with soot and the paint was discoloured (Ref. Photo No. 46, red arrow). The externally mounted accessories were attached to their respective mounting pad on the gearbox.

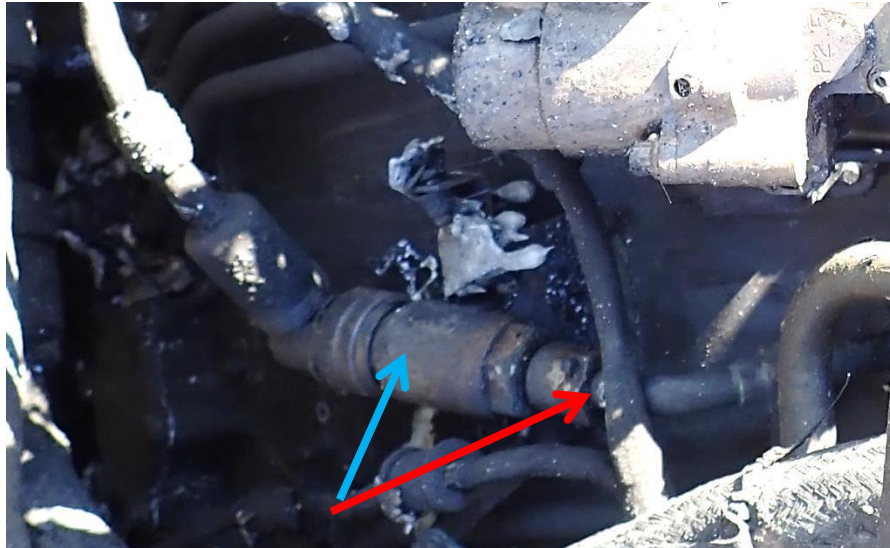
Photo No. 48

Compressor Discharge Air (P3) Transducer Tube: The line was in place and secure (Ref. Photo No. 48, red arrow).

P3 Pressure Transducer: The transducer was secure on its respective mounting pad on the bypass duct (Ref. Photo No. 48, blue arrow).

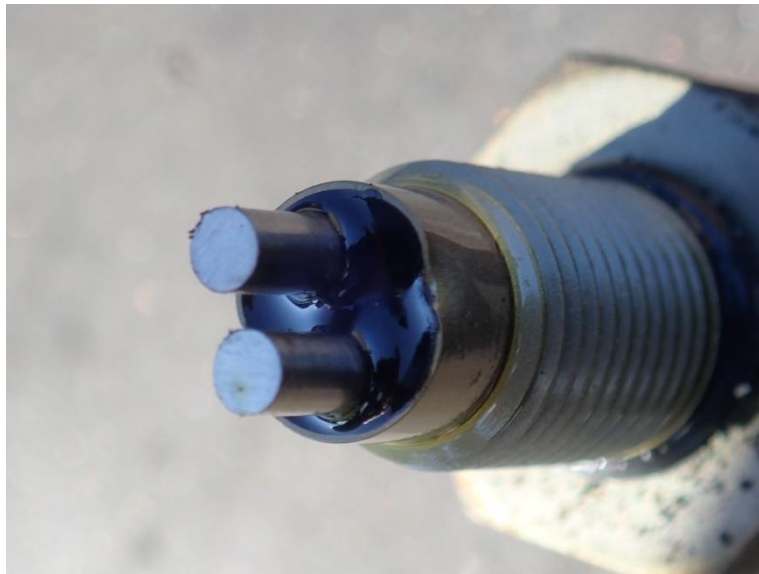
Photo No. 50

Accessory Gearbox Chip Detector: Some small particulate was adhered to magnetic poles of the chip detector (Ref. Photo No. 50).

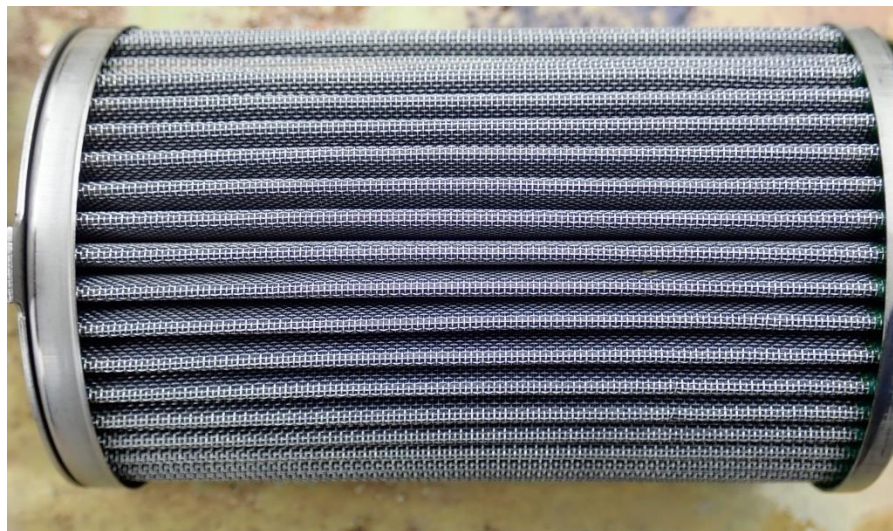
Photo No. 51

Oil Filter: No visible contamination was evident in the filter (Ref. Photo No. 51).

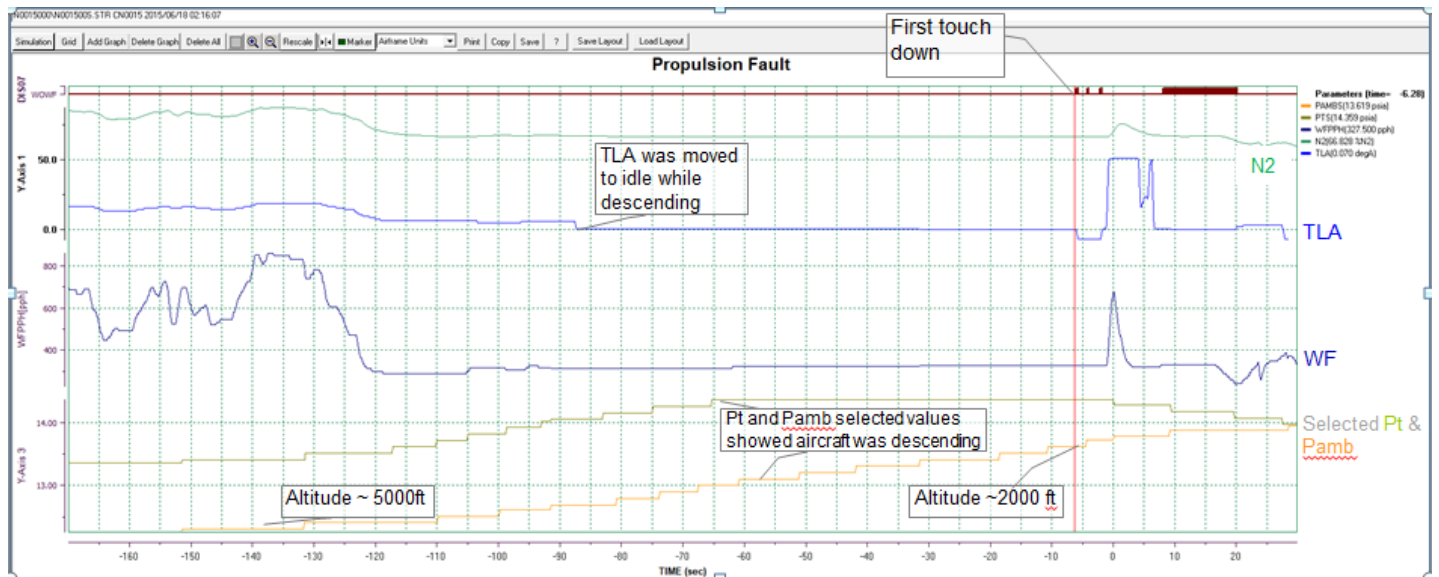
Graph No. 1

The EDU has trace data from -163.72 seconds before the first touchdown to 36.28 seconds after. Following the TLA movements to idle at -87.07 seconds, the EEC commanded the engine to idle setting schedule as expected (Ref. Graph No. 1).

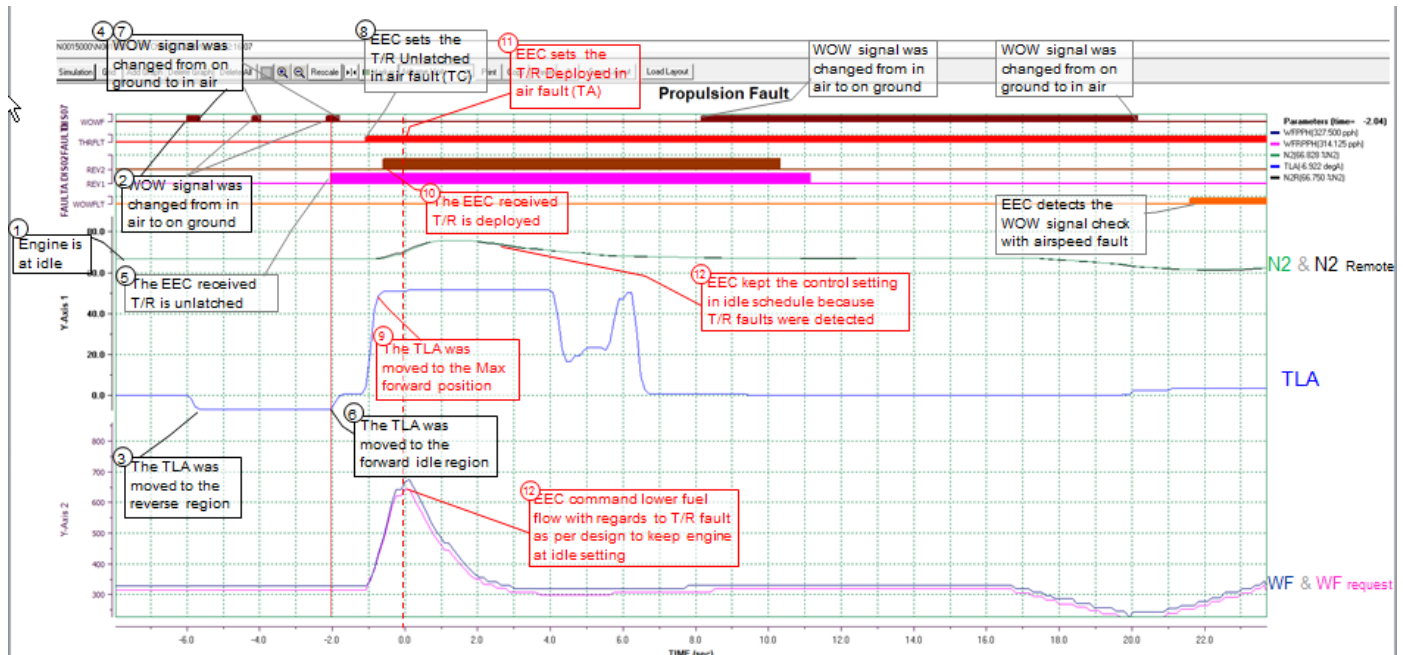
Graph No. 2

The focus of the next slide is from -6.28 seconds (first touchdown) to 30 seconds after. The following slide demonstrates the sequence of commands sent and feedback received by the EEC corresponding to the numbers on the Graph No. 2:

- 10. 1.4 seconds after the T/R unlatched, the EEC received the T/R deployed status (Rev 2 = True). The EEC recognizes the T/R status to be “Deployed and Locked”
- 11. 0.5 seconds later, the EEC annunciated a T/R Deployed In-Flight fault (TA) as per design.
- 12. When the TA fault was declared, the EEC commanded the engine to idle as per design and fuel flow was reduced to keep the engine at flight idle.

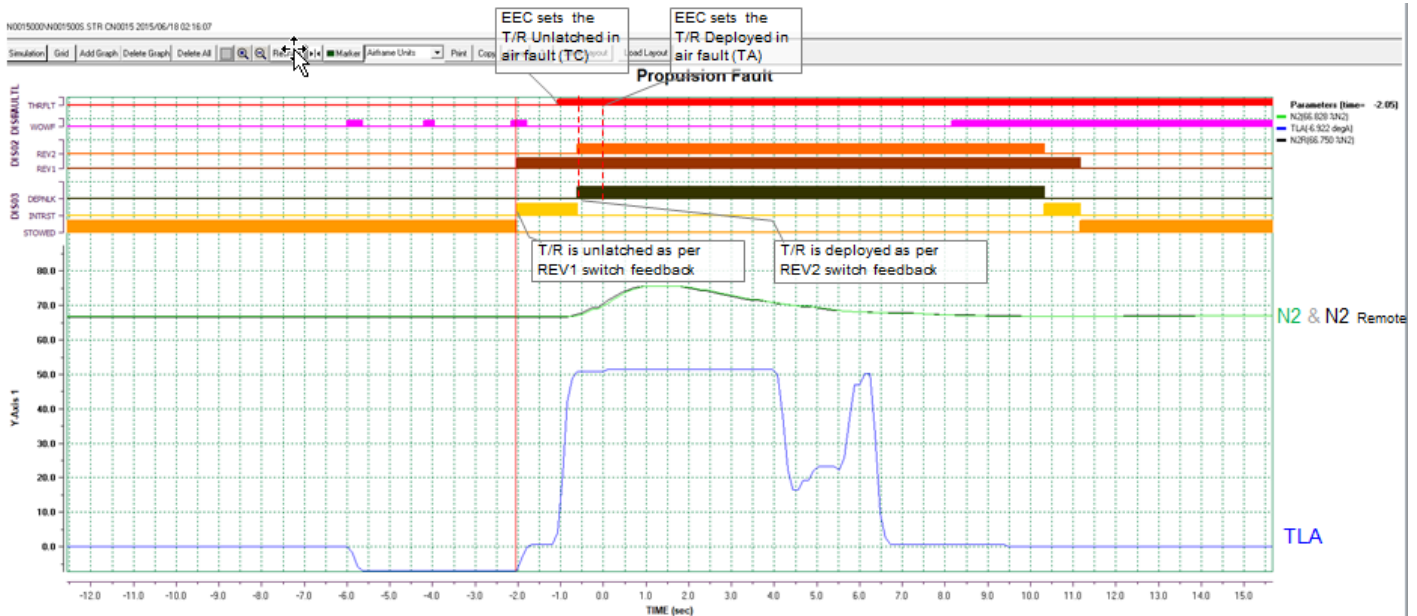
The following Graph No. 3 shows the EEC processed parameters for the T/R status:
