I ANALYSIS

1.0 Accident Synopsis

- 1.1 The subject engine was removed from an Agusta A119 Aircraft Registration No.N403CF following an aircraft mishap.
- 1.2 It was reported that the aircraft was found substantially damaged when it impacted terrain while approaching to land to a remote landing zone (LZ) approximately 8 miles northeast of Mancos, Colorado. The pilot, nurse, and paramedic were fatally injured.

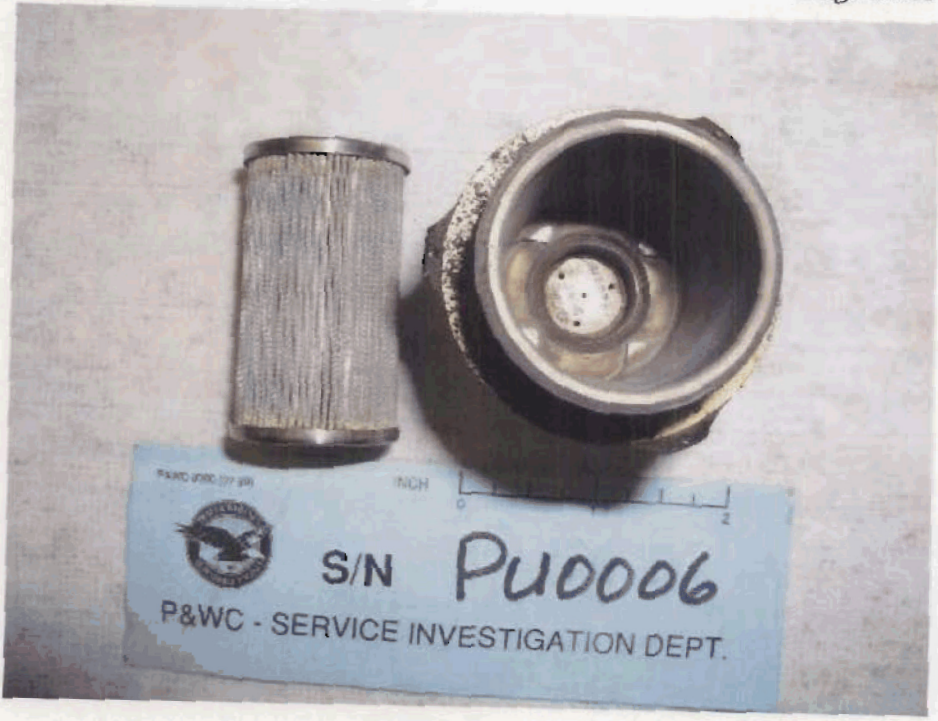
Photo no. 27
View of the P3 filter & the inside of the filter bowl being dry and clean

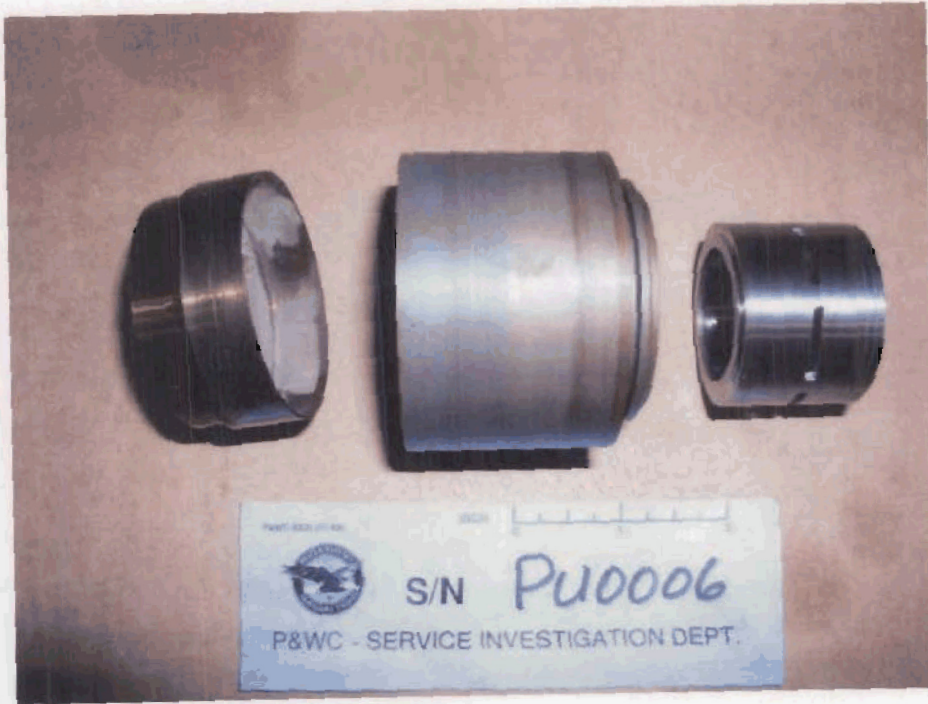
Photo no. 39
View of the compressor rotor air seals shows no impact rubbing damage to the OD's.

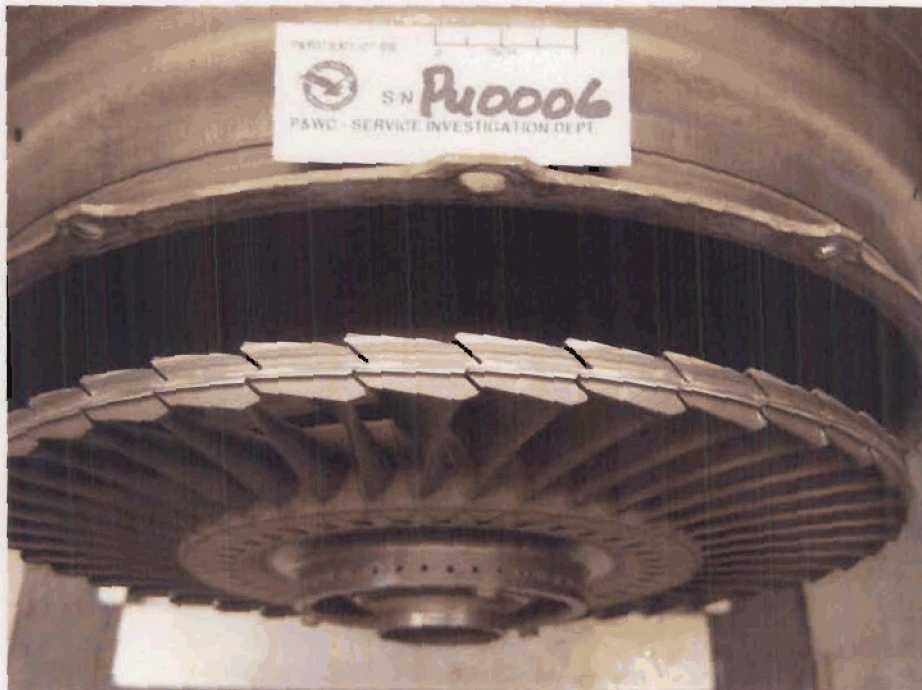
Photo no. 44
View of the PT blade shrouded tips show light rubs.

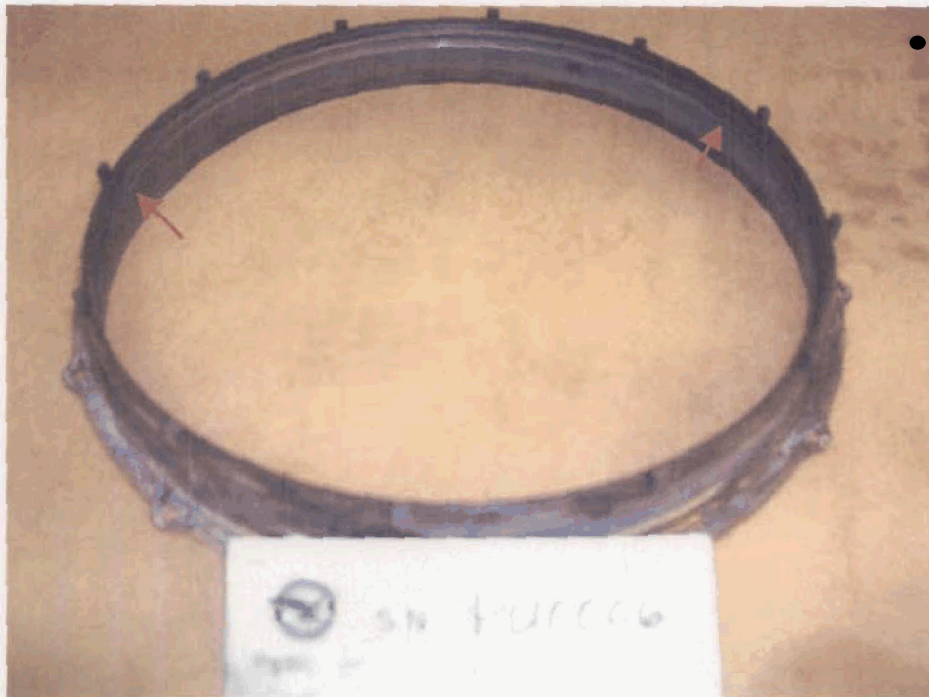
Photo no. 45
View of the PT shroud shows the rubbed seal knives between the arrows.

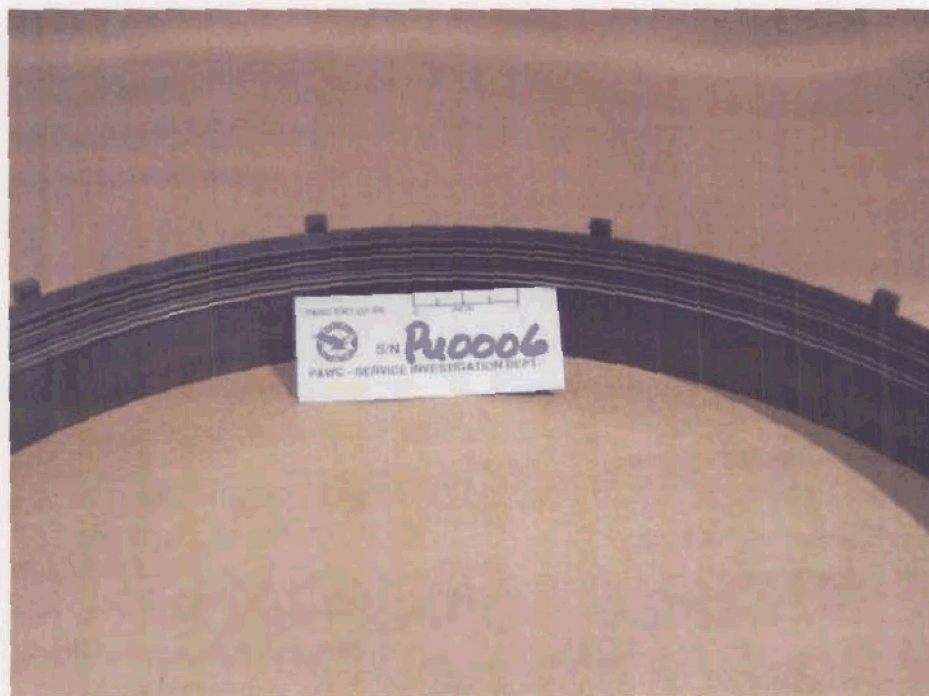
Photo no. 46
Another section view of the PT shroud shows the light rubs to the seal knives referred in photo no. 43 above.

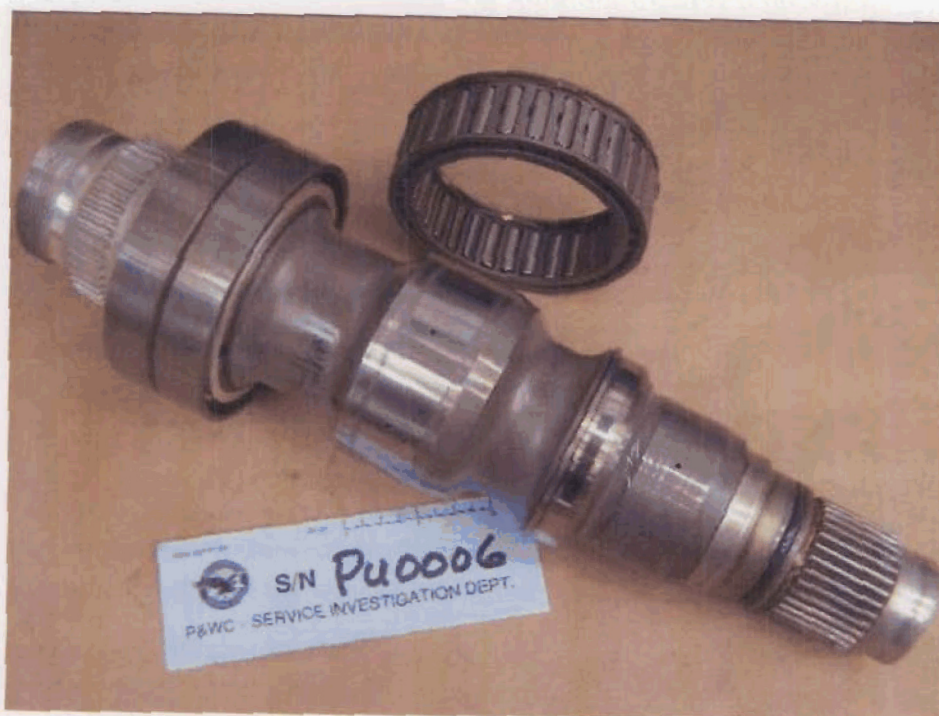
Photo no. 50
View of the intact RGB output shaft, sprag clutch & No. 14 duplex bearings

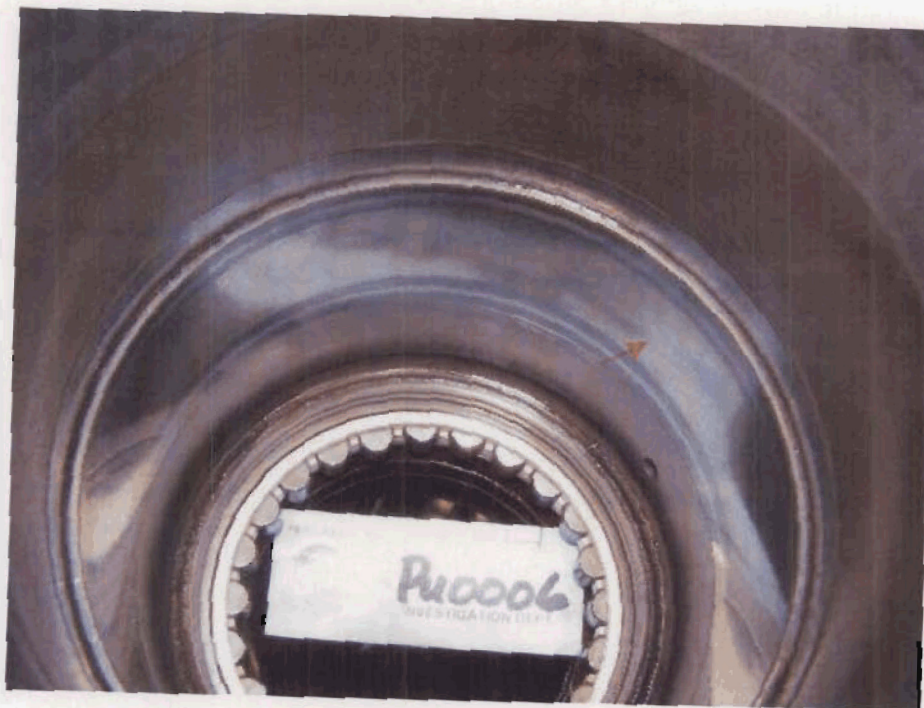
Photo no. 51
Closer view of the intact sprag clutch
