Continental Motors, Inc.

ENGINE OPERATIONAL TEST

DATE	October 5, 2011
REGISTRATION #	N444YM
ENGINE MODEL	IO470VO
ENGINE SERIAL	455788
INSPECTOR	Phillip Grice
SEARCH CODE	15-12-68

DATE	October 6, 2011
REGISTRATION #	N444YM
ENGINE MODEL	IO470VO
ENGINE SERIAL	455789
INSPECTOR	Phillip Grice
SEARCH CODE	15-12-68

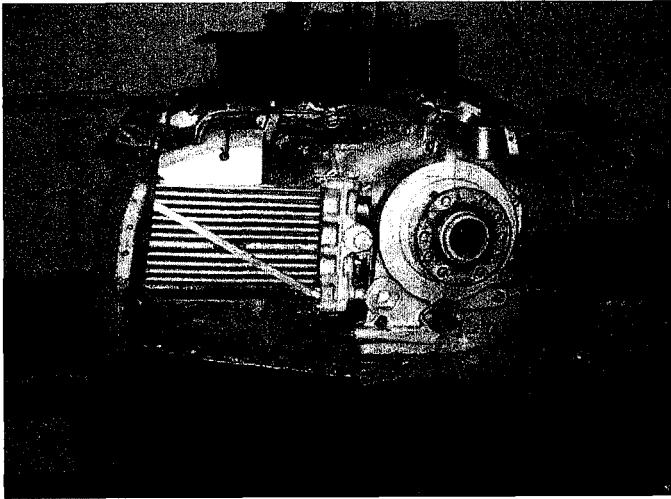
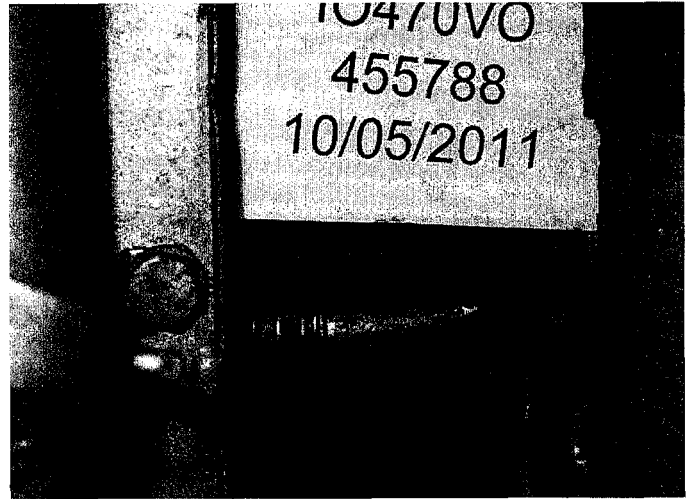
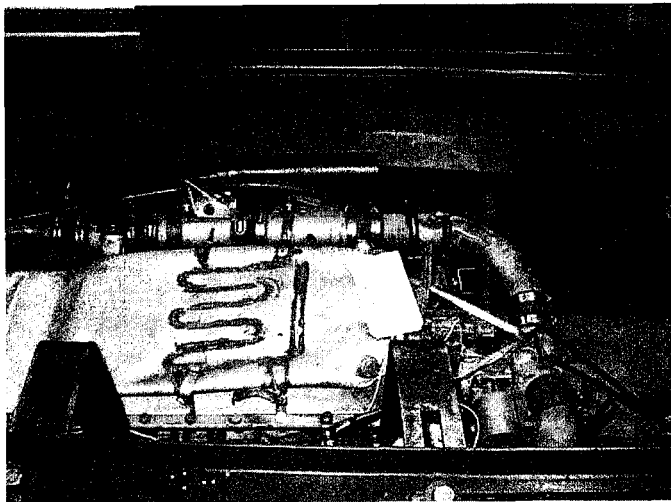
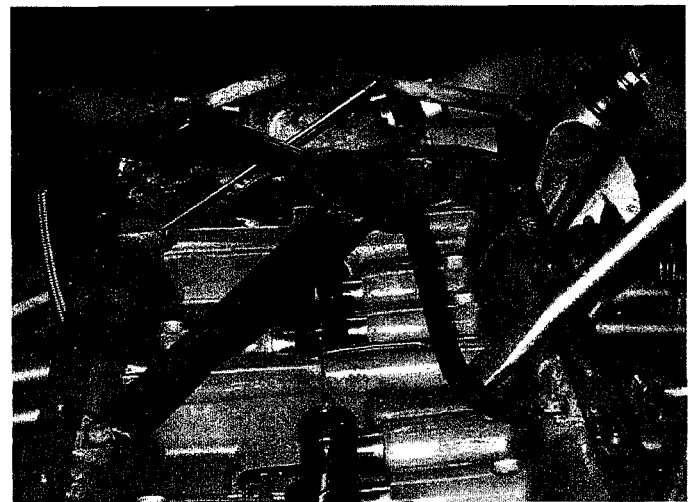
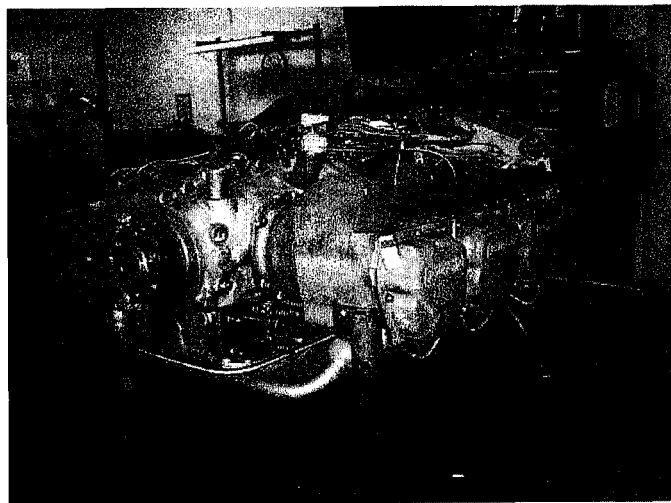
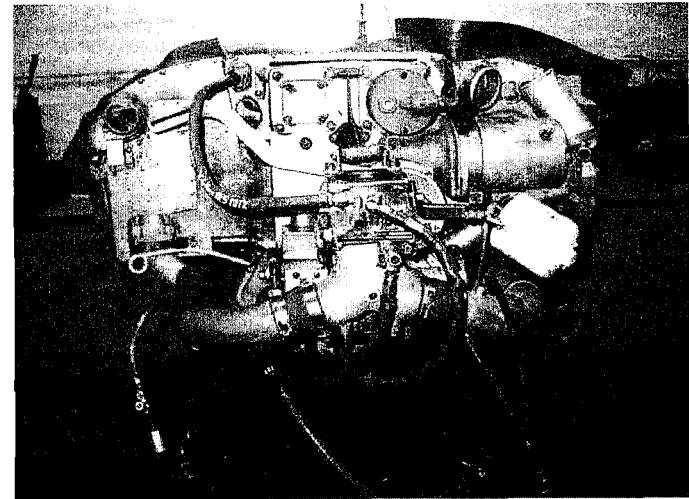
The engine exhibited impact damage concentrated at the bottom of the engine. The oil sump, exhaust runner on the 2, 4, 6 side, induction tube cylinder 6, and the balance tube was replaced before the test run. All engine mount legs were replaced to facilitate mounting to run stand.

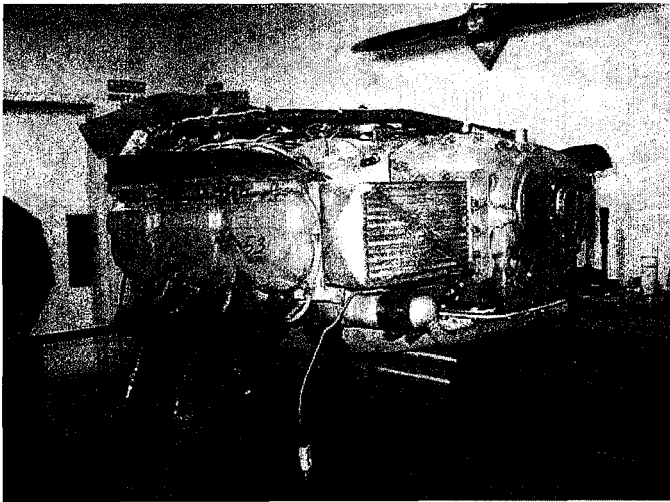
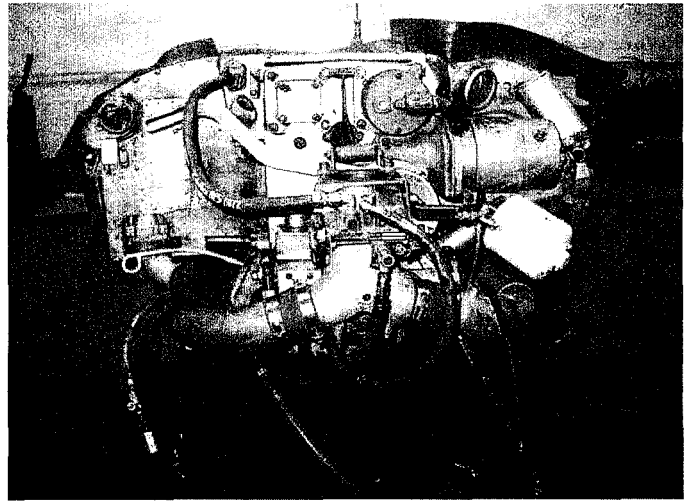
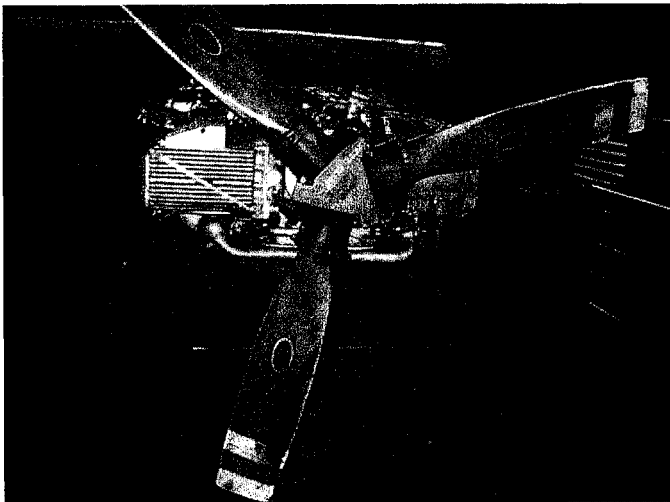
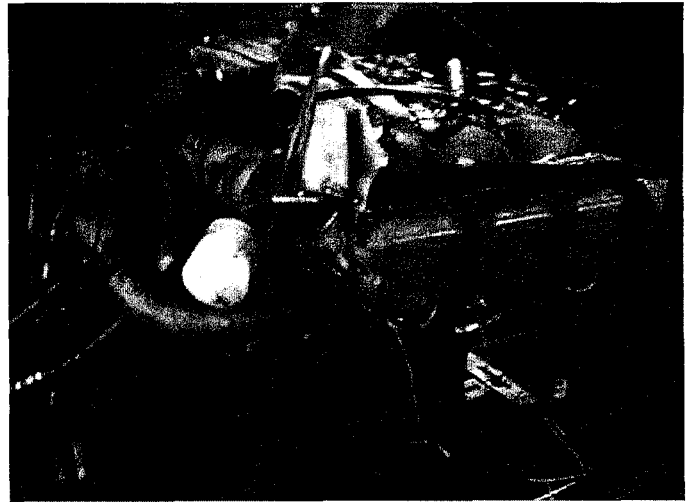
The operation of this engine was normal and did not reveal any abnormalities that would have prevented normal operation and production of rated horsepower.

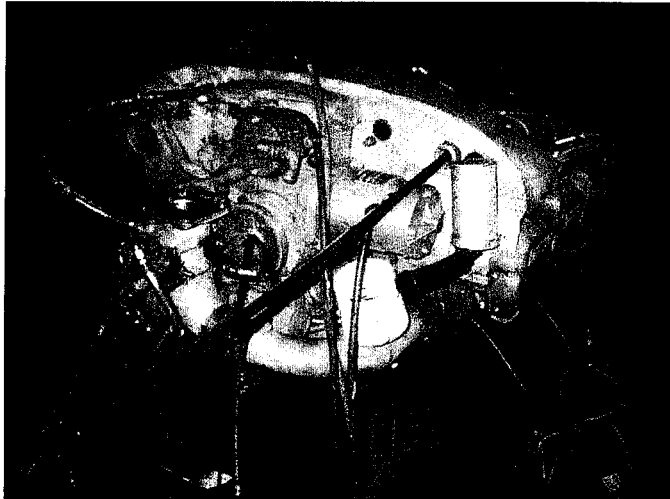
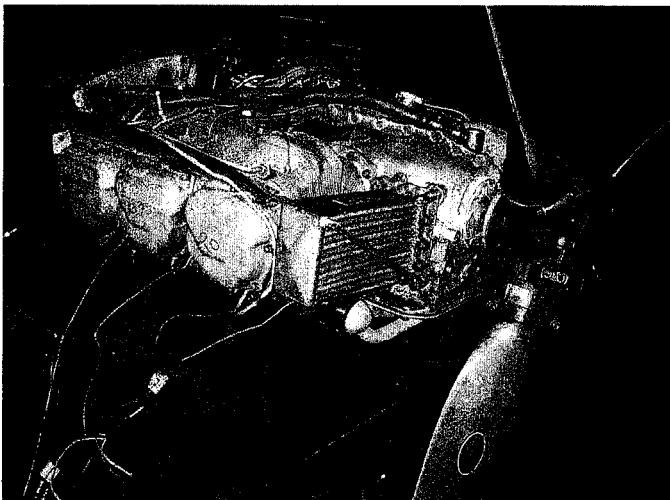
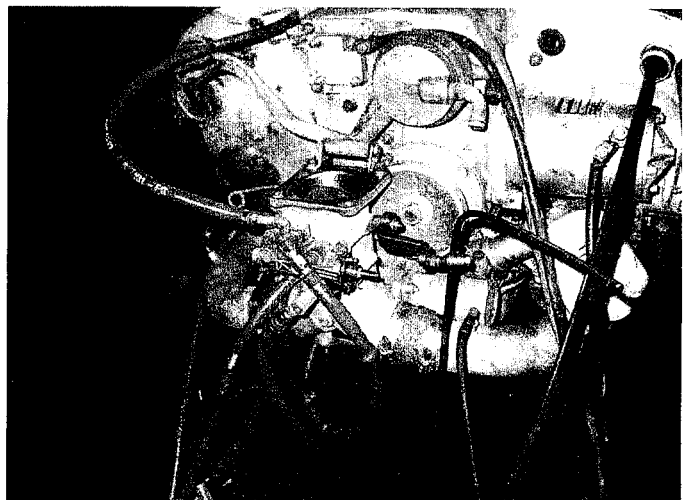
The operation of this engine was normal and did not reveal any abnormalities that would have prevented normal operation and production of rated horsepower.
