Re: Comair Airlines d.b.a. Delta Connection Flight 5191
Accident Number DCA064MA064
Lexington, Kentucky
August 27, 2006

**SUBMISSION OF THE
AIR LINE PILOTS ASSOCIATION, INTERNATIONAL
TO THE
NATIONAL TRANSPORTATION SAFETY BOARD
REGARDING THE ACCIDENT INVOLVING**

**COMAIR 5191
CRJ-100
DCA064MA064**

**LEXINGTON, KY
AUGUST 27, 2006**

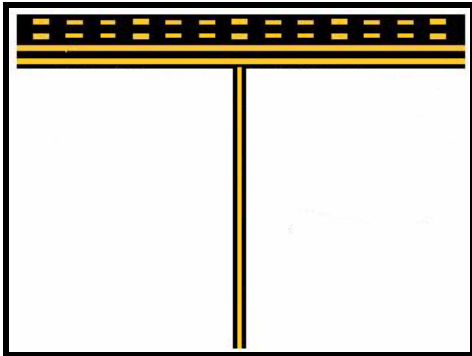
Figure 3: Standard Hold Short Marking

Blue Grass Airport. Figure 4 shows the enhanced marking with surface painted holding position signs, we recommend based on the current AC.

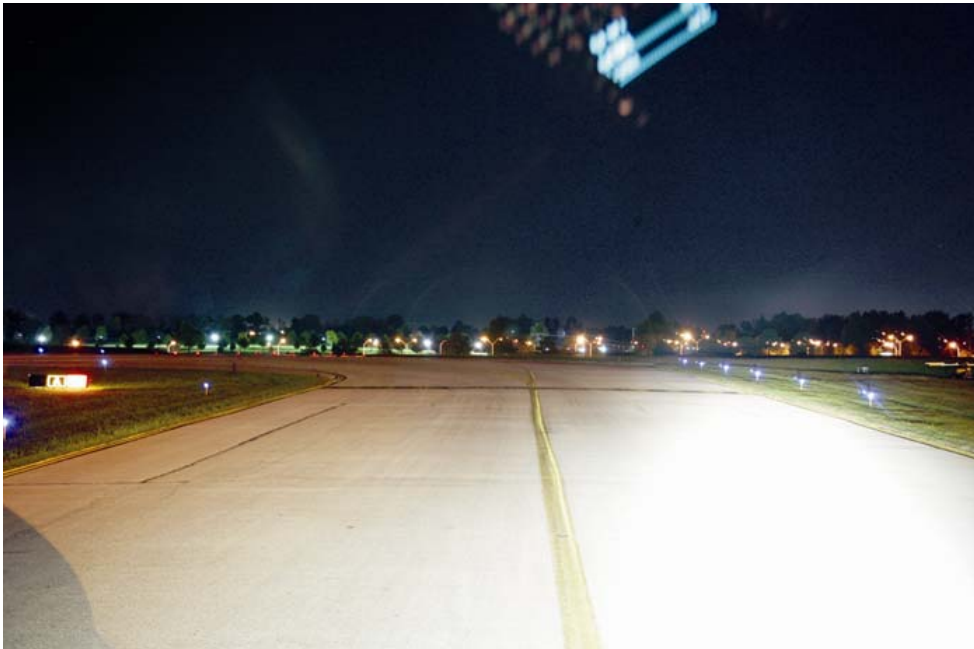
Photo 5: Taxiway "A" Approaching Runway 26

The geographical location of the aircraft while the first officer was task saturated was from approaching taxiway "A6" intersection until the turn on to the final segment of

taxiway "A" to holding short at runway 26 at 06:04:36. Photo 5 shows the view in front of the aircraft as it makes its final turn onto this segment.

At this point of the taxi event, both crew members situational awareness as compared to reality probably differs from each other for different reasons. Notably, it is wrong in both cases. This will be further explored in the next flight segment. Confirmation bias and plan continuation now play an integral role in why this series of errors and misperceptions was not trapped at this point in time. Three threats are identified to exist during this flight segment and by their very nature, it is reasonable to assume that the crew was not consciously aware of any of them (See Table 7). As a result, none of these were recognized, discussed or managed to any degree. All three will play a significant role in the danger to this flight. With sufficient layers of protection in a safe system, any one of these threats by themselves would not be catastrophic. However, the addition of these threats with the existing threats and errors already discussed made this situation extremely dangerous.

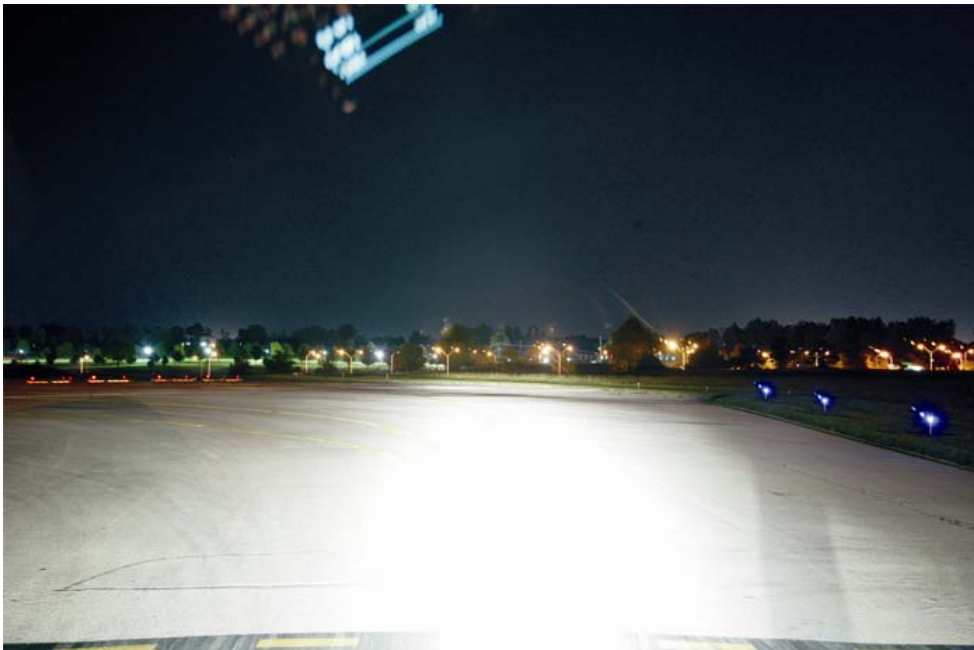
Photo 6: Hold Short of Runway 26 on Taxiway "A"

The first officer is again heads down reading the rest of the before takeoff checklist and announces that he is going to the back (euphemism for using the number two radio tuning unit to select the PA system) to make the passenger announcement. The captain at this time and with the aircraft still in motion agrees and takes on the additional cognitive task of monitoring the number one radio for ATC transmissions. This reallocation of duties is a normal function for the captain when the first officer makes his required passenger briefing advising the flight attendant to prepare for takeoff. One second later, four ATC/other aircraft transmissions take place as the captain brings the aircraft to a complete stop at the hold short line for runway 26. Photo 6 below shows this location.

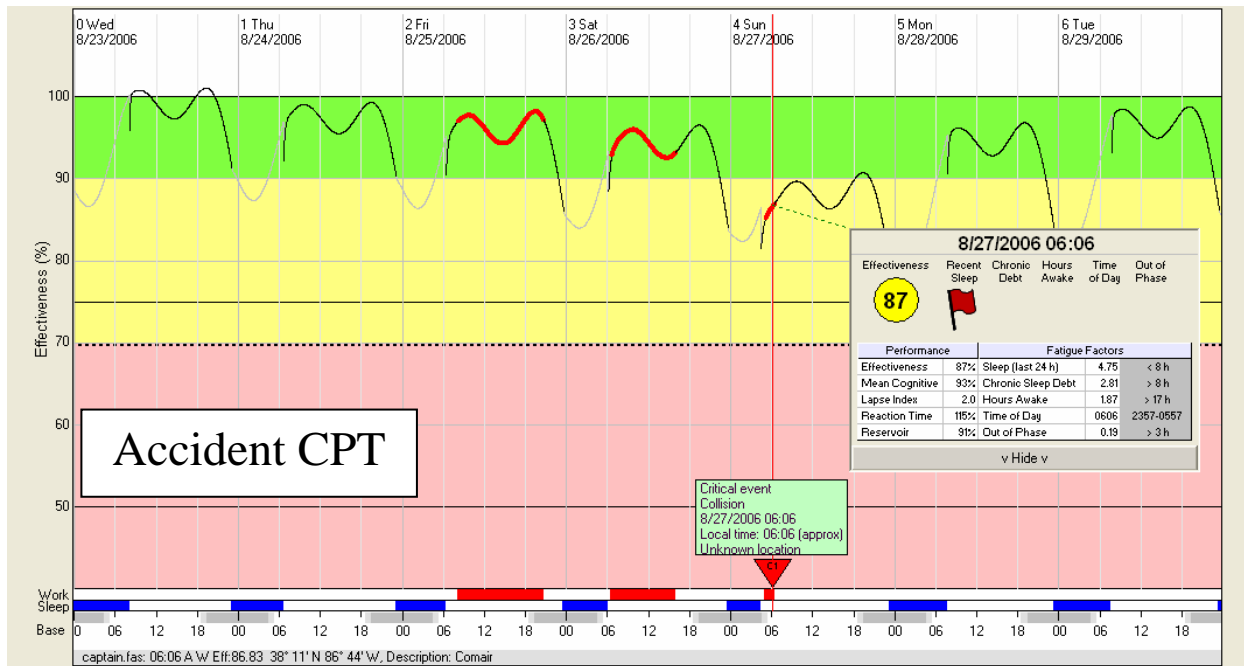
Figure 8 - Performance prediction for accident CPT based on estimated sleep/wake schedule and circadian phase using the SAFTE/FAST model (courtesy of S.R. Hursh)

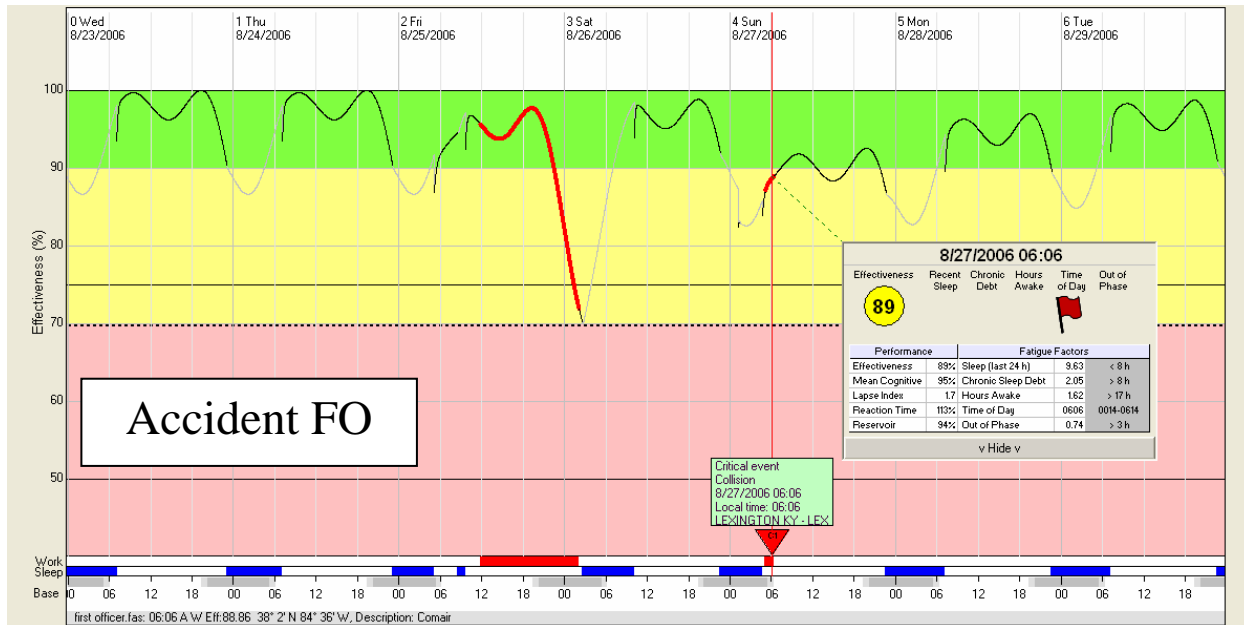
Figure 9 - Performance prediction for accident FO based on estimated sleep/wake schedule and circadian phase using the SAFTE/FAST model (courtesy of S.R. Hursh).

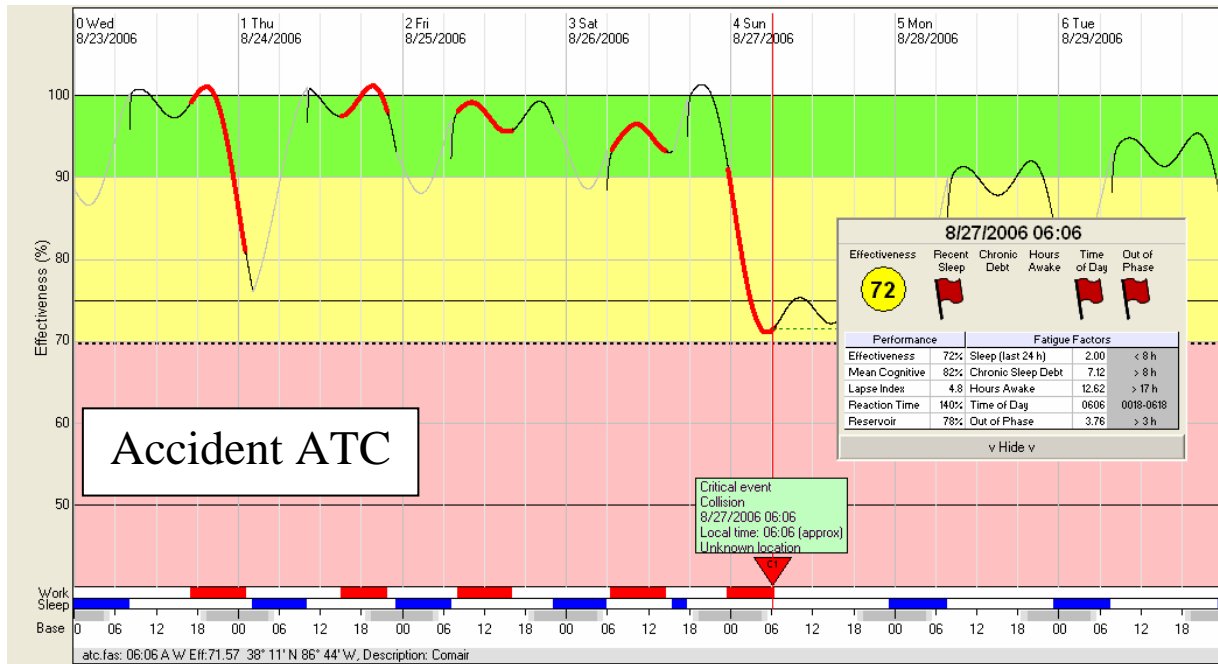
Figure 10 - Performance prediction for accident ATC based on estimated sleep/wake schedule and circadian phase using the SAFTE/FAST model (courtesy of S.R. Hursh).
