Our Reference: 420.1261/15 Rev01

USA A320 MSN1141 N113UW flight 1702 - Rejected take-off after rotation at Philadelphia - Airbus submission

On March 13, 2014, about 1830 eastern standard time, US Airways flight 1702, an Airbus A320, N113UW, experienced substantial damage after the captain rejected the takeoff after rotation on runway 27L at Philadelphia International Airport, Philadelphia, Pennsylvania.

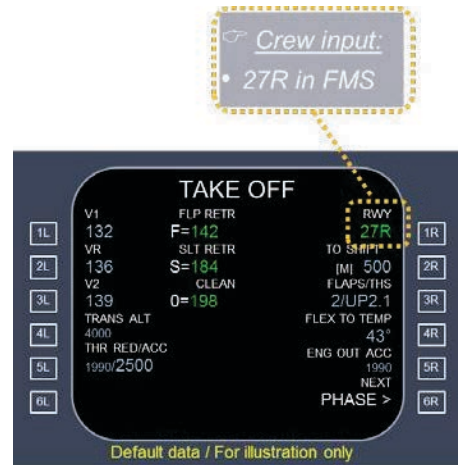
At the time of the accident, the aircraft had been assigned runway 27L by ATC. However the crew entered the data for runway 27R during FMS preparation. Relevant performance take-off data was inserted, which included the V-speeds (V1, VR, V2) and the flexible temperature (FLEX TO TEMP) since the take-off was to be performed at reduced thrust.

The discrepancy in FMS entry remained unnoticed during briefings and checks. The aircraft was taxied towards the assigned runway 27L. Taxi was performed with one engine shut down.

As the aircraft was in the queue, ATC informed that flight 1702, previously number 6, had become number 2. Consequently there was a change in the take-off sequence while a number of tasks were still to be carried out, including starting the second engine and performing the take-off briefing. At this stage, the FMS runway discrepancy, 27R instead of 27L was still unnoticed.

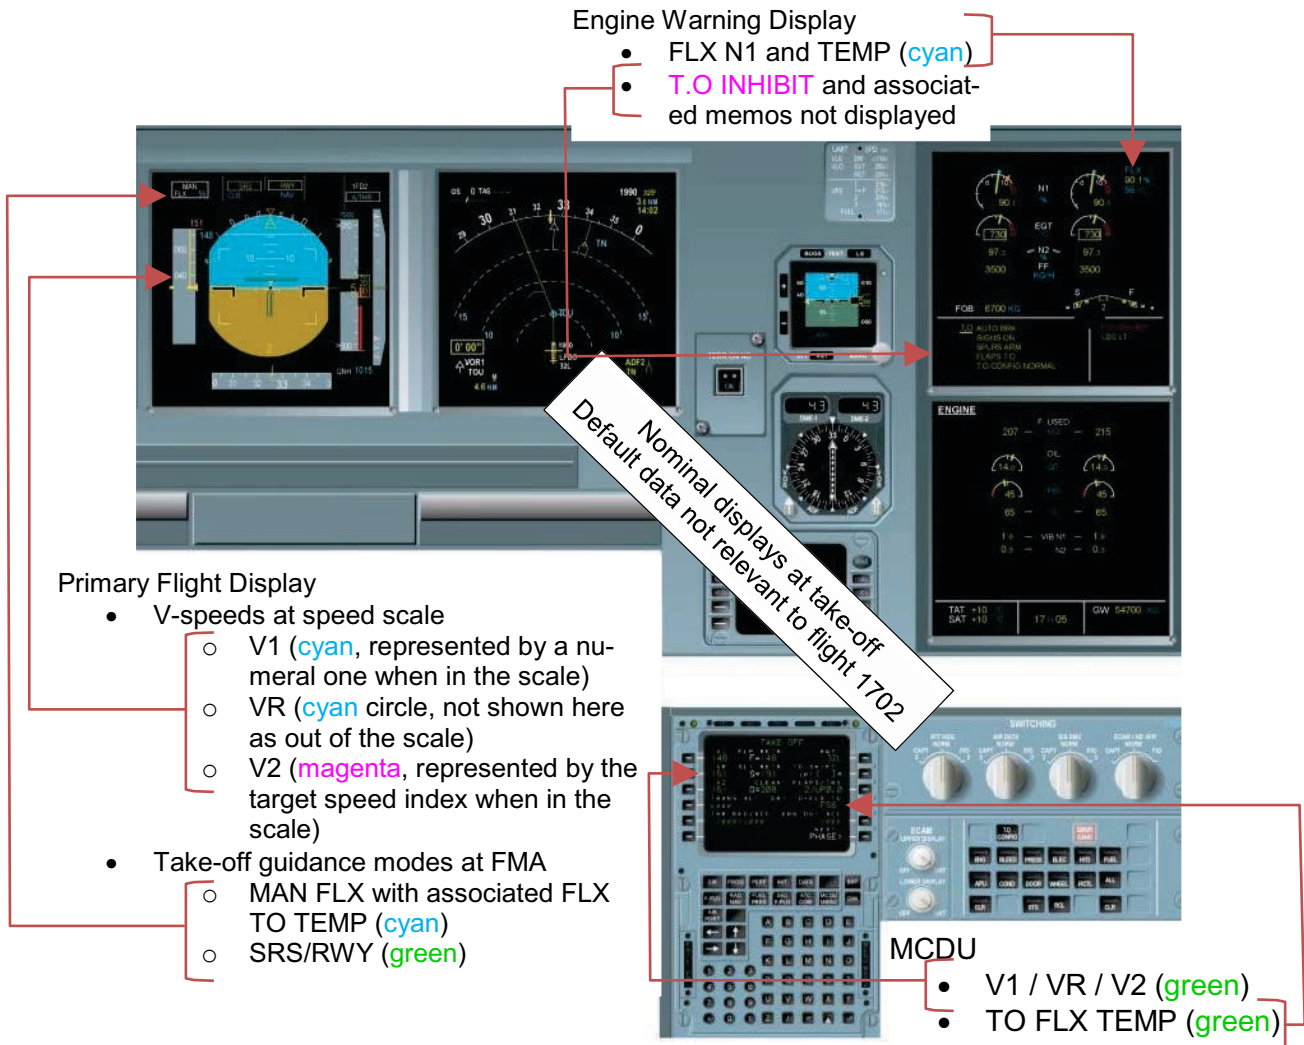
Nominal displays in case of a flexible take-off are illustrated here after. They are to be compared with the illustrations of §3.1. Only left hand and center displays are shown, right hand ones would be similar to the left ones.

During flight 1702, there were salient cues that FMS was not configured properly and that the take-off modes did not engage. These were mainly:

- At the MCDU, active boxes were empty, data was in the adjacent ones, and the amber memo **CHECK TO DATA** was displayed;
- At the speed scale, V-speeds were replaced by the red memo **SPD SEL**;
- At the FMA, take-off guidance modes and FLX MAN thrust mode were not displayed;
- At the Engine section of the E/WD, TOGA was displayed in place of FLX and FLX TEMP (after automatic thrust setting by FADEC);
- At the ECAM section of the E/WD, **T.O INHIBIT** and take-off memos were not displayed. Instead, **LDG INHIBIT** appeared as airspeed reached 80kt.

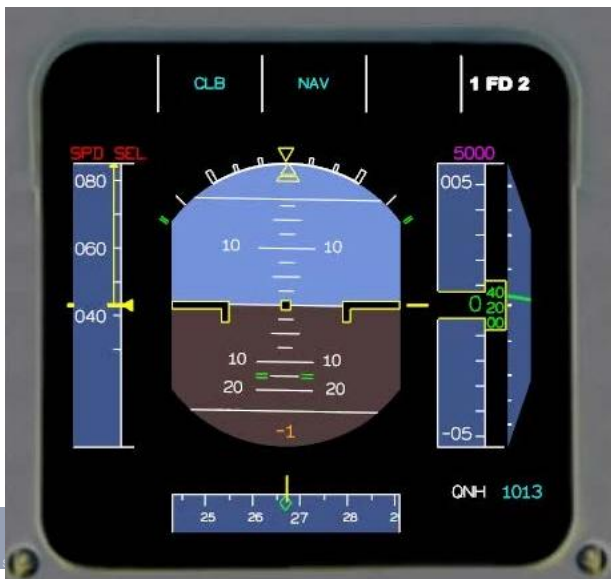
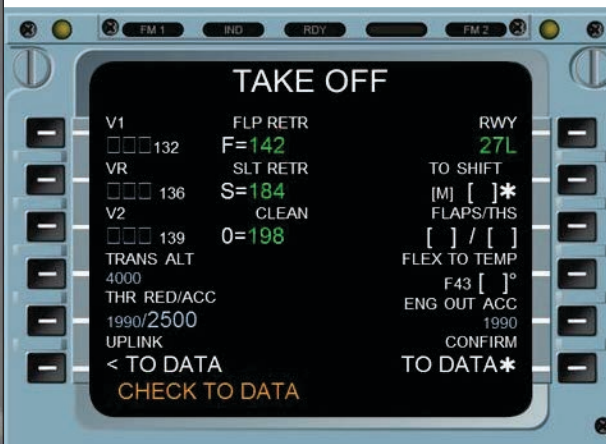
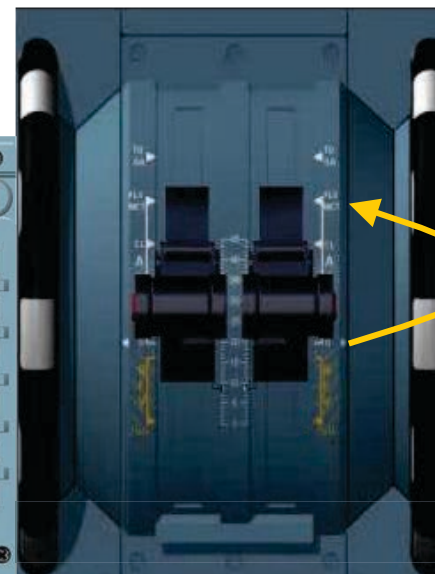
- Thrust levers set to FLX
 - Without FLX TEMP entered in the FMS, TO modes did not engage
 - Crew noticed V-Speeds were not displayed
 - T/O was continued with the V-Speeds in mind

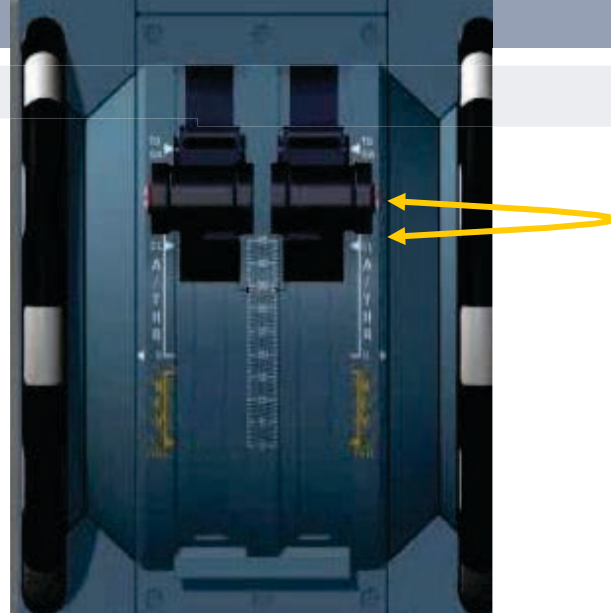
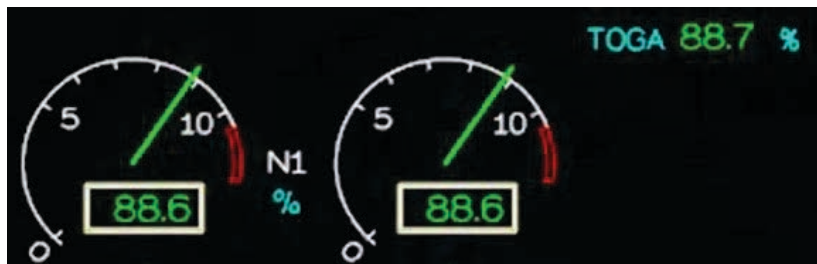
- Levers pulled back and then returned to FLX

- FADEC automatically set TOGA
- TO mode not engaged due to thrust levers setting
- Crew action:
- Crew confirmed TOGA thrust values
